# PRESERVATION OF CULTURAL HERITAGE OF THE KURDISH REGION IN IRAQ

Italian Cooperation Project  
in Iraqi Kurdistan (2009-2010)

1.1 <i>Topographic Survey and Cartography in the Ancient Center of Erbil</i> Sven Stefano Tilia	pp. 9-12
1.2 <i>The Graphic Documentation of the Rashid Agha diwan khanah</i> Angela Bizzarro	pp. 13-16
<b>2. Restoration Plan for the Rashid Agha diwan khanah on Erbil Citadel</b>	<b>p. 17</b>

2.1 <i>Project Methodology and Historical Profile</i> Giuseppe Morganti	pp. 17-20
2.2 <i>Diagnostic and Conservation</i> Giolj F. Guidi	pp. 21-24
2.3 <i>The Knowledge of the Building as a Basis for the Intervention and the Restoration Plan Design</i> Rossana Nicolò	pp. 25-30

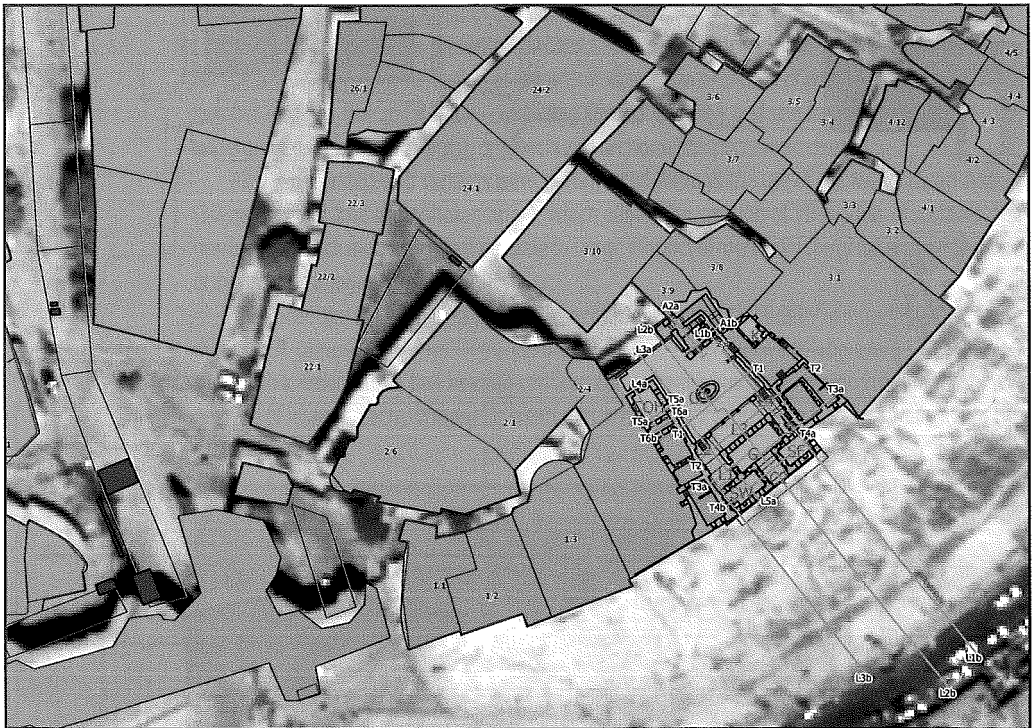
Fig. 7. View of the GIS system with the Rashid Agha diwan khanah and the surrounding areas of the Citadel. The red lines cover the geophysical surveys (in blue, the detected anomalies)

In collaboration with Julian Bogdani, this complex system of data acquisition, closely connected thanks to the geographic reference of the data, is managed through a Geographical Information System (GIS) in which different kind of information are contextualized with all the related analyses, from the general to the detailed plan, to the sampling areas (Fig. 7).

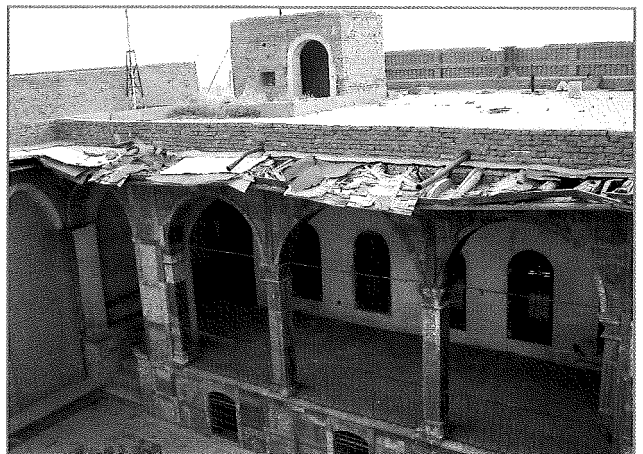
Fig. 2. Façade, NNW prospect (view from the roof). Degradation of wooden shed

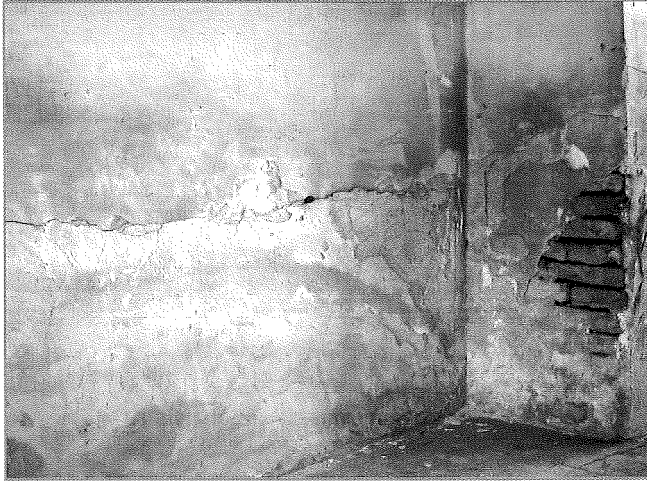
Fig. 3. Damage caused by water seepage on the SW wall, adjacent to B1-1/3 building

plastered walls of the loggia, instead, are generally very compromised as a result of the seepage of capillary rising water, revealed by dark spots and disintegration of the plaster (Fig. 3).

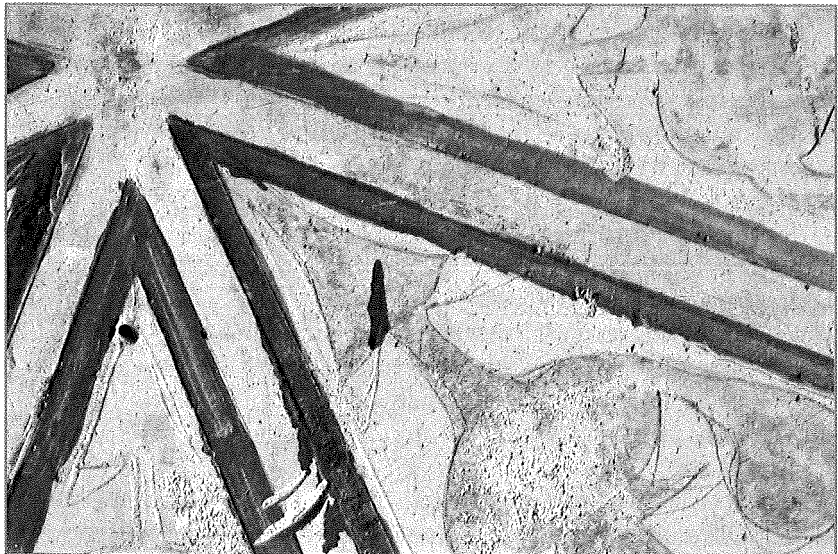
Fig. 3. Geometric decoration in purpurin (phase 4), performed on the vegetal decoration in blue (phase 3)

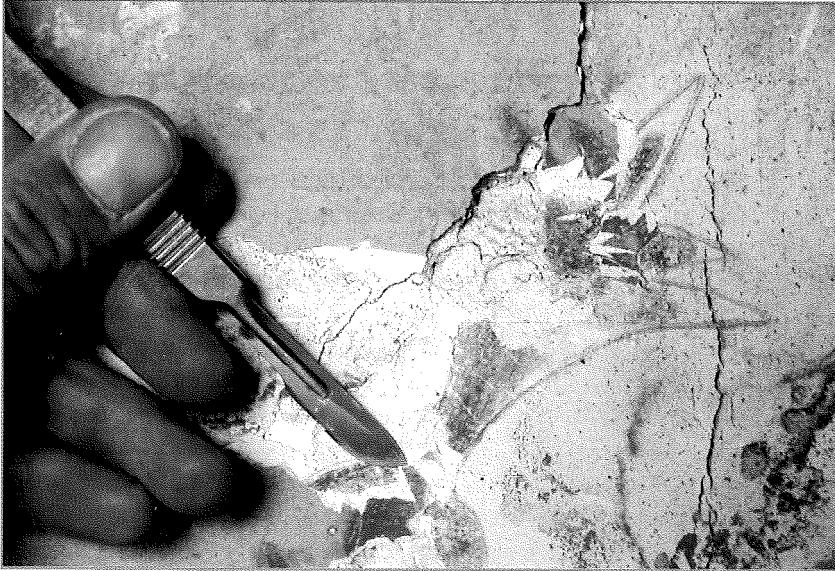
*Fig. 4. The image shows a stage of the stratigraphic investigation carried out with the tip of a scalpel on a portion of the decoration in room C1. Note the overlap of phases 2 and 3, the preparatory incision, the drawing in graphite (pencil), the traces of dust between the two layers and the clear difference of the constituent pigments of the two pictorial phases*
