NOTE ON THE FOURTH SEASON OF THE ITALIAN RESTORATION PROJECT IN KINGDOM SAUDI ARABIA,  
DŪMAT AL-JANDAL

Romolo Loreto, Università degli Studi di Napoli, "L'Orientale"

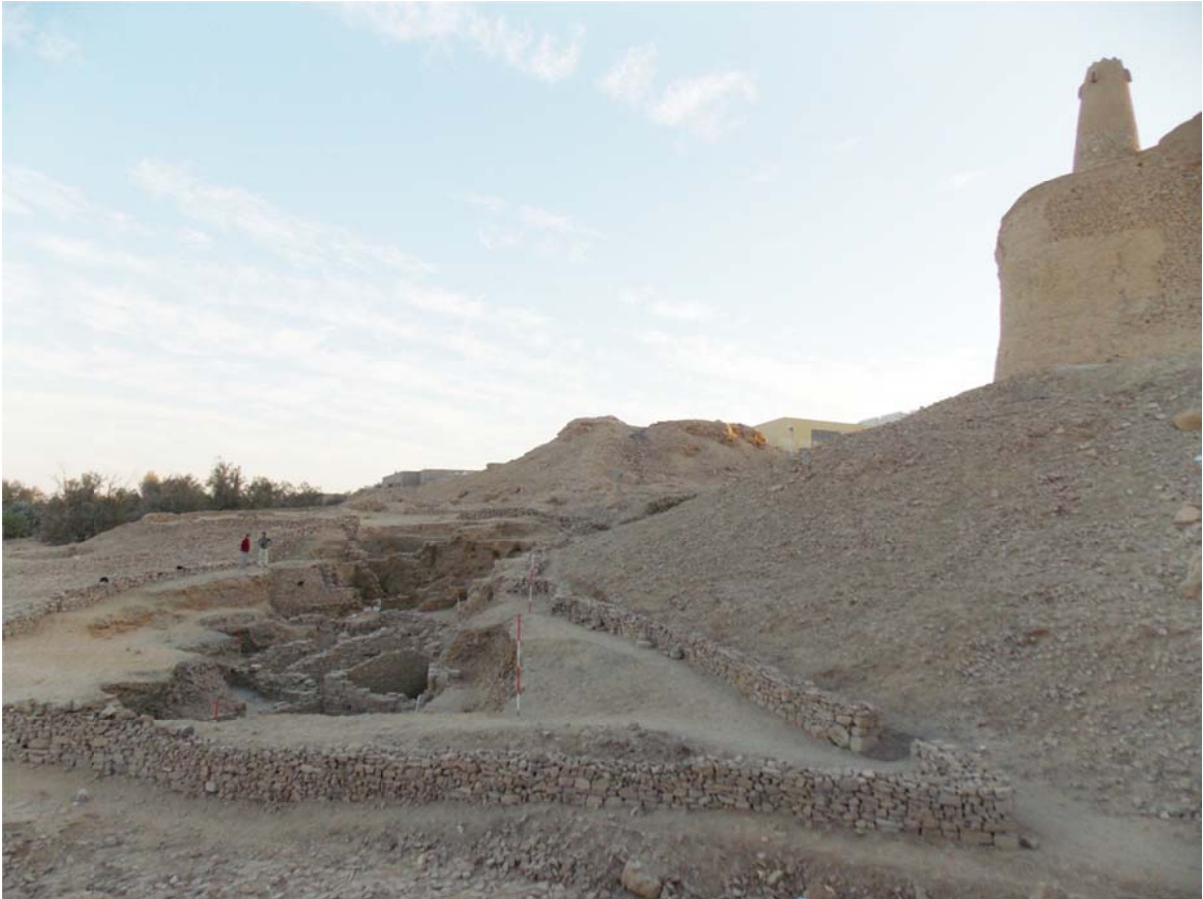
Fig. 1 - General view of the Trench 1 (2009-2016). In the foreground the southern slope of the *wādī* al-Sirhān; on the right the eastern slope of the acropolis. View from North

- 1) the action of water washout that determined collapses and landslides of various material (sandy material, stones, etc.) coming both from south (from the top of the wādī al-Sirhān southern slope) and from west (from the top of the acropolis) (Fig. 1);
- 2) the corrosive rainwater phenomenon that determines the mechanical erosion of the mud and clay. Thus, a detailed hydrogeological study will be conducted in order to define practical solutions for the canalization of the water streams.

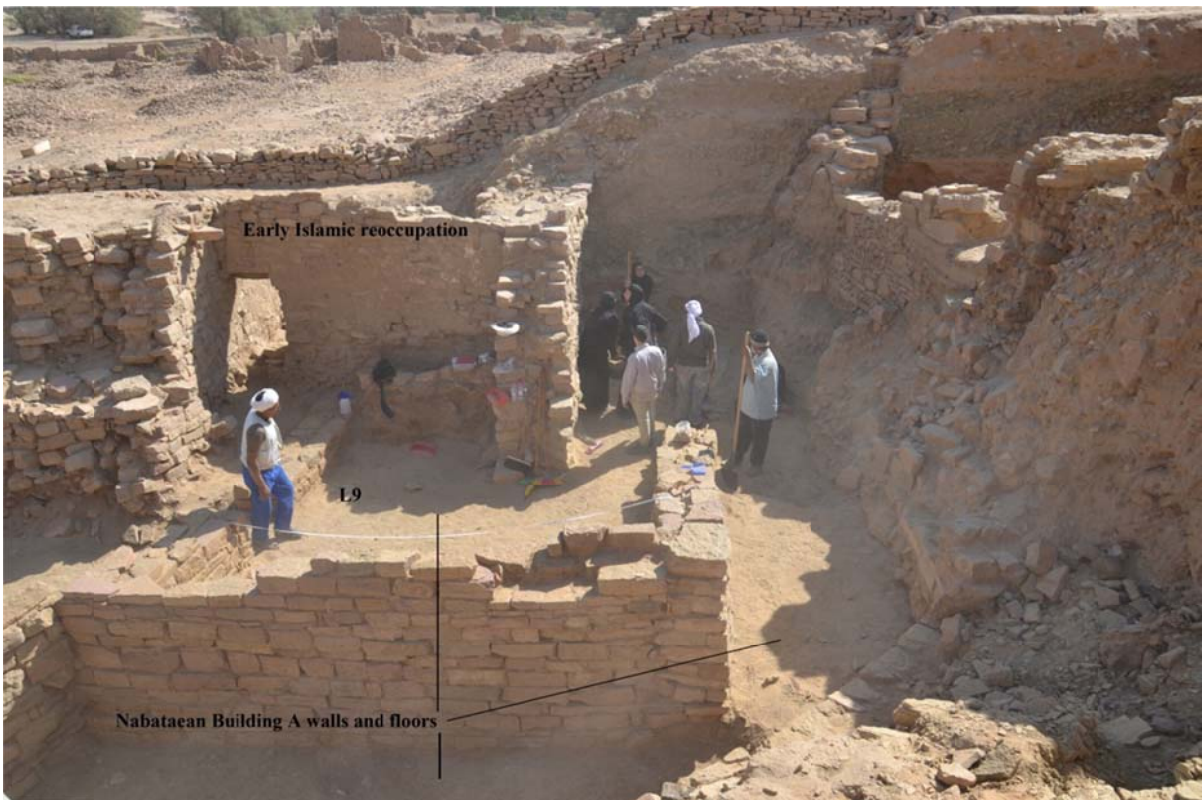
Fig. 2 - Cleaning of the Nabatean Building A floors. View from West

All surface deposits (sand, debris and vegetal remains) were removed with brushes and flat brushes with soft bristles (Figs. 2-3). This procedure took place on the upper sections of the walls, on the walls façade and on the floors.

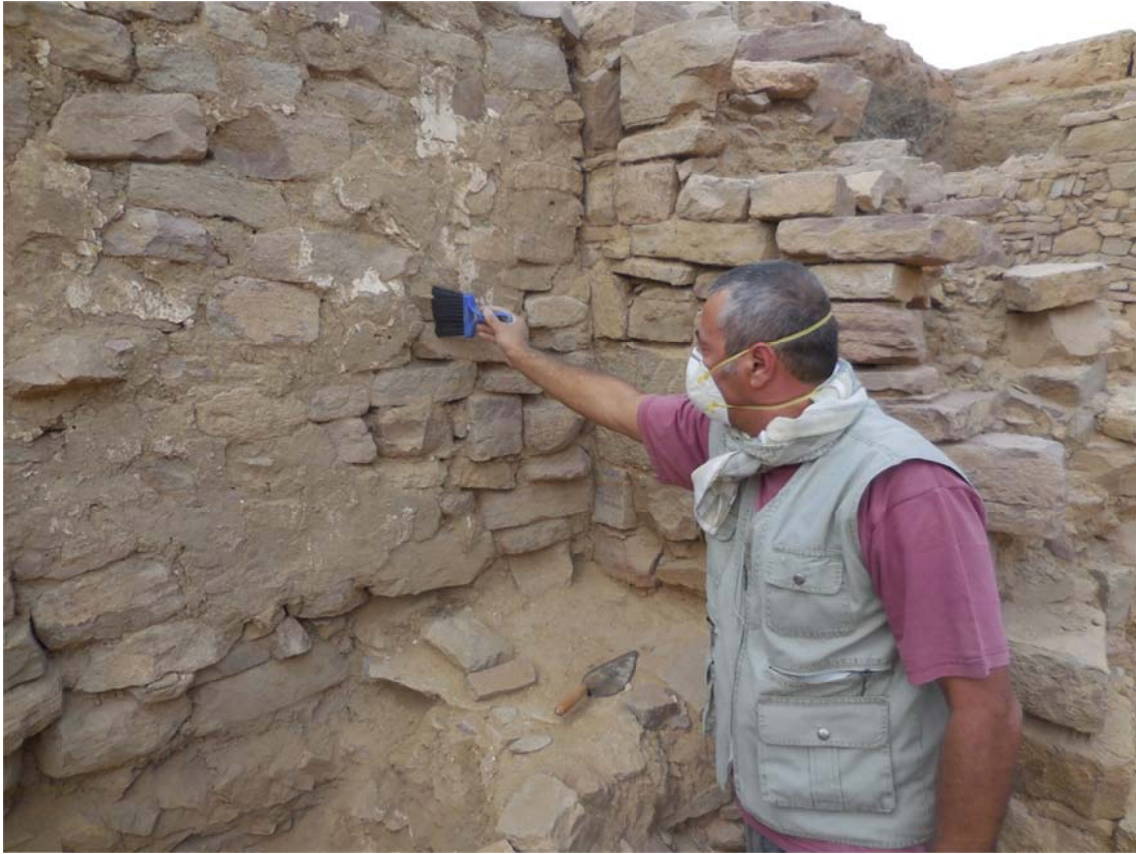
Fig. 3 - Cleaning of the white *tin* plaster on the Early Islamic walls

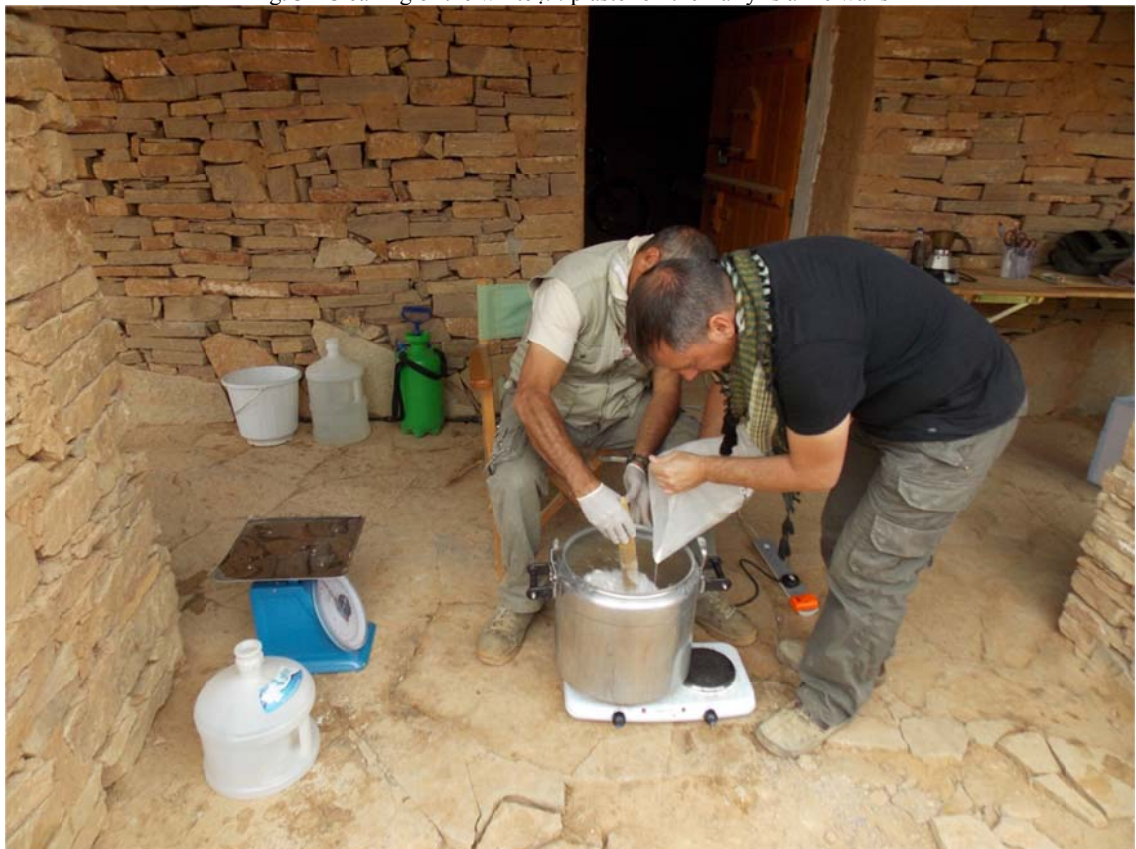
Fig. 4 - Preparation of consolidating natural resin

Consolidation of upper sections of the walls, walls façades and floors was carried out by impregnation of 5-10% natural resin mixed in hot water (Figs. 4-8), to improve the cohesion

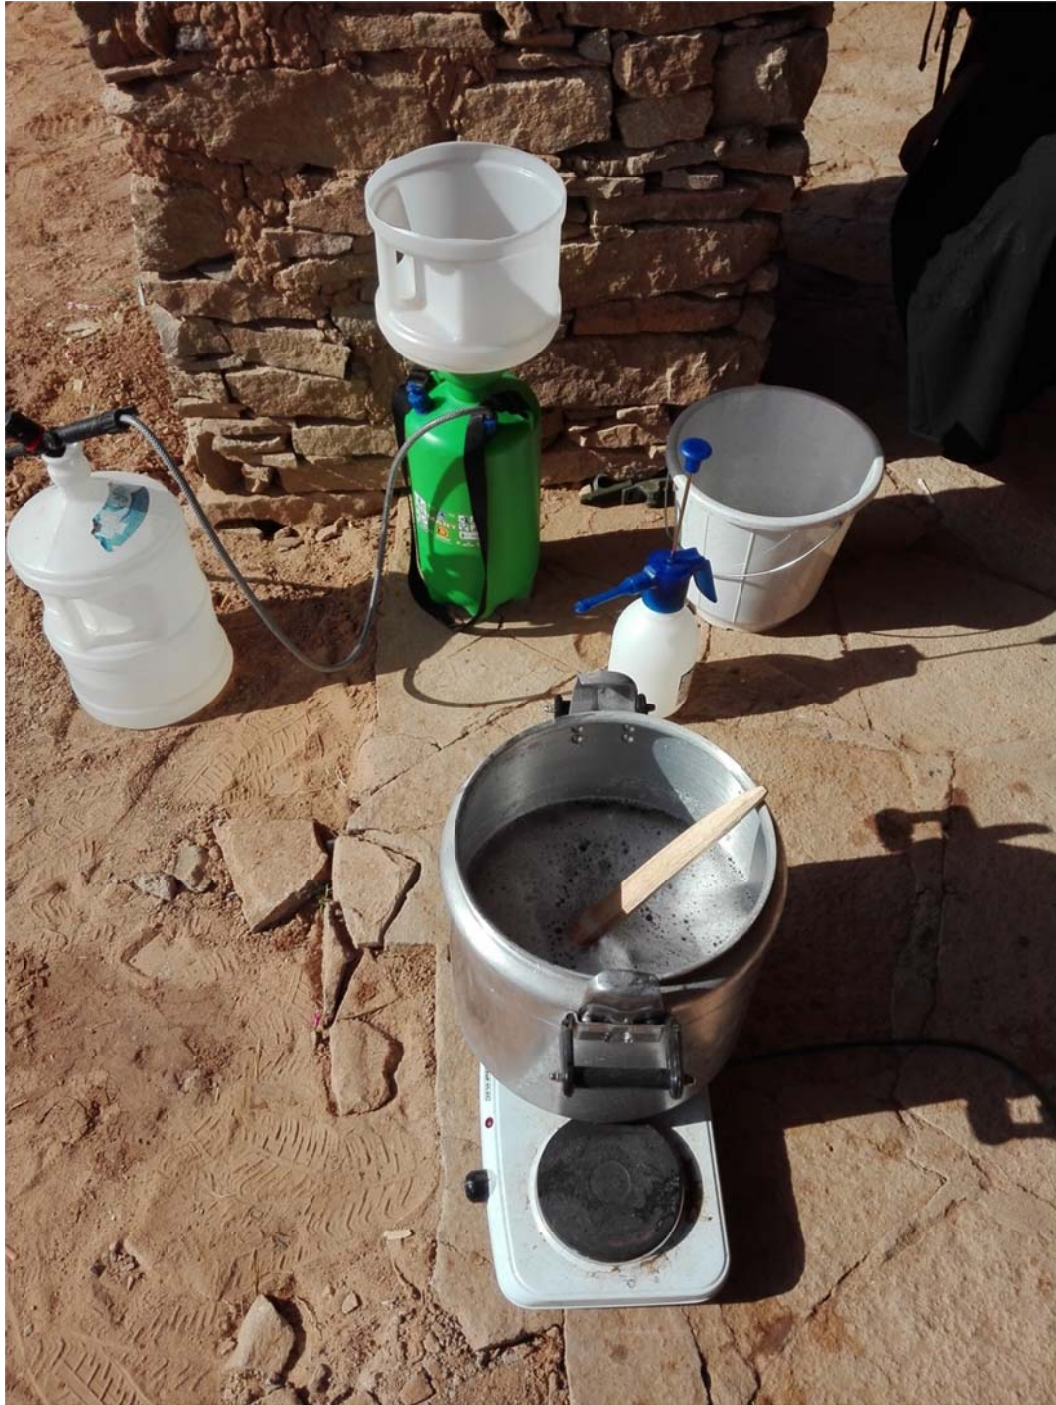
Fig. 5 - Boiling water for the preparation of the natural resin

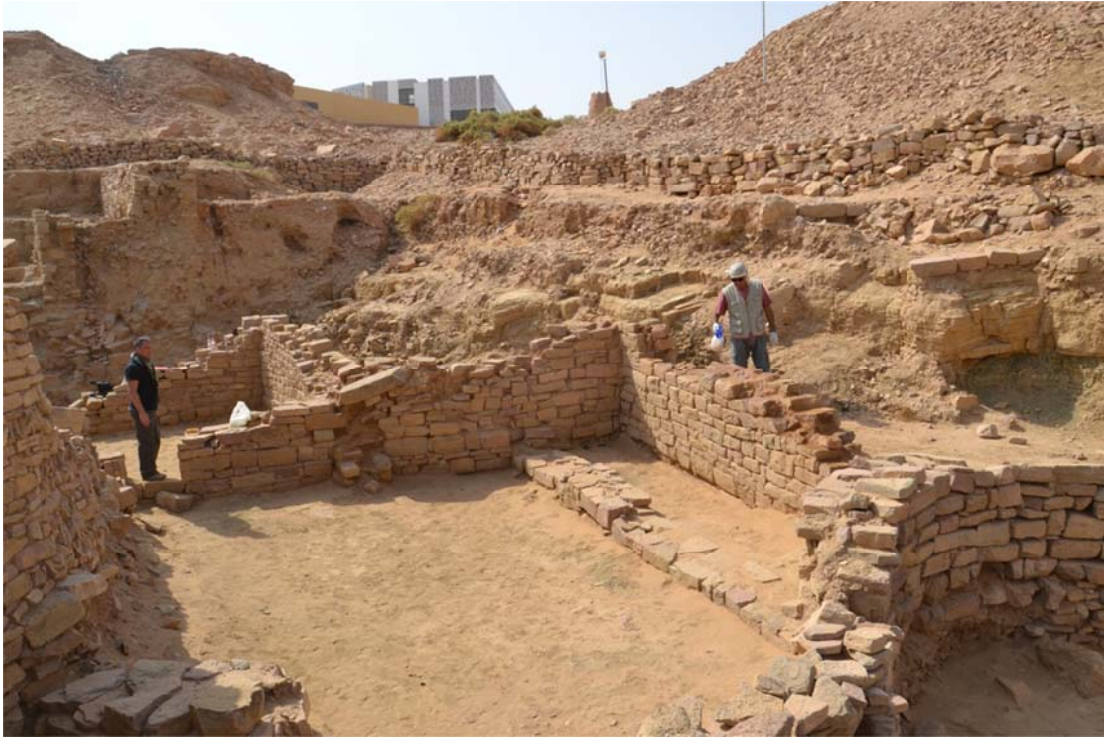
Fig. 6 - Consolidation of the upper sections of the Building A walls. View from North-East

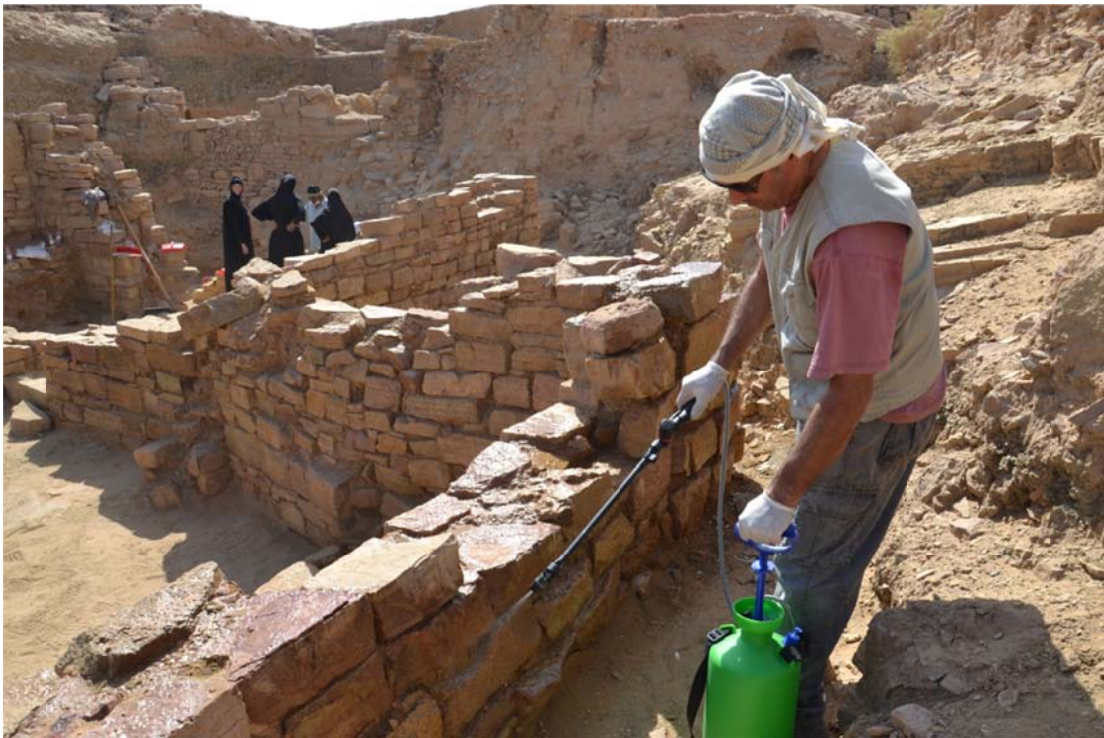
Fig. 7 - Detail of the consolidation of the façade of the Building A walls

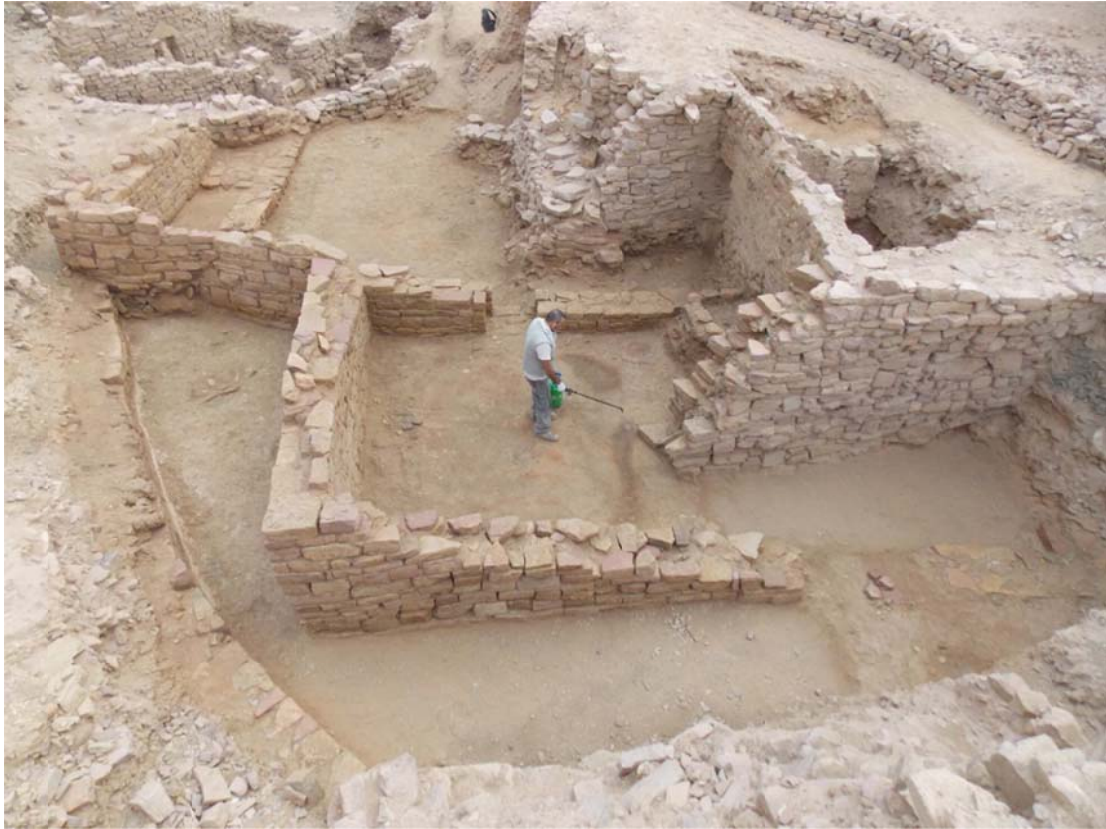
Fig. 8 - Building A after the first complete consolidating intervention. View from South

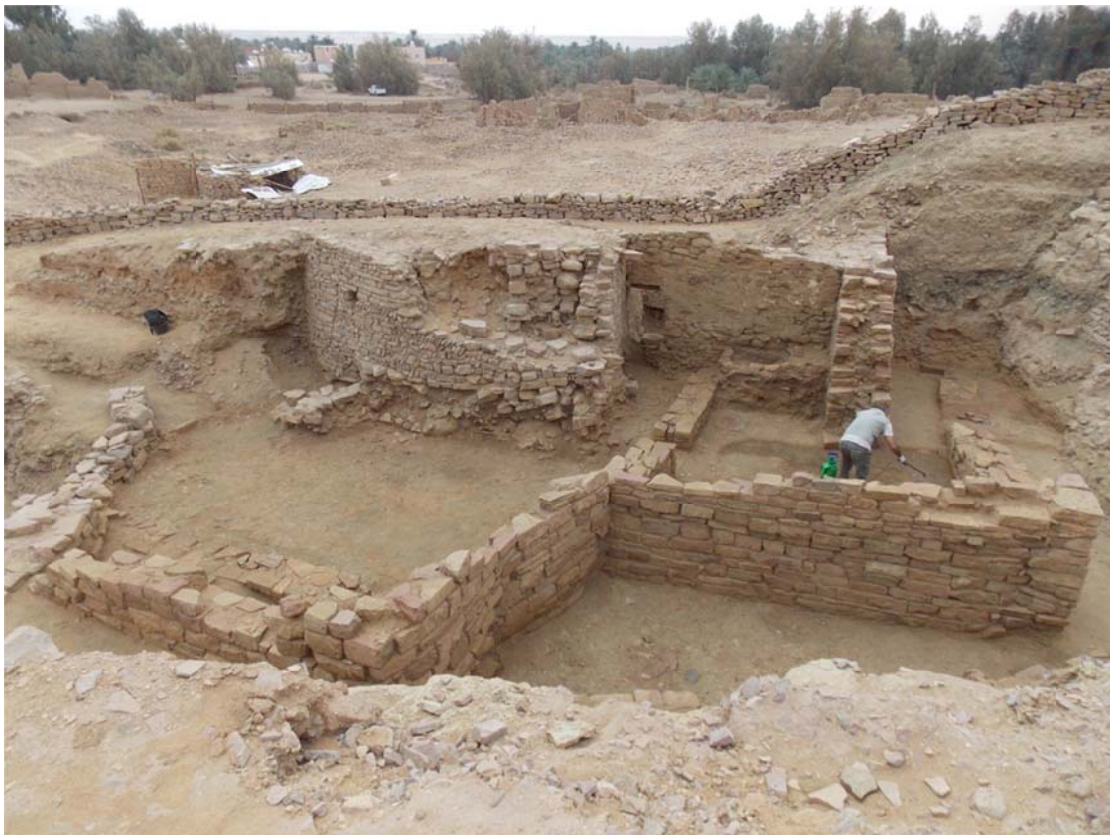
Fig. 9 - Building A during the second consolidating intervention. View from South-West

and adhesion of mud and clay. Repeated treatments have been performed in order to increase the adhesive capacity and the anchorage of the masonry core and a greater resistance against the action of rainwater (Fig. 9). The efficacy of treatment with natural resin was immediately noticeable and satisfying. Obviously one has to wait at least a year to ascertain the true condition of the treated surface, since the real dynamics and environmental degradation rate of the building, still under study, is not certain.

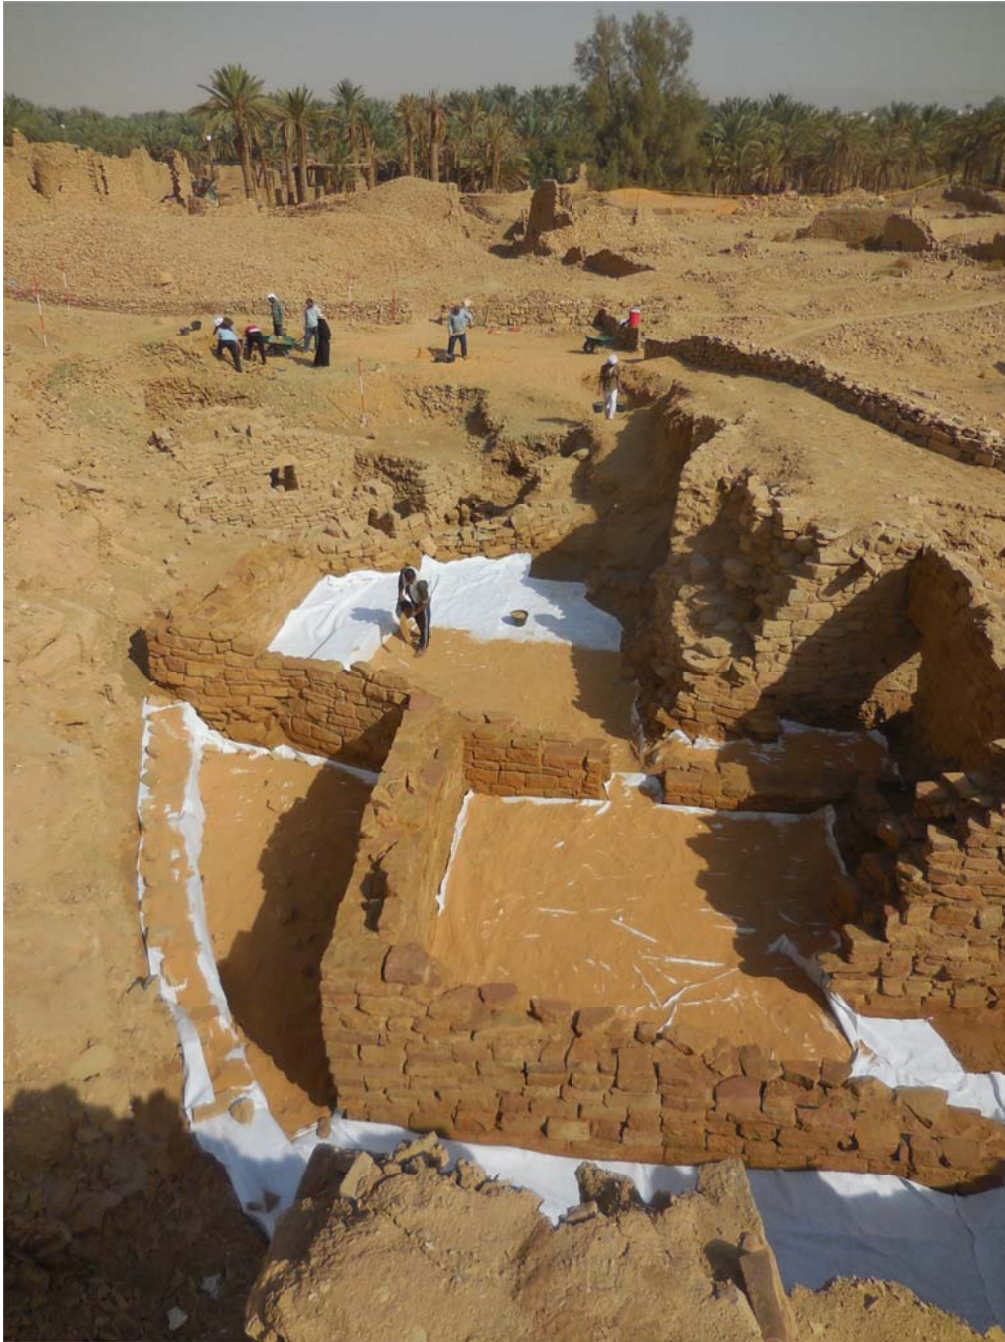
Fig. 10 - Final protective step, placement of the cover non-woven Geodren 200. View from South

Over the entire surface of the floors a protective cover non-woven (Geodren 200) was placed (then covered by sand and stones) in order to protect the original mud from the mechanical action of rain and anthropic action (Fig. 10).

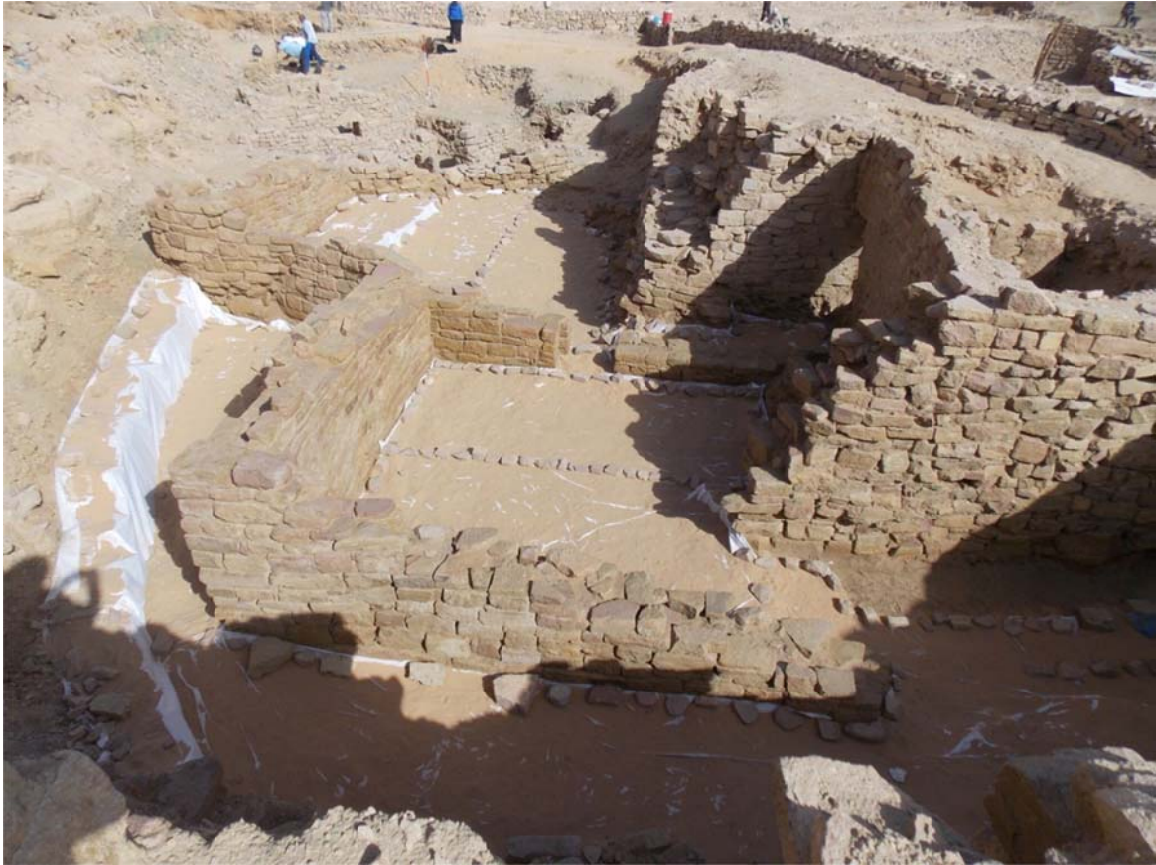
Fig. 11 - Building A at the end of the intervention. View from South

The photographic documentation related to the different stages of work was arranged in a digital archive (Fig. 11).
