## THE ITALIAN EGYPTIAN PROJECT OF STUDY AND CONSERVATION OF THE MONASTERY OF ABBA NEFER AT MANQABAD 2018 - 5TH CAMPAIGN

Rosanna Pirelli, Università degli Studi di Napoli "L'Orientale"  
with contributions by Angela Bosco, Paola Buzi, Andrea D'Andrea, Mohamed Kenawi, Ilaria Incordino, Pasquale Musella,  
Stefania Mainieri, M. Dilettia Pubblico, Andrea Ragionieri, Anna Salsano

The report is divided into four main paragraphs (with some sub-paragraphs), corresponding to the activities carried out: A. Topographical survey; B. Archaeological activities; C. Epigraphic survey; D. Restoration activities; in the Concluding remarks the main results will be summarized.

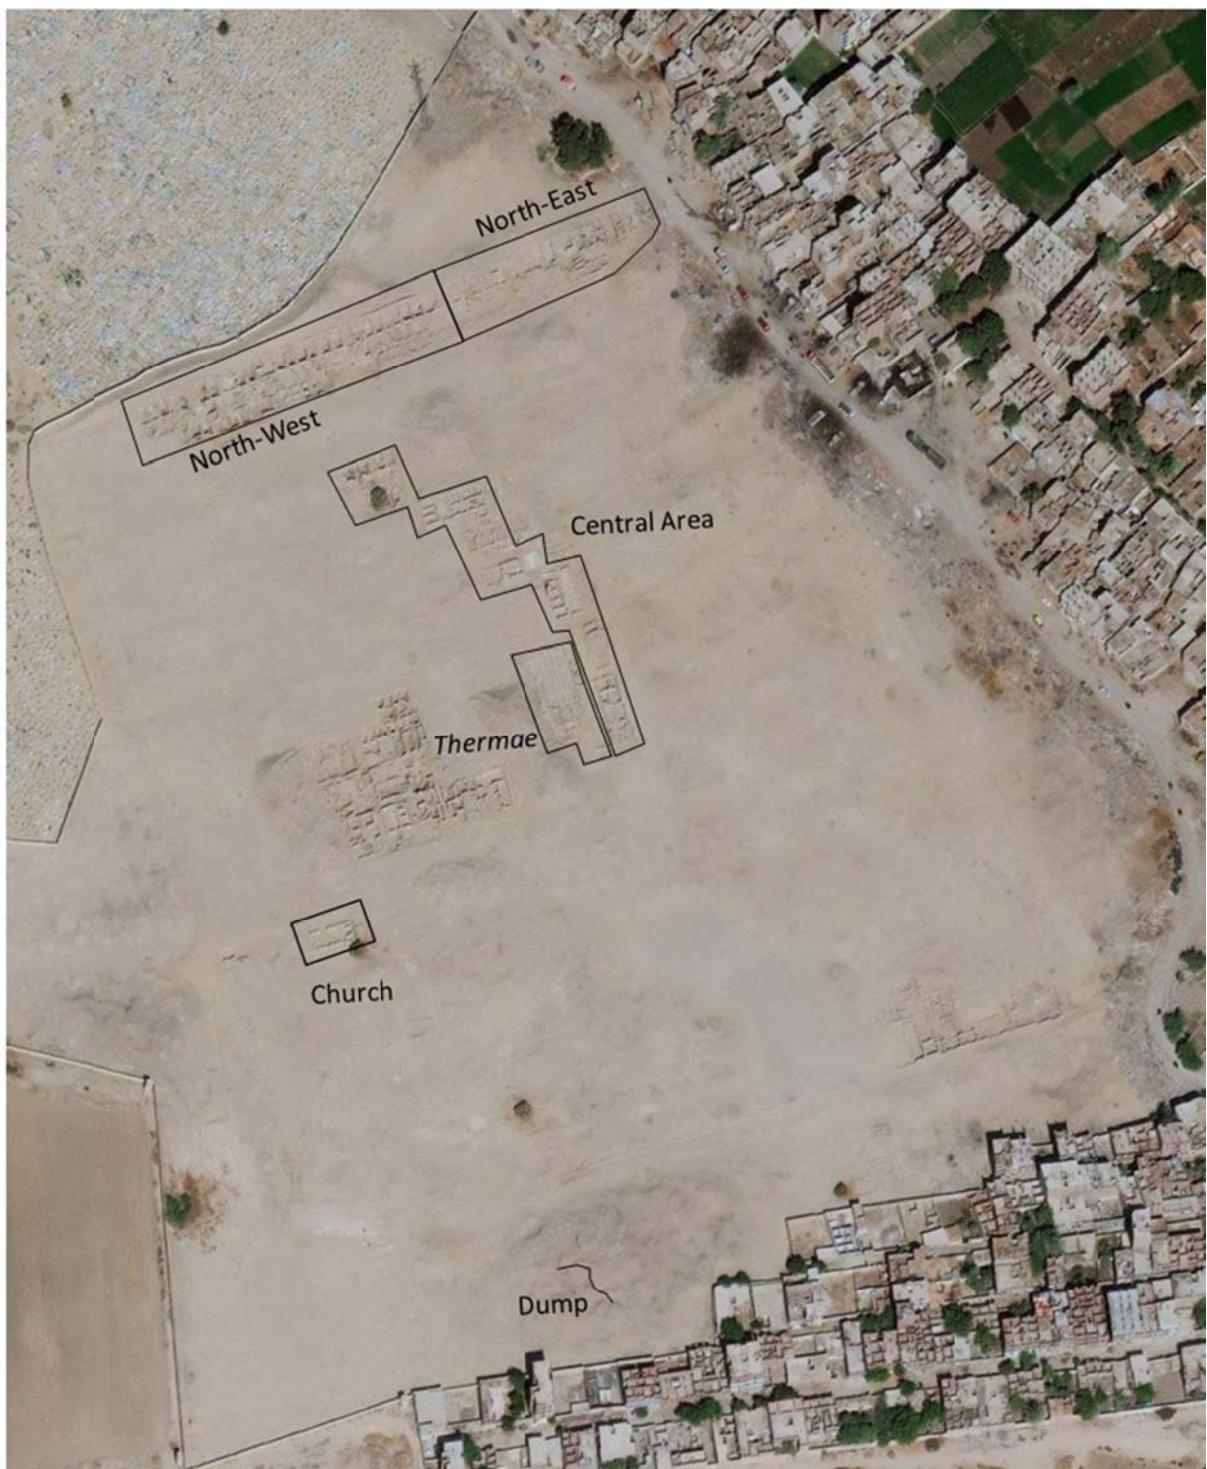
Fig. 1 - Satellite view of the archaeological area. The black rectangles identify the areas surveyed by photogrammetry during the 2014 and 2018 campaigns

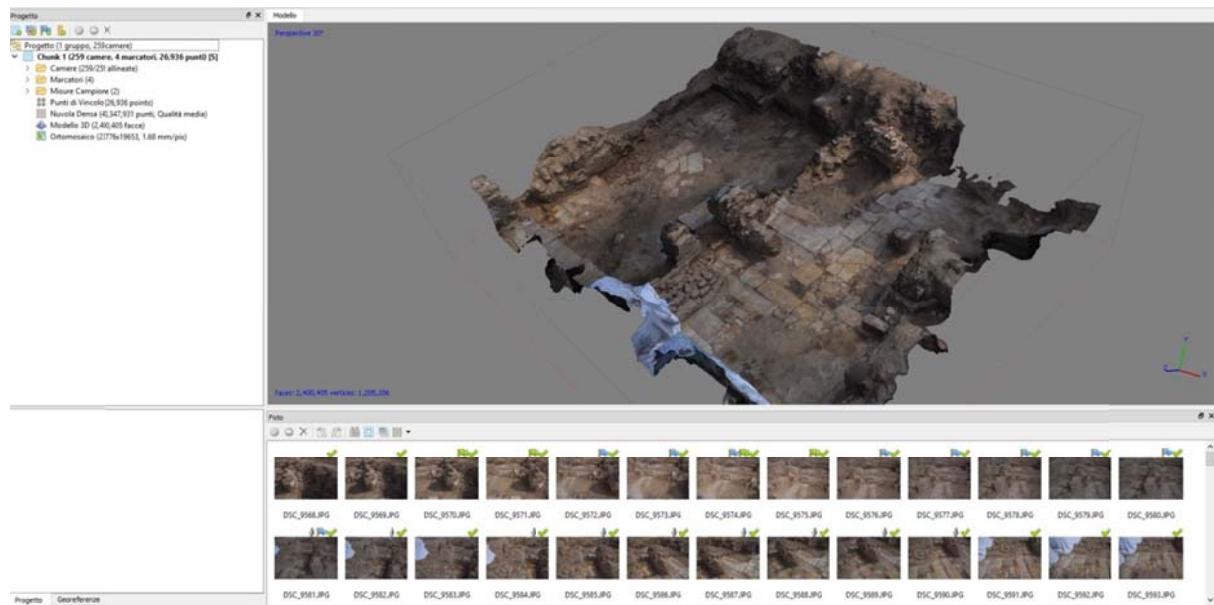
Fig. 2 - The final model of the rooms 2-3S processed by Agisoft Photoscan. The images were acquired by Nikon D750

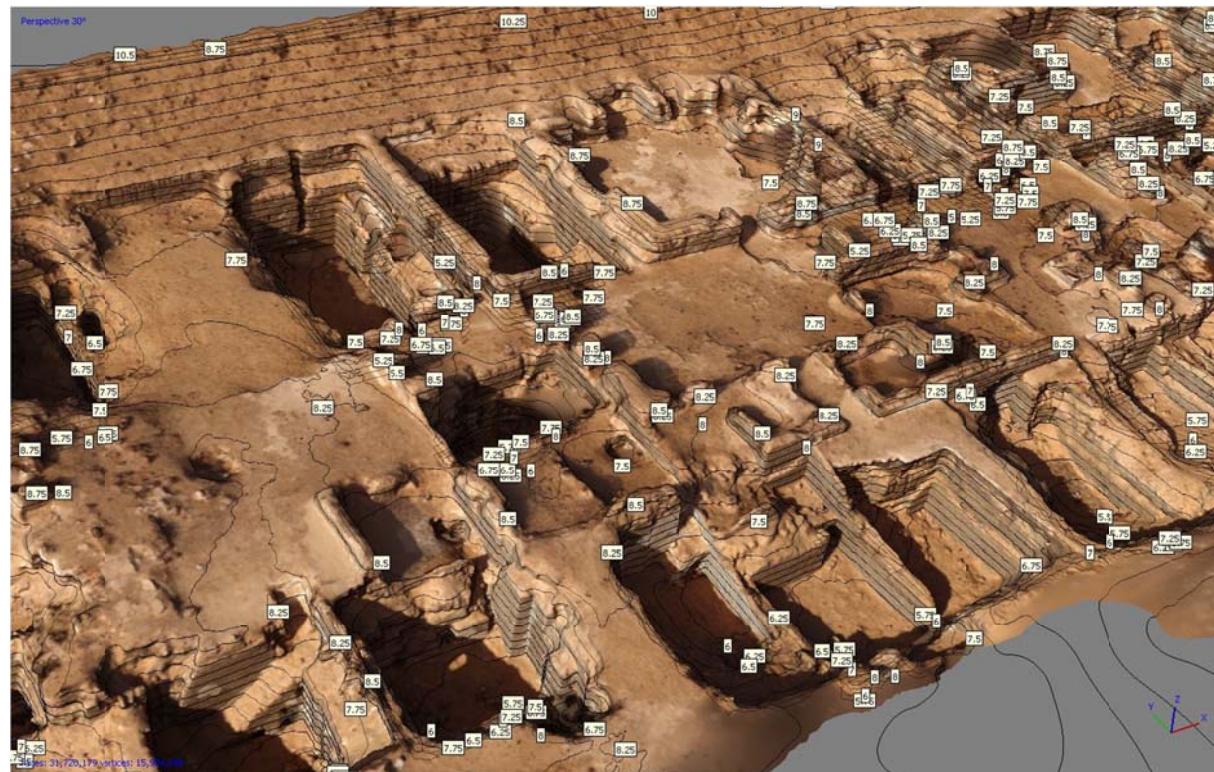
Fig. 3 - The 3D model of the North area after applying the tool to create contour polylines. The labels indicate the elevation each 25cm

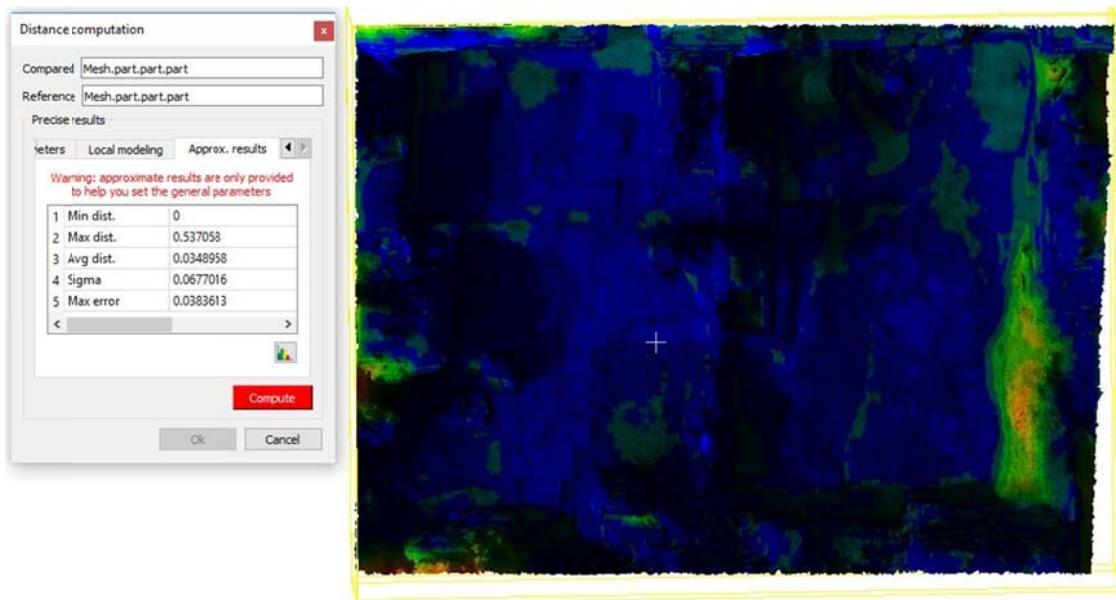
Fig. 5 - A comparison between the surveys by Osmo and Nikon D750 of AUs 2 and 3 of the North area. The colours highlight the areas of complete overlap in blue and deviations in yellow and green

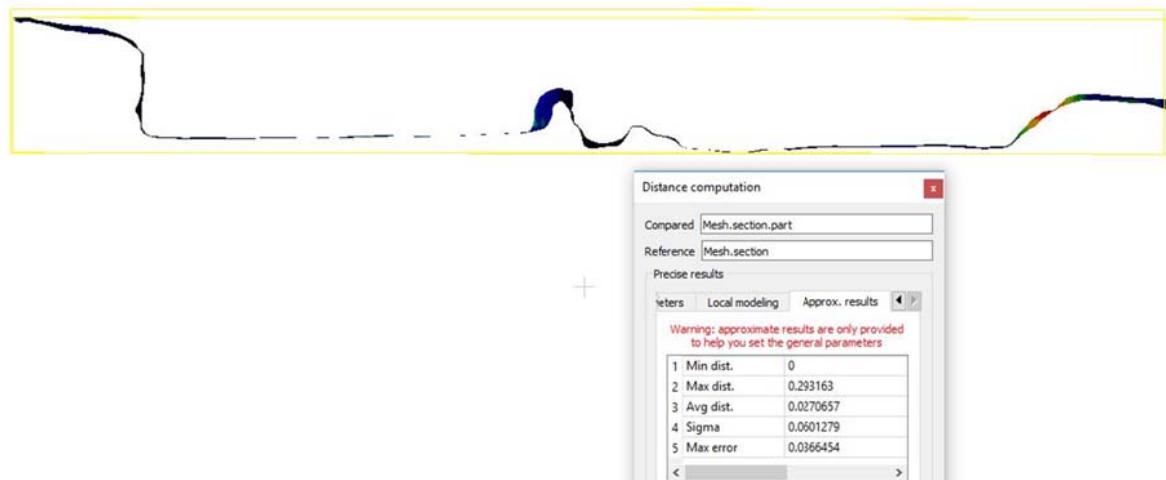
Fig. 6 - A comparison between the sections by Osmo and Nikon D750. The area with the greatest deviation (in red) is related to an accumulation of sand removed after the acquisition by Osmo

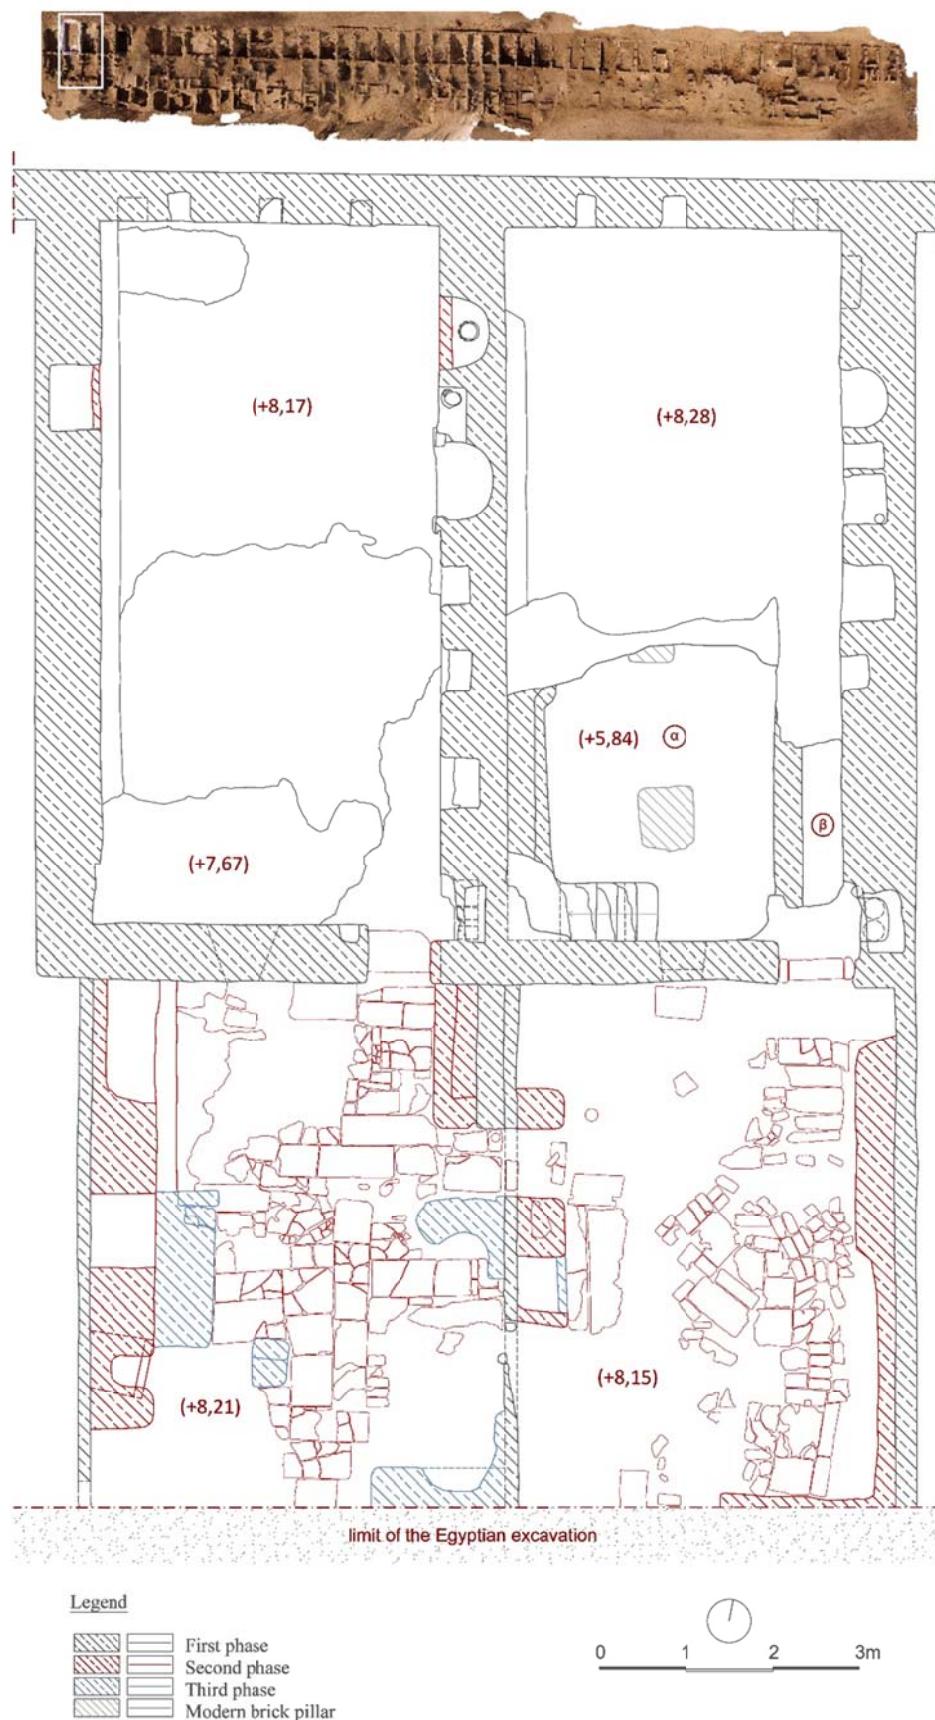
The northern sector is occupied by a HU of Type 1, while its southern sector is occupied by a complex of service buildings. The whole AU is in a bad condition, due above all to the previous digging activities, but also to the fragility of the thin walls of the court (Fig. 7).

Fig. 7 - Plan of the contiguous AU2 and AU3 (Drawn by Daniela Palomba, Dep. Of Architecture, University of Naples, Federico II)

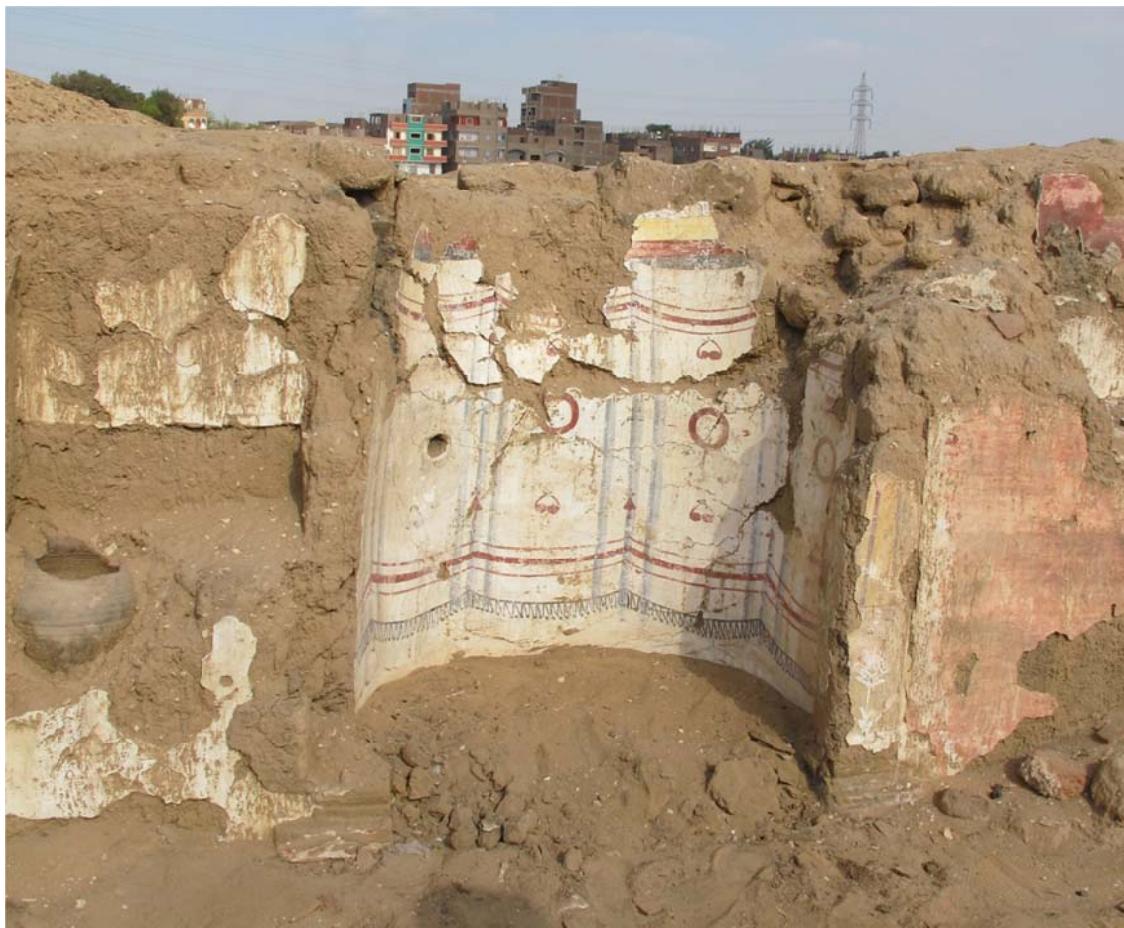
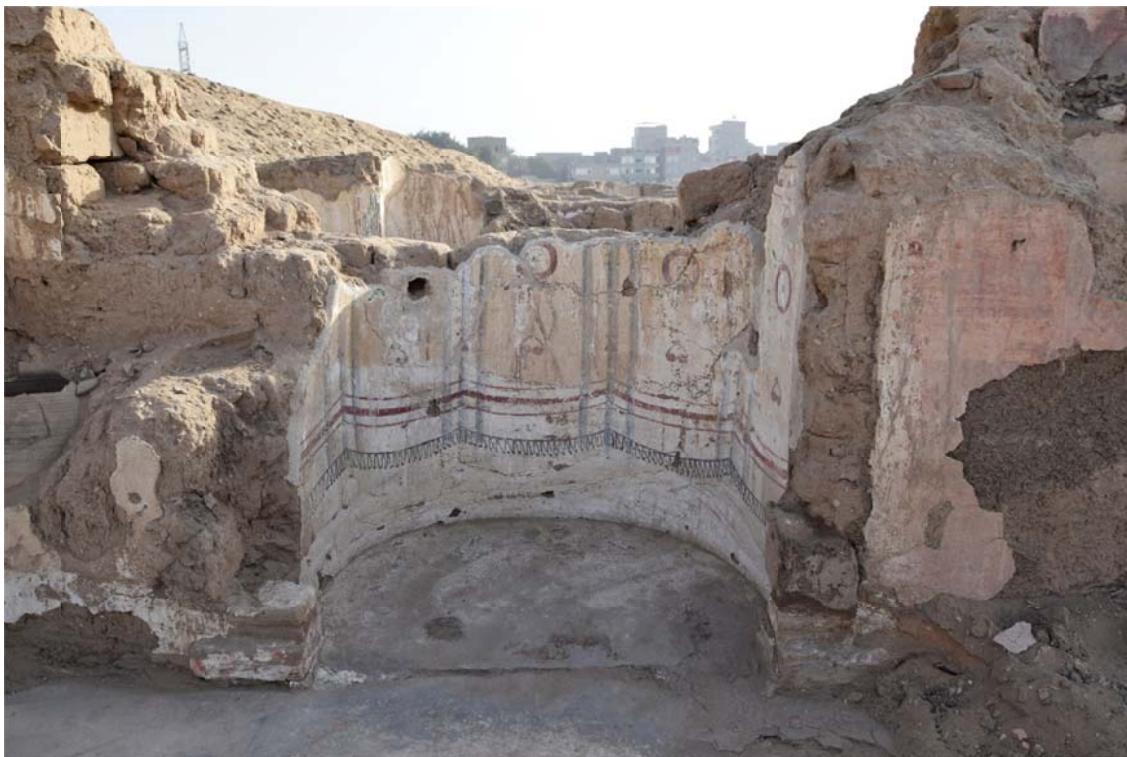
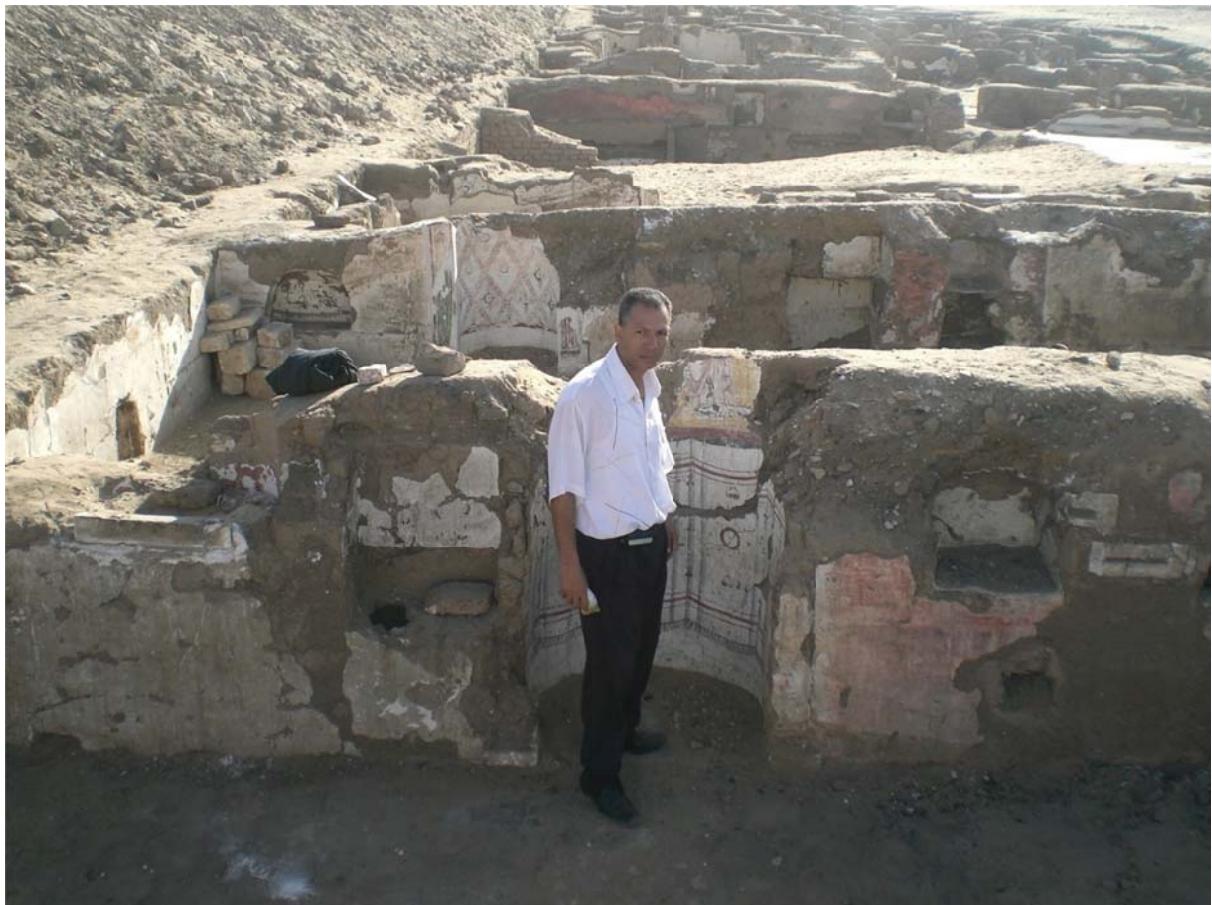
has undergone major damage between our survey in 2014 and this last season, due to atmospheric agents (Figs. 8, 9, 10) (see also § D. Restoration activities). Moreover on comparing our pictures, taken both in 2014 and in 2018, with some photographs of the previous excavations, kindly provided to us by Dr Ahmed Suleiman during this season's work, we also have to regret the loss of an important portion of the niche showing the lower part of the image of a saint, today completely missing (Fig. 10).

Fig. 8 - The oratory niche of AU2N in 2018

Fig. 9 - The oratory niche of AU2N in 2014

Fig. 10 - The oratory niche of AU2N during the Egyptian investigation in 2006

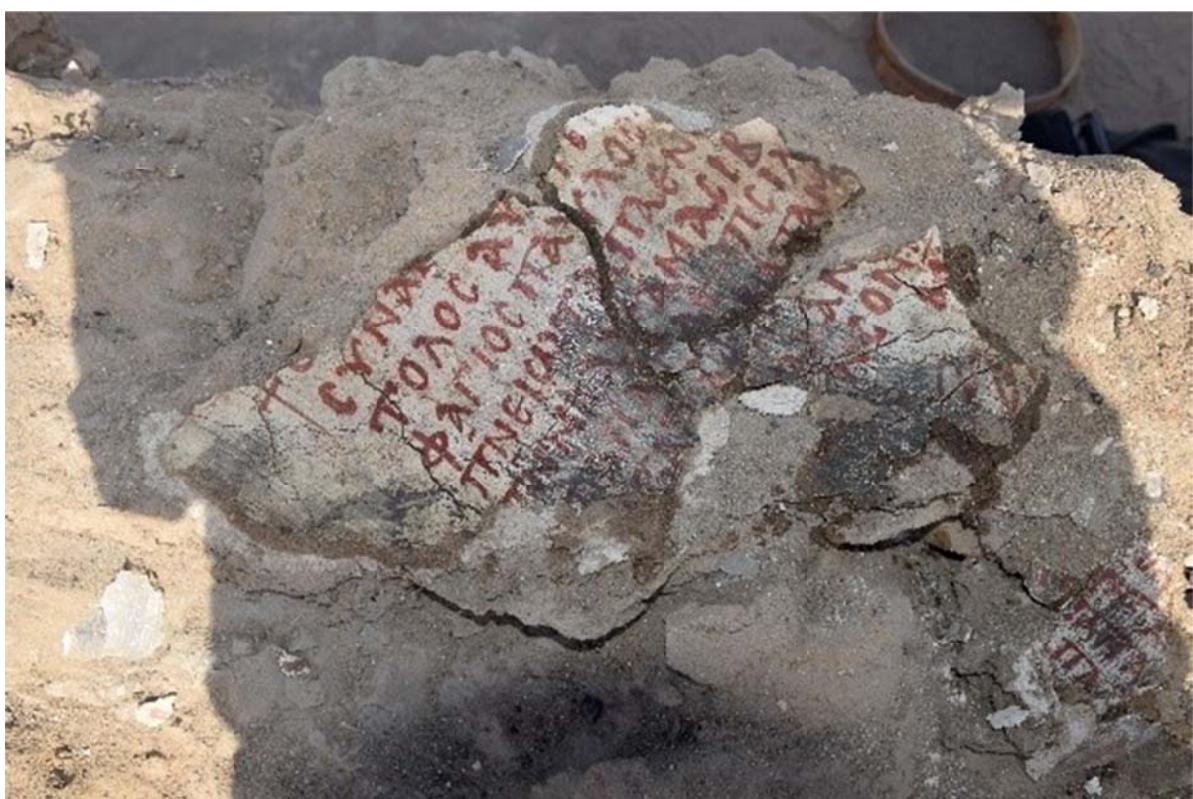
Finally, on the remnants of the western wall of the room, separating AU2N from AU1N, a Coptic inscription painted in red ink was found. It was detached by the restorers and kept in the storehouse of the site to enable it to be studied (Fig. 11).

The second inscription is a long, uncompleted text (Fig. 11), found in collapsed layer of AU2 and mentioning the ‘usual’ saints of Saqqara and Manqabad - Apa Jeremias, Apa Enoch, our mother Ama Sybilla - but also a certain Paul, who very likely is Paul of Tamma. All these characters are related to the cultural and monastic milieu of the so-called Middle Egypt and they represented a form of semi-coenobitic monasticism.

Fig. 11 - The newly discovered Coptic inscription, from top of the wall between AU1N and AU2N

Notably during dusting in AU2N, working on the West wall (bordering the East wall of AU1N) some pieces of inscription plaster were found: first they were cleaned from sediment of ground until the inscription was clearly readable. The painted surfaces were consolidated with ethyl silicate and then they were covered with Japanese paper and carboxyl cellulose; when this overlay dried out, the pieces of the inscription were removed.

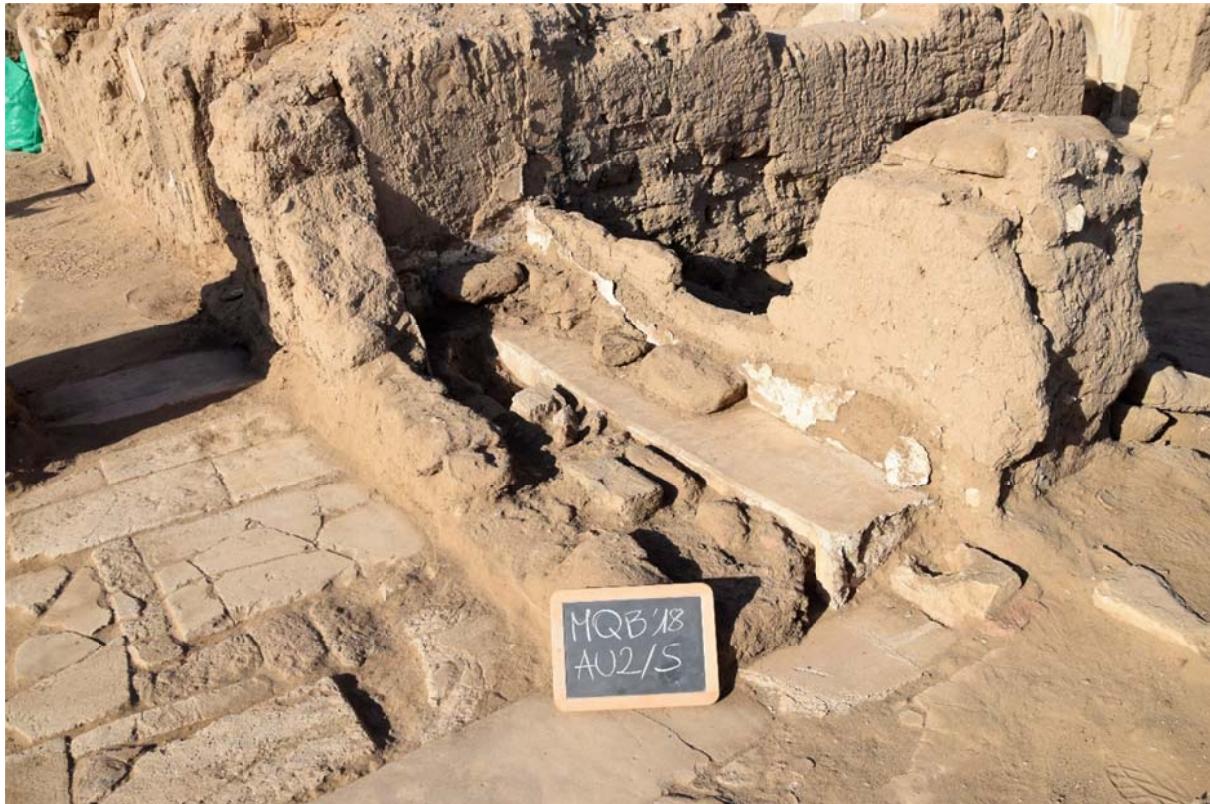
- a. the floor was almost completely paved with reused square and rectangular limestone slabs<sup>15</sup>;
- b. the western wall was reinforced to a thickness of 0.60m;
- c. a small hearth was collocated close to it, about 3 m from the façade of the cell;
- d. a rectangular basin (currently missing) was built into the south-eastern corner of the court<sup>16</sup>;
- e. a door was opened in the eastern wall to connect AU2S with AU3S (at a distance of 1.65m from the façade of the HU), its limestone threshold being on the same level as the limestone floor of the court. The opening of the door caused the cutting of a portion of the plinth of the eastern wall;
- f. the plinth was enlarged and transformed into a low *mastaba*, whose dimensions (1.63x0.80m) appear appropriate to host a person lying down (Fig. 12).

Fig. 12 - The “mastaba” right of the door of AU2N

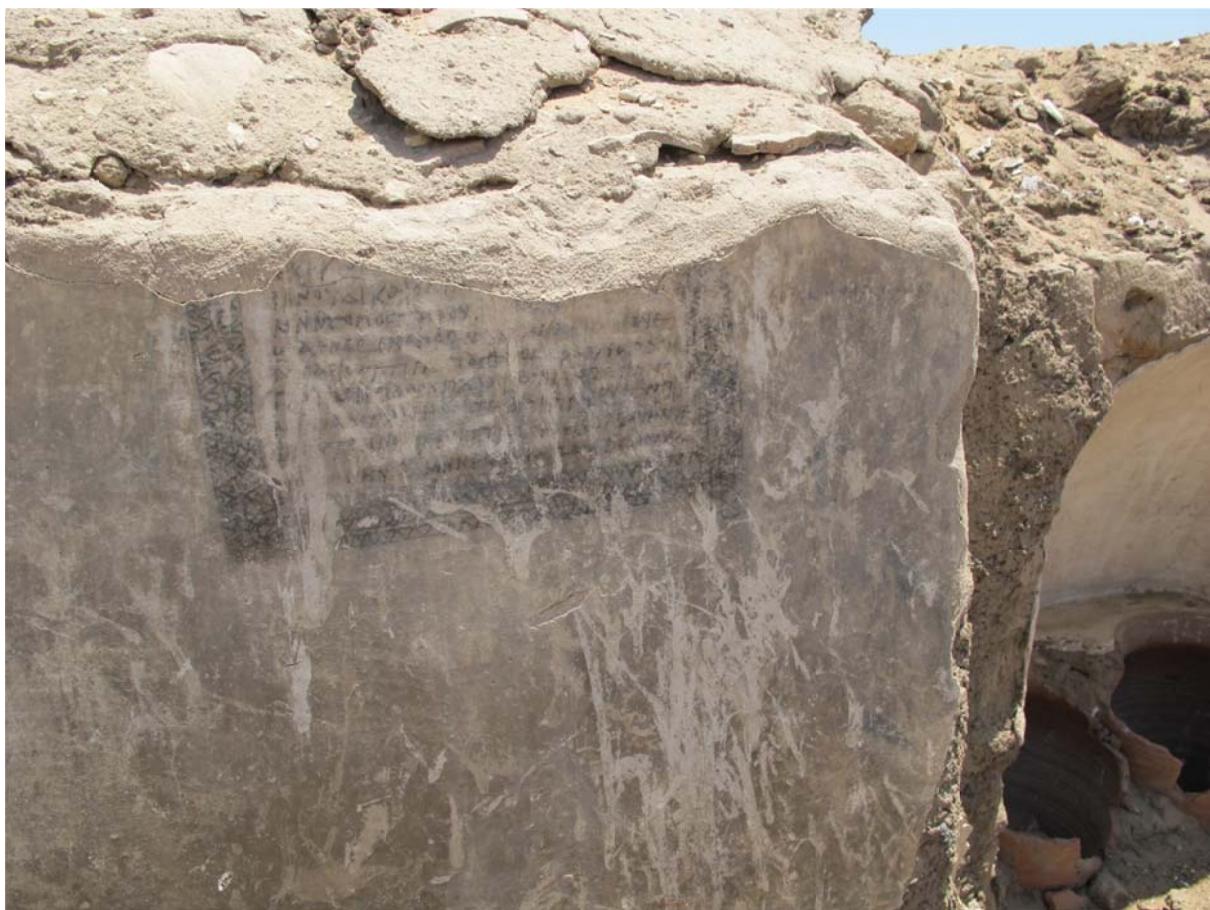
The eastern wall is in a very bad condition, but some features can be detected. Immediately after the door, a vaulted niche (h 0.60m; 0.50m, max depth 0.33m) contains two jars with flaring rims, embedded in the masonry and partly preserved ( $\varnothing$  23/24cm, 30cm deep). On the portion of wall immediately after the niche, there is part of a Coptic inscription painted in black ink and closed within a geometrically decorated frame, about 0.70m from the ground floor. As the upper part of the wall is missing, the inscription is not complete, but 10 horizontal lines are still visible: the max width of the inscription with its frame is 35cm, its max preserved height being 20cm (Fig. 13).

Fig. 13 - The Coptic inscription on the East wall of AU3N

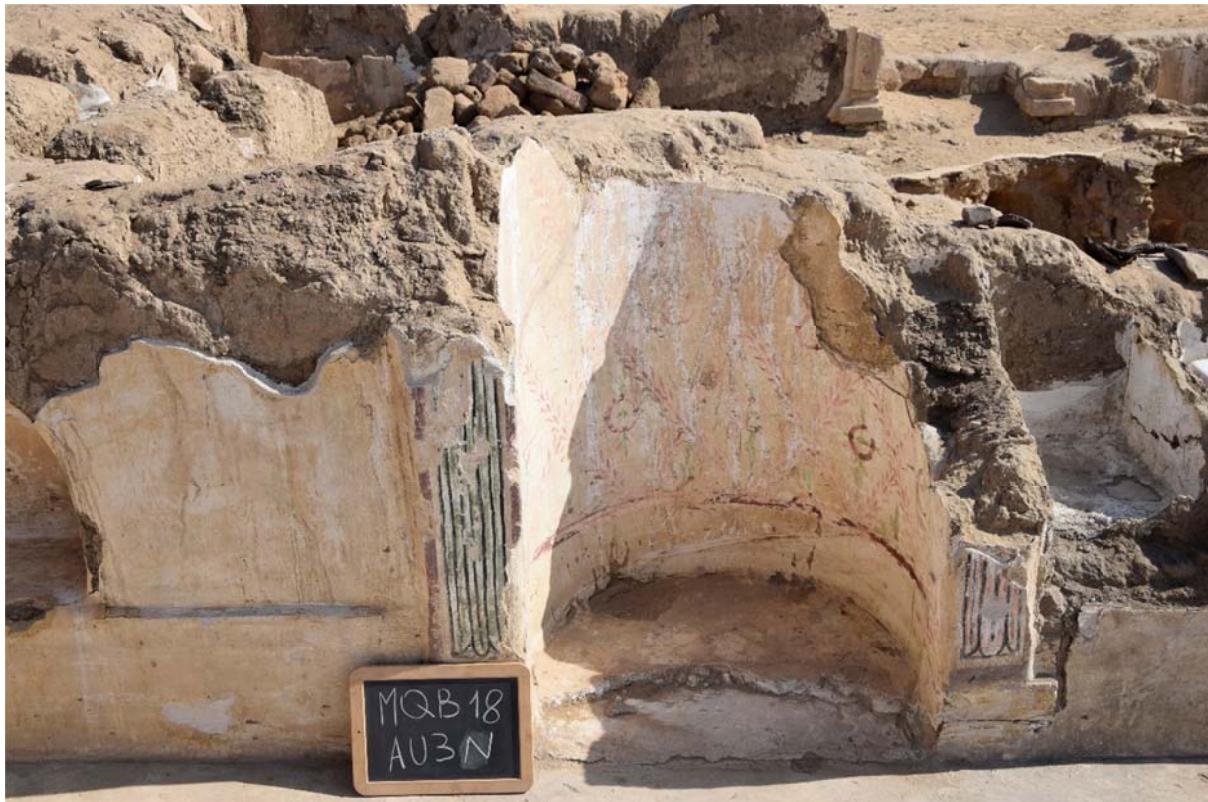
Fig. 14 - The oratory niche of AU3N

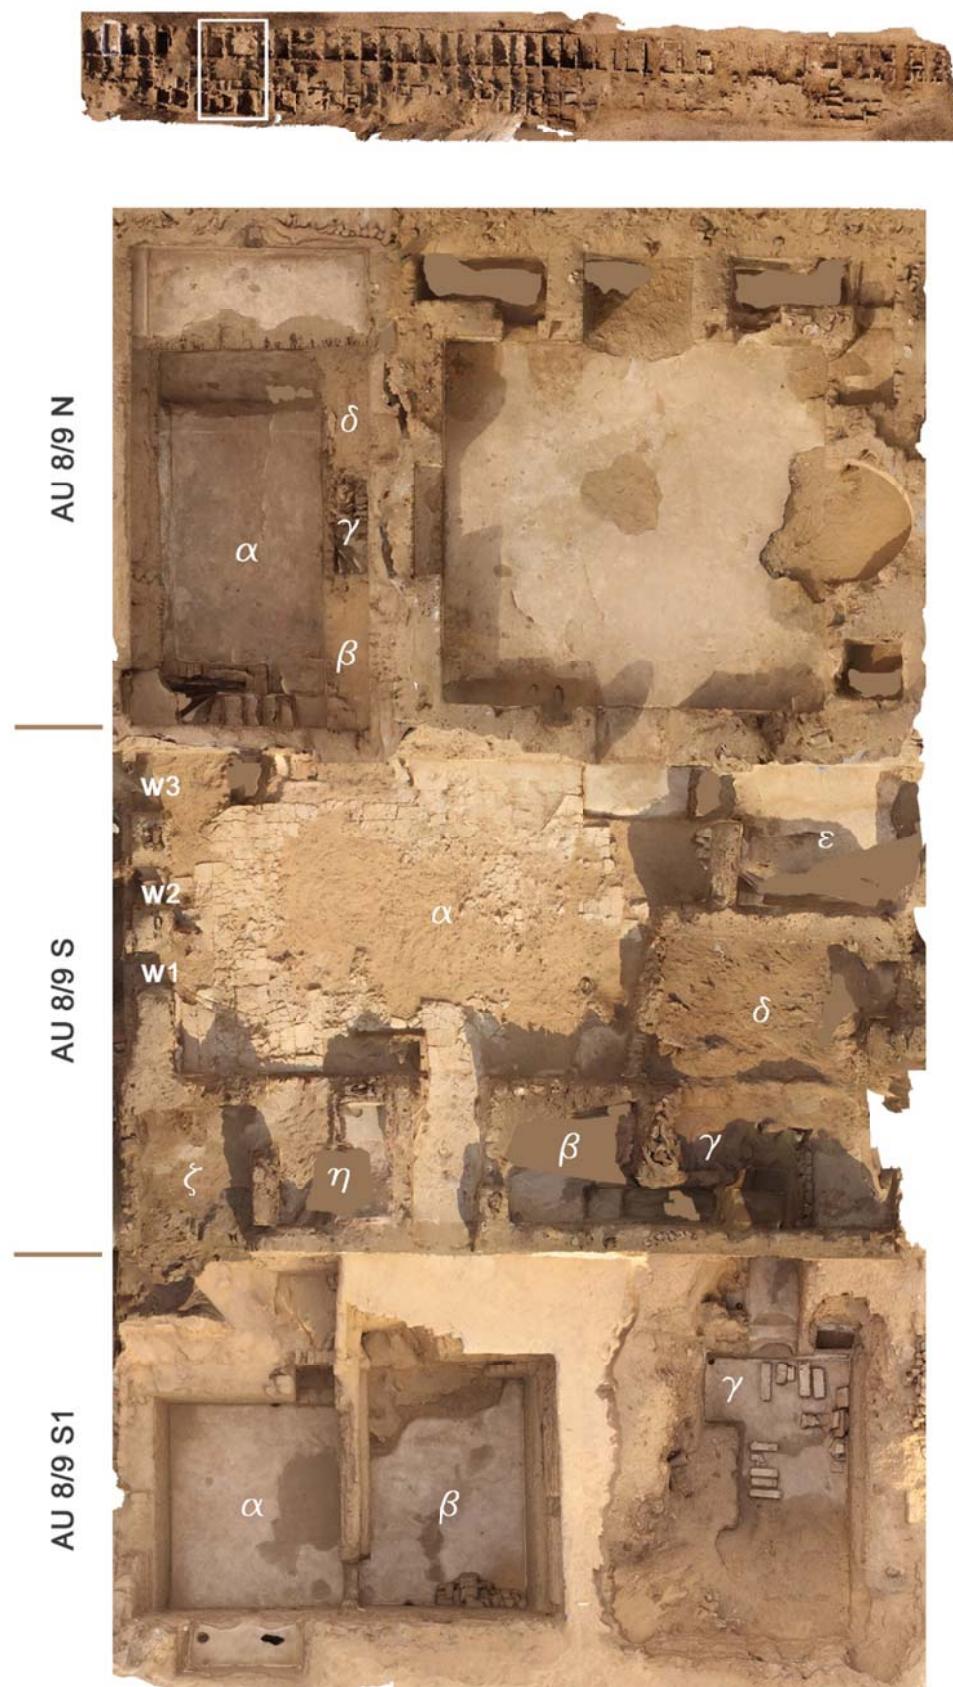
Fig. 17 - General plan of AU8/9

This double Areal Unit consists of a Housing Unit of type 1 (AU8N), a large square oratory (AU9N), a large open court with side service rooms (AU8/9 S) and a complex of underground warehouses (AU8/9 S1). To judge from its dimensions and major structures, it was certainly the Housing Unit belonging to the head of the complex (Abbot) (Fig. 17)

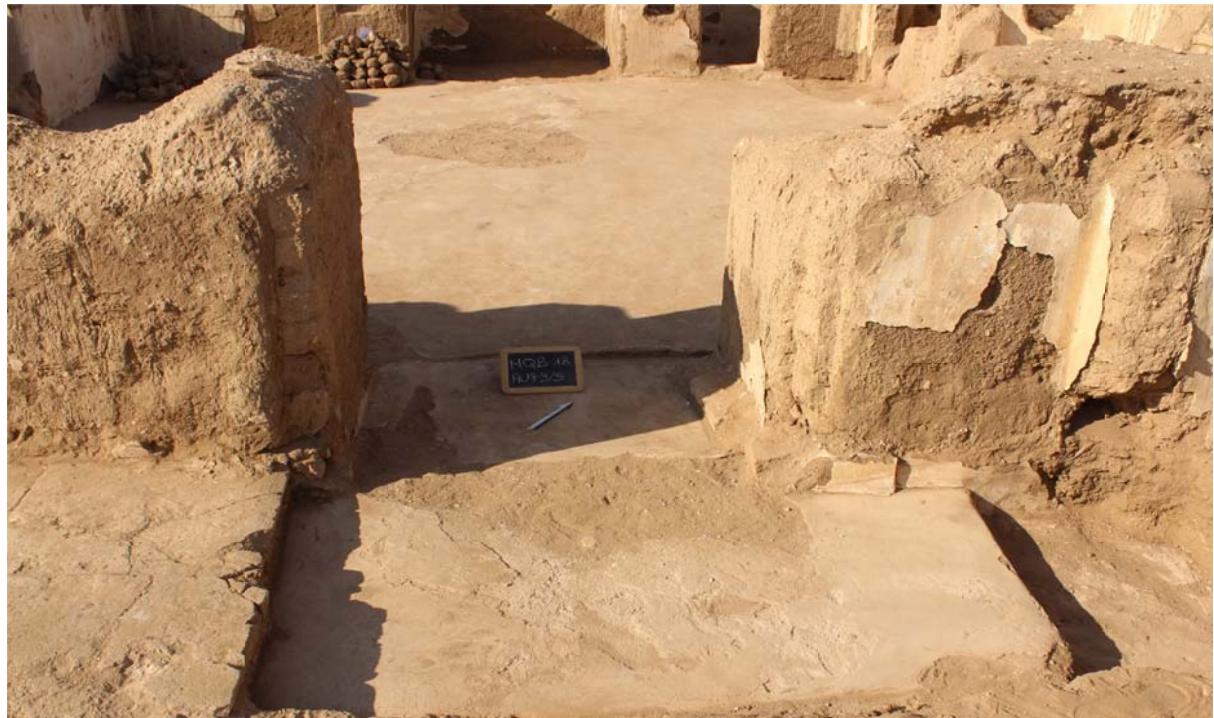
- a. the court was limited by thin walls, as already observed in AU2;
- b. the floor of the court was at a lower level than the floor of the oratory, and a large white-plastered step was in front of its door (Fig. 18); no trace is now visible of an extended paving<sup>18</sup>;

Fig. 18 - Large step in front of the door of AU9N

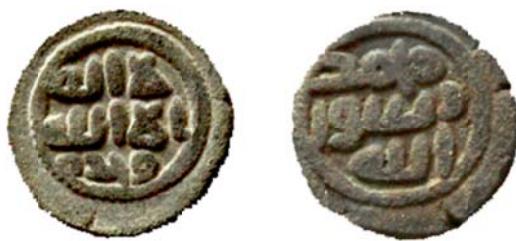
Fig. 21 - Coin of the Islamic period with the shahada, from E2 of AU26N

probably dating back to the 8<sup>th</sup> century (Fig. 21). It is inscribed with the *shahada*, whose text is divided between the *recto* and the *verso*. Palaeographically, it is very close to another coin that the mission was able to study in the storehouse of el-Ashmunein in 2014 (Pirelli 2015). Its diameter is 13mm and its weight is 5.90g. The text says:

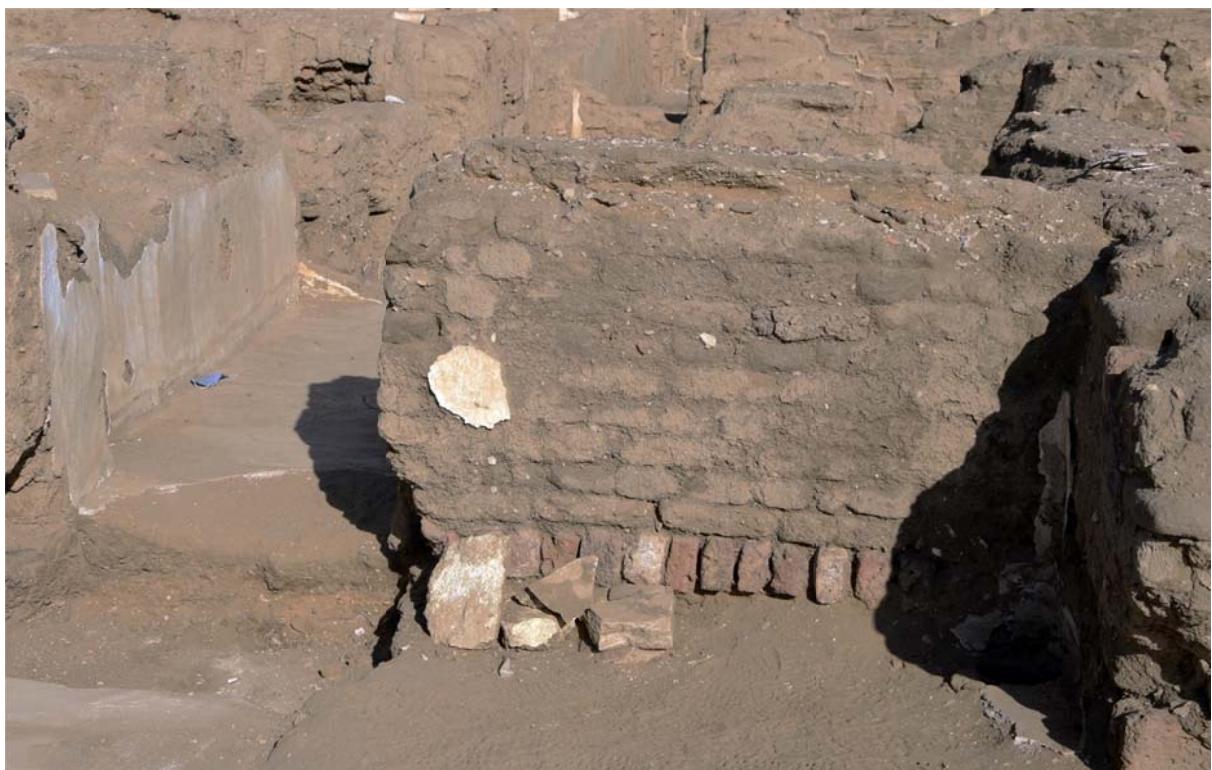
As usual in Egypt, the domestic architecture is characterised by the use of mud-brick. We can also find baked-bricks at the site, but these were used primarily to consolidate the foundations of later mud-brick structures (Fig. 23), for basins and in a large and certainly multi-storey structure in the Central Sector of the site (Pirelli *et alii* 2017, 14).

Fig. 23 - One of the walls of the annex room in AU 8-9S

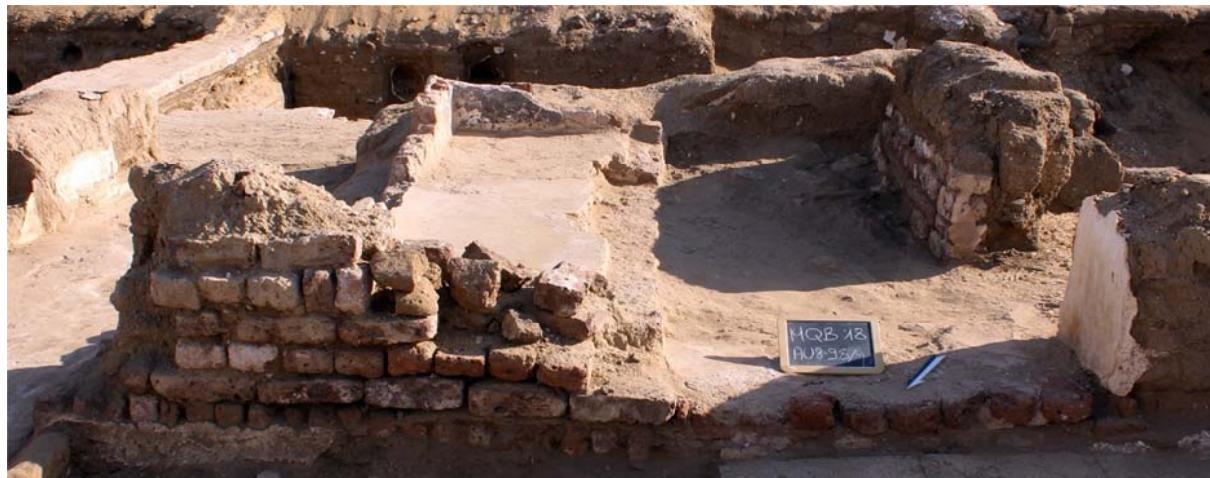
Baked bricks are scattered all over the site in different conditions to support heavy structures, to reinforce walls, in structures associated with the presence of water (Fig. 24).

Fig. 24 - Basins in AU 8-9S/η

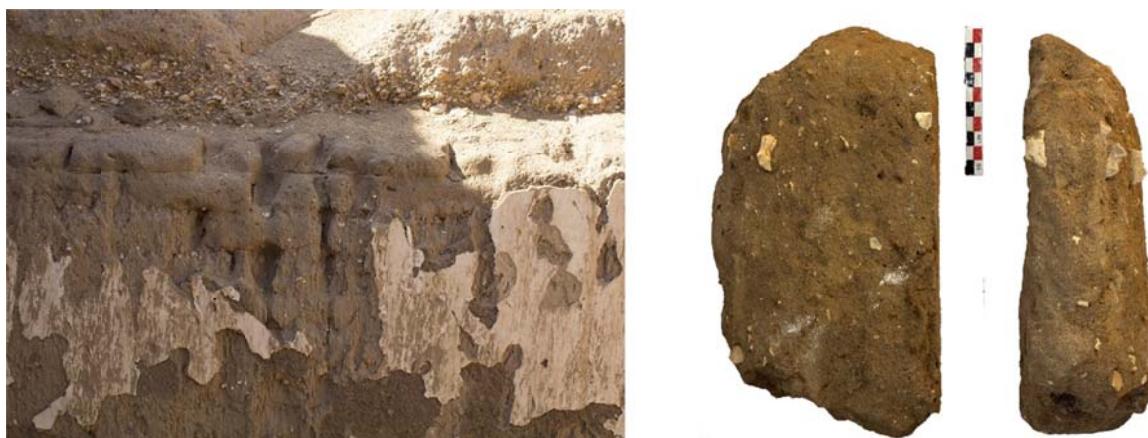
a. The most common special form belongs to type 1 (in fabric and size) which presents a smoothed profile on one of the long sides. Examples of this type have been documented in AU26N both *in situ* and loose (Fig. 25).

Fig. 25 - (On the left) special vault brick from AU26N, South-West wall of the underground floor. (On the right) isolated special vault-brick from the same area

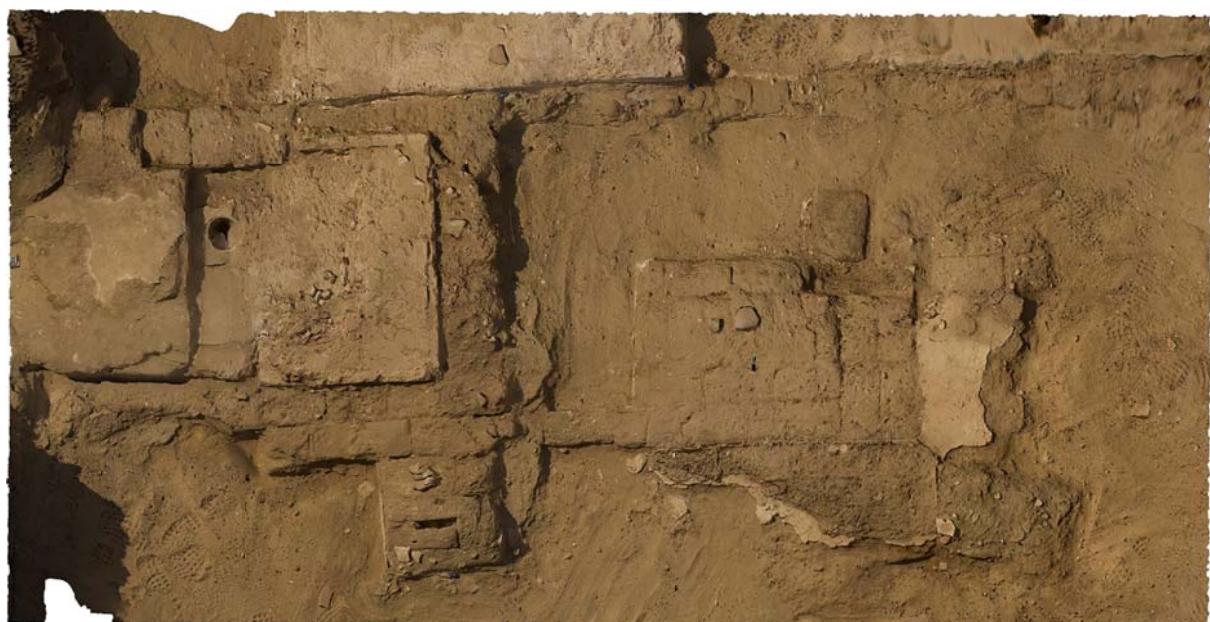
Fig. 26 - Rounded corner mud-bricks used for basin and to finish edges of walls in AU26S

b. Both square and rectangular bricks can have one of the corners rounded. These bricks were used to finish the edges of some structures such as basins or walls. They have very different dimensions due to their specific functions: AU8/9S - 2 special form bricks of 20x10x5cm; AU2 special form bricks of 24x12x6 and 30x2cm; AU26 special form bricks of 15x16cm or 23x12cm (Fig. 26).

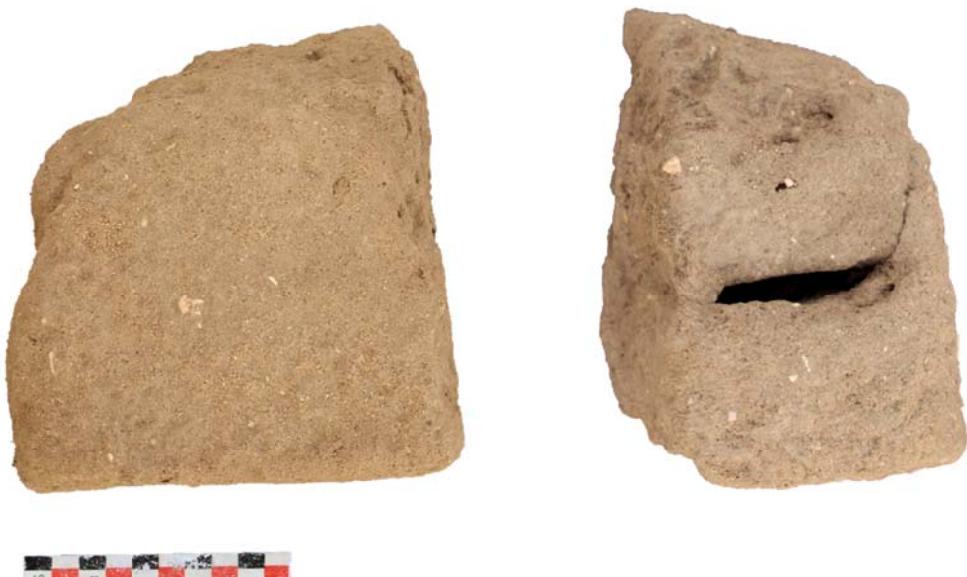
Fig. 27 - Special (type 1) mud-brick with a rounded corner and a narrow rectangular hollow on one short side

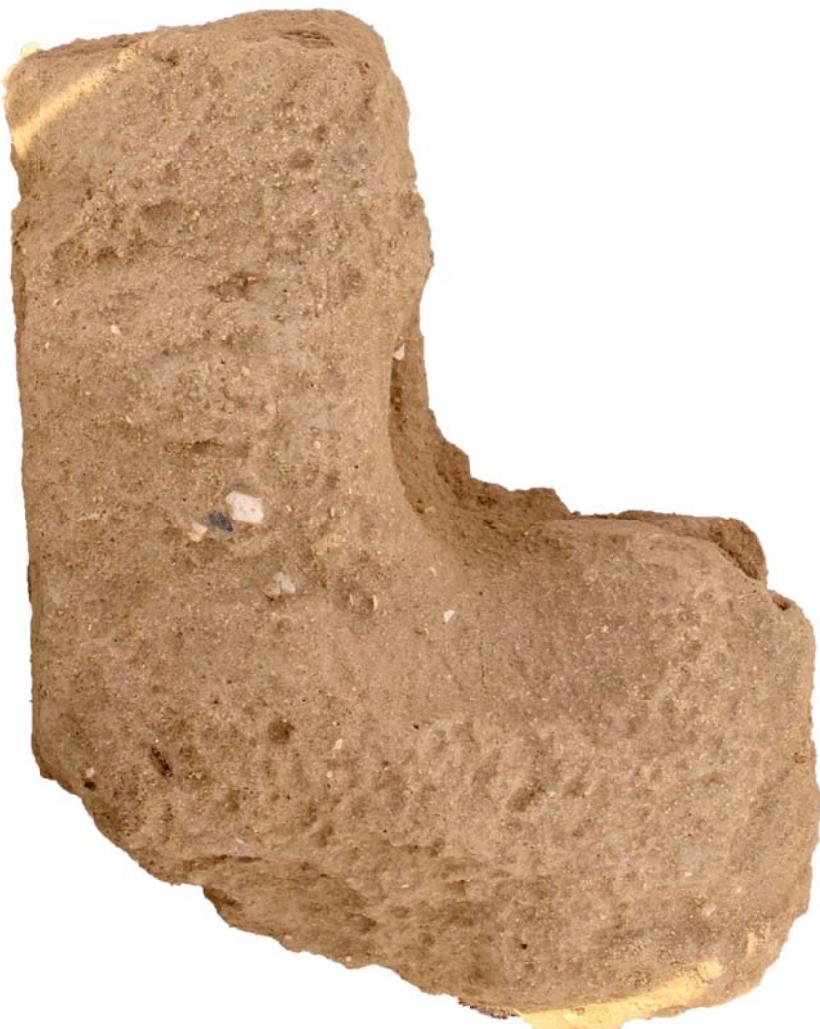
c. A group of special (type 1) mud bricks come from a collapsed structure found at the southern edge of AU2S (see above). We could not analyse this area because we stopped our investigation where our Egyptian colleagues stopped digging. However, we decided to document these bricks because of their special features (Figs. 27-28), which will be the object of a study in depth in connection with the future investigation of this area.

Fig. 28 - L-shape (type 1) mud-brick with rounded borders but flat on the back from a collapsed structure found at the southern edge of AU2S
