## THE ITALIAN EGYPTIAN PROJECT OF STUDY AND CONSERVATION OF THE MONASTERY OF ABBA NEFER AT MANQABAD 2018 - 5TH CAMPAIGN

Rosanna Pirelli, Università degli Studi di Napoli "L'Orientale"  
with contributions by Angela Bosco, Paola Buzi, Andrea D'Andrea, Mohamed Kenawi, Ilaria Incordino, Pasquale Musella,  
Stefania Mainieri, M. Dilettia Pubblico, Andrea Ragionieri, Anna Salsano

The report is divided into four main paragraphs (with some sub-paragraphs), corresponding to the activities carried out: A. Topographical survey; B. Archaeological activities; C. Epigraphic survey; D. Restoration activities; in the Concluding remarks the main results will be summarized.

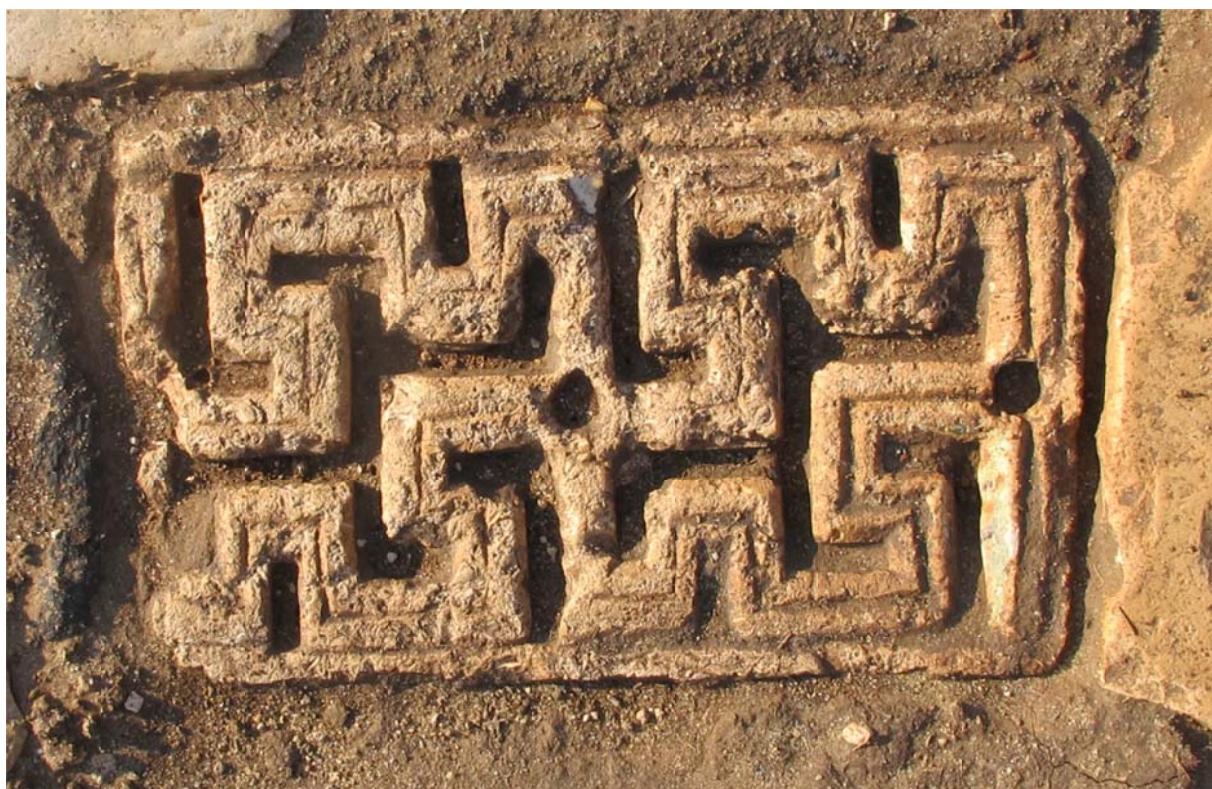
Two fragmentary elements of friezes (Fig. 30) were found in the paving of AU3S; they are both decorated with the same meander motif with a double line and were originally embedded in a

wall, probably as parts of the same architectural element or of two elements placed symmetrically. One has traces of green painting in a corner. Some probably blind<sup>27</sup> holes are carved in the middle of the meanders: they are at least 2.5cm deep and one of them shows traces of rust, probably due to the original presence of decorative metal elements or rings.

Fig. 30 - A fragmentary element of the friezes, decorated with a meander motif, which was found in the paving of AU3S

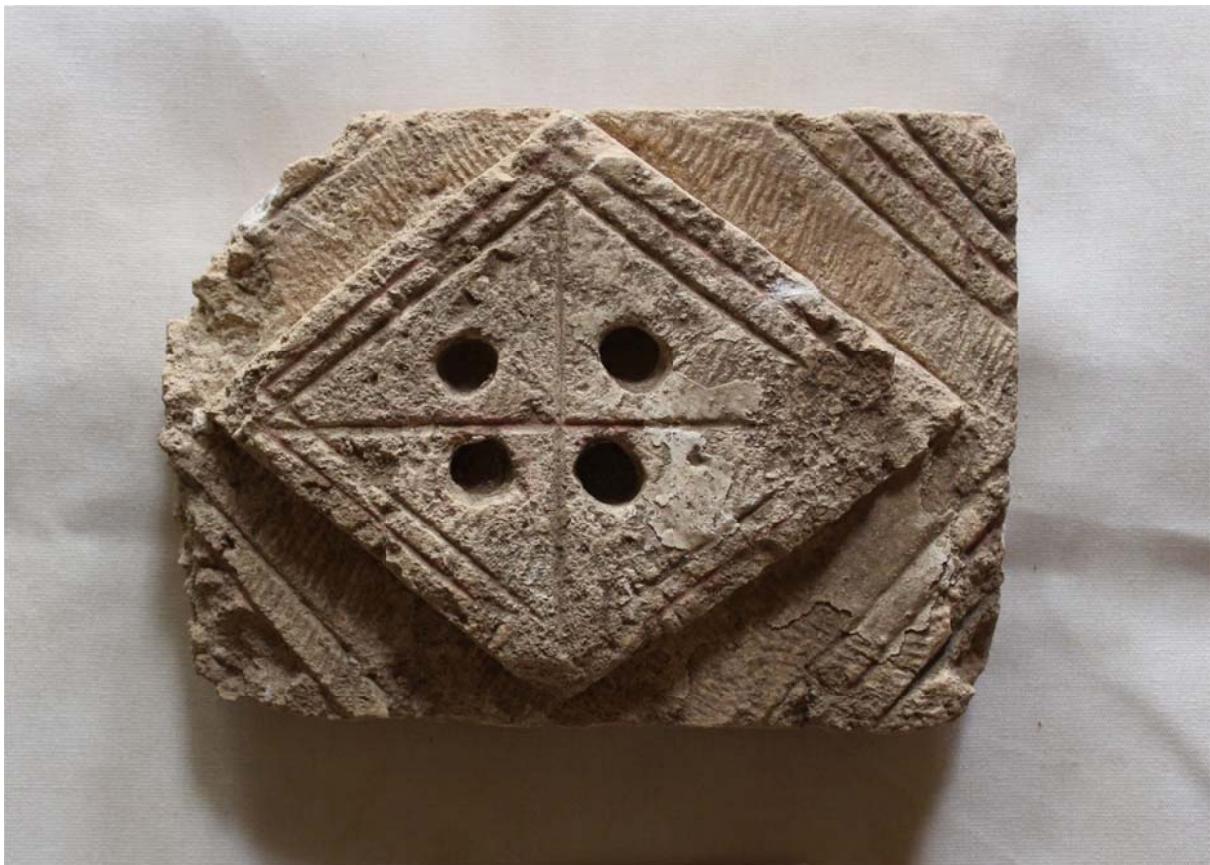
During the survey in the Northern Sector, a stone element (Fig. 31) with a red rhomboidal decoration was found (19.5x15.5x4.3cm; main diagonal: 17.5cm; minor diagonal: 13.5cm). The rhombus juts from the background of the slab, has a double frame and is divided into four parts by two crossing lines; each part is carved with a through hole (diameter: 1.4cm). The slab is almost entirely preserved except for two corners, one missing and the other damaged; the preserved corners show a decoration with three strips. A slab with a similar decoration, through holes and similar measures was documented in the storehouse during the 2014 campaign<sup>28</sup>.

Fig. 31 - The stone element with a red rhomboidal decoration, found during the survey in the Northern Sector

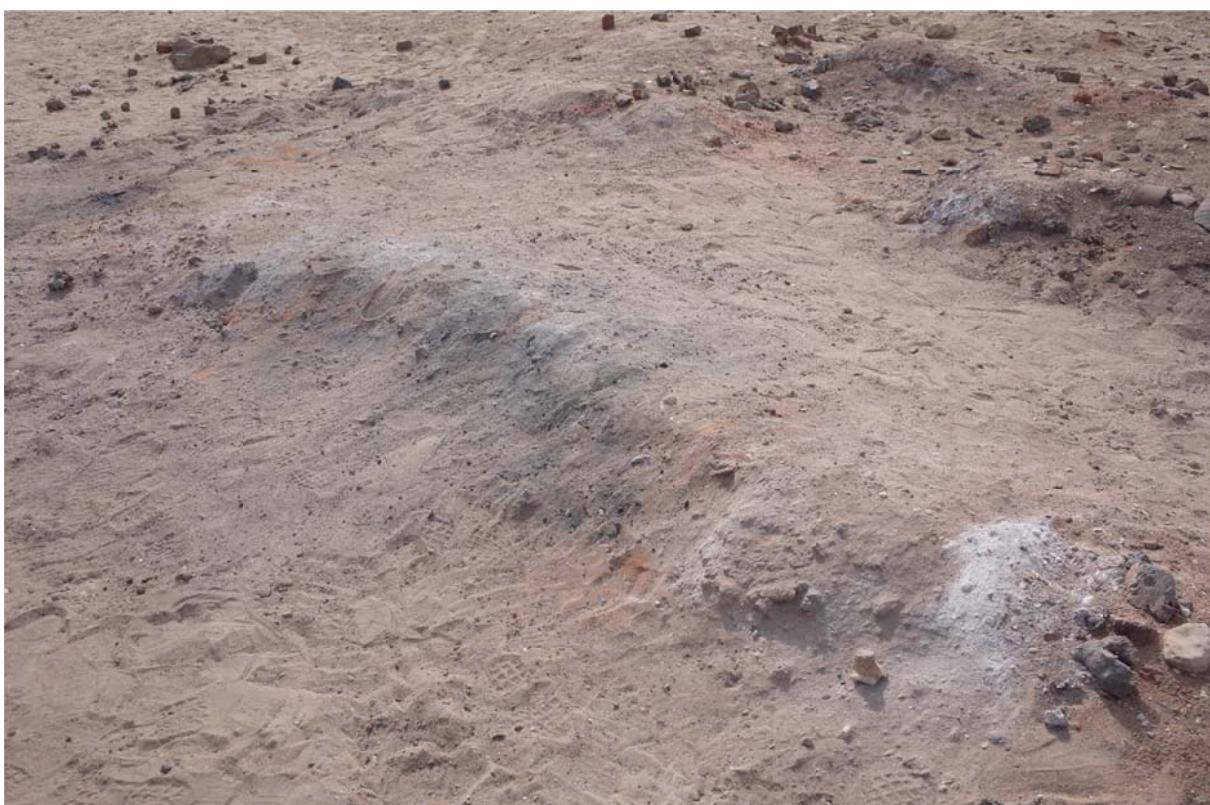
An area with clear traces of scorching was identified; several fragments of fired bricks with one side overexposed to heat and vitrified were noted on its surface. After simple superficial cleaning, it was possible to identify a structure with a South-North orientation where the surrounding earth makes it possible to observe the earth reddened by the heat, evident ash dispersion and charcoal fragments. It is not possible to speculate on the shape of the structure from observation of the ground (Fig. 32).

Fig. 32 - Remains of surface structures related to firing process

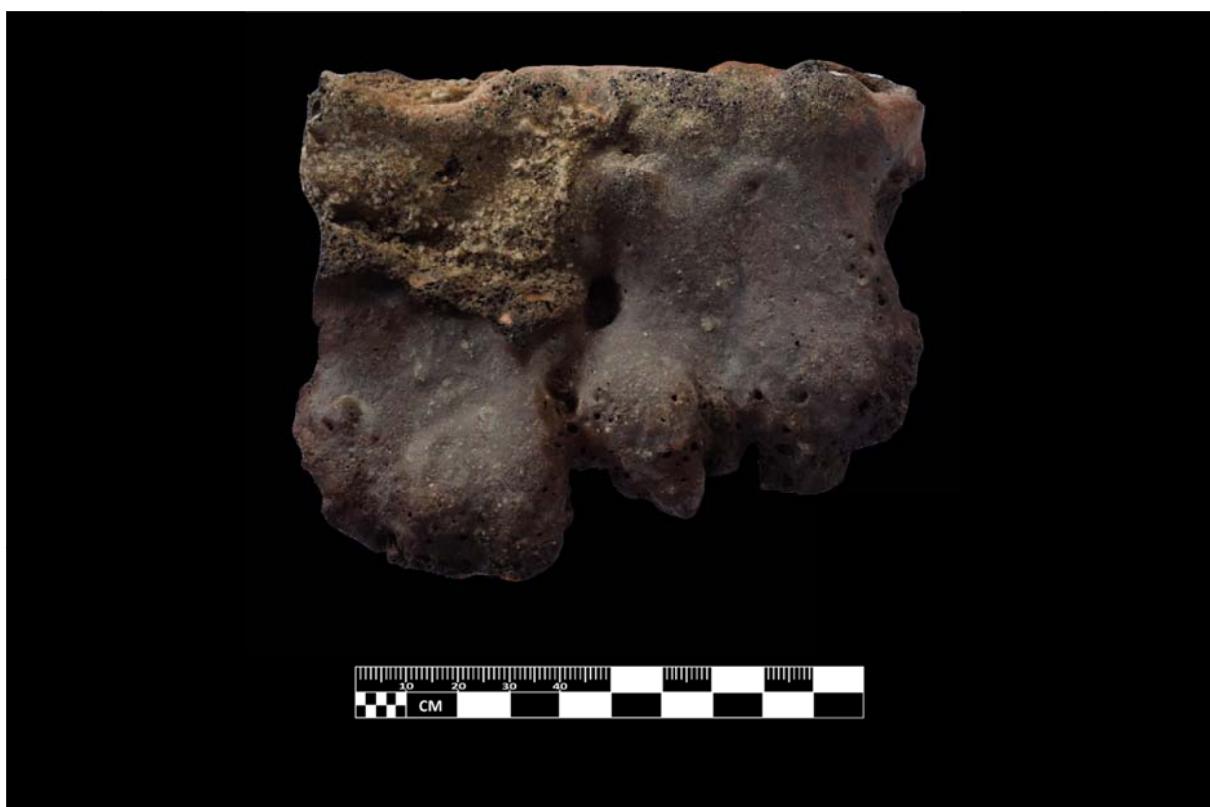
Fig. 34 - Overcooked bricks from one side which was facing the firing room

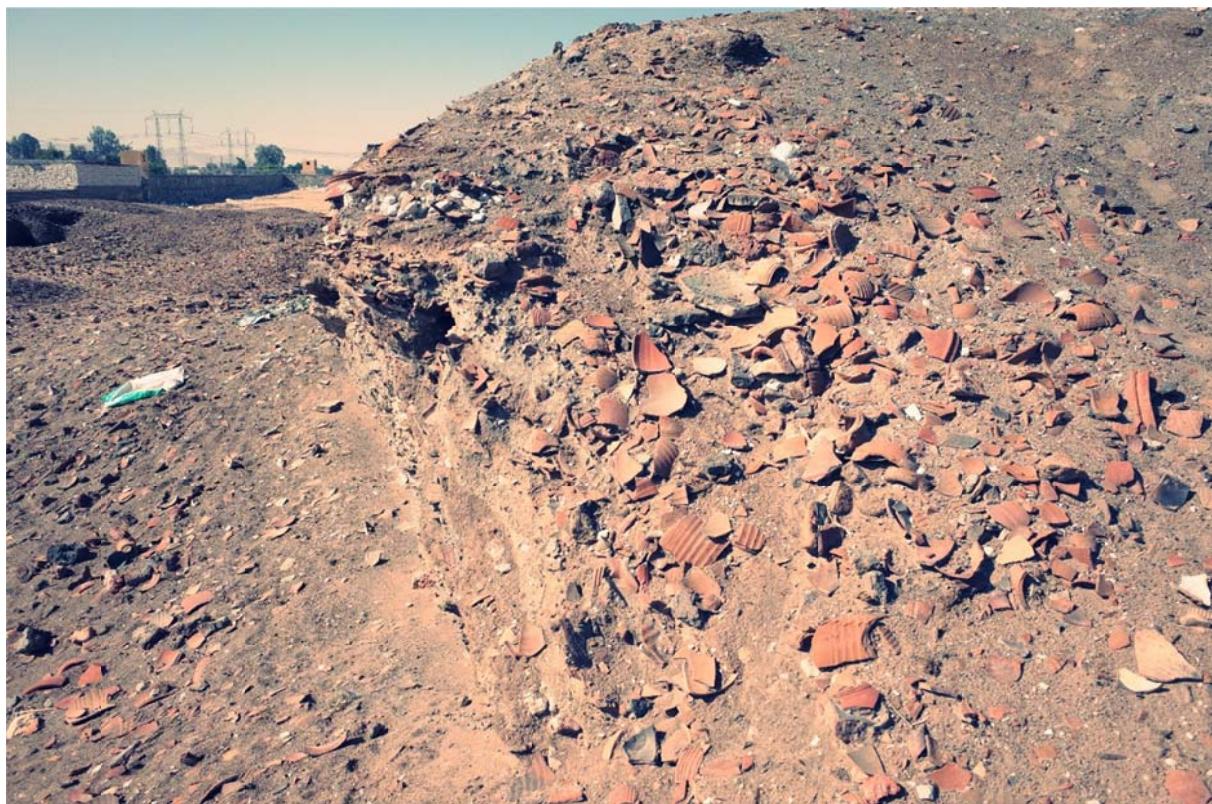
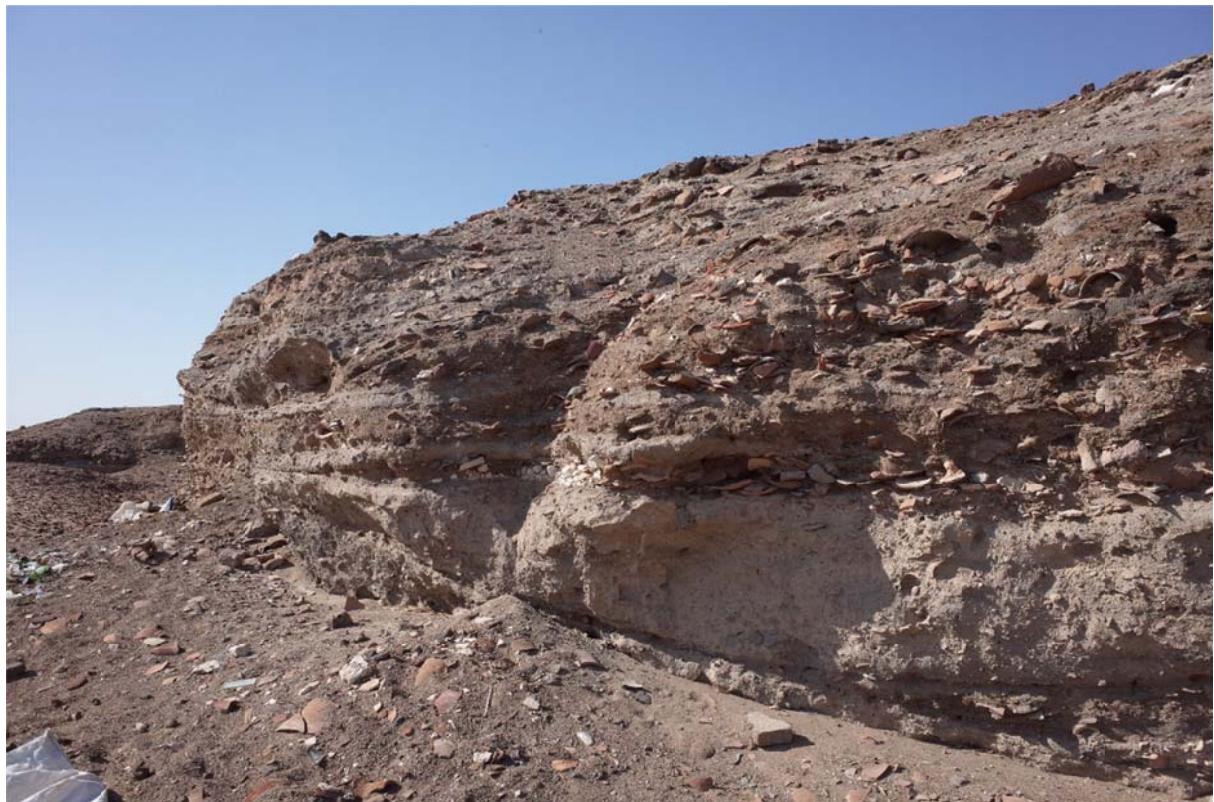
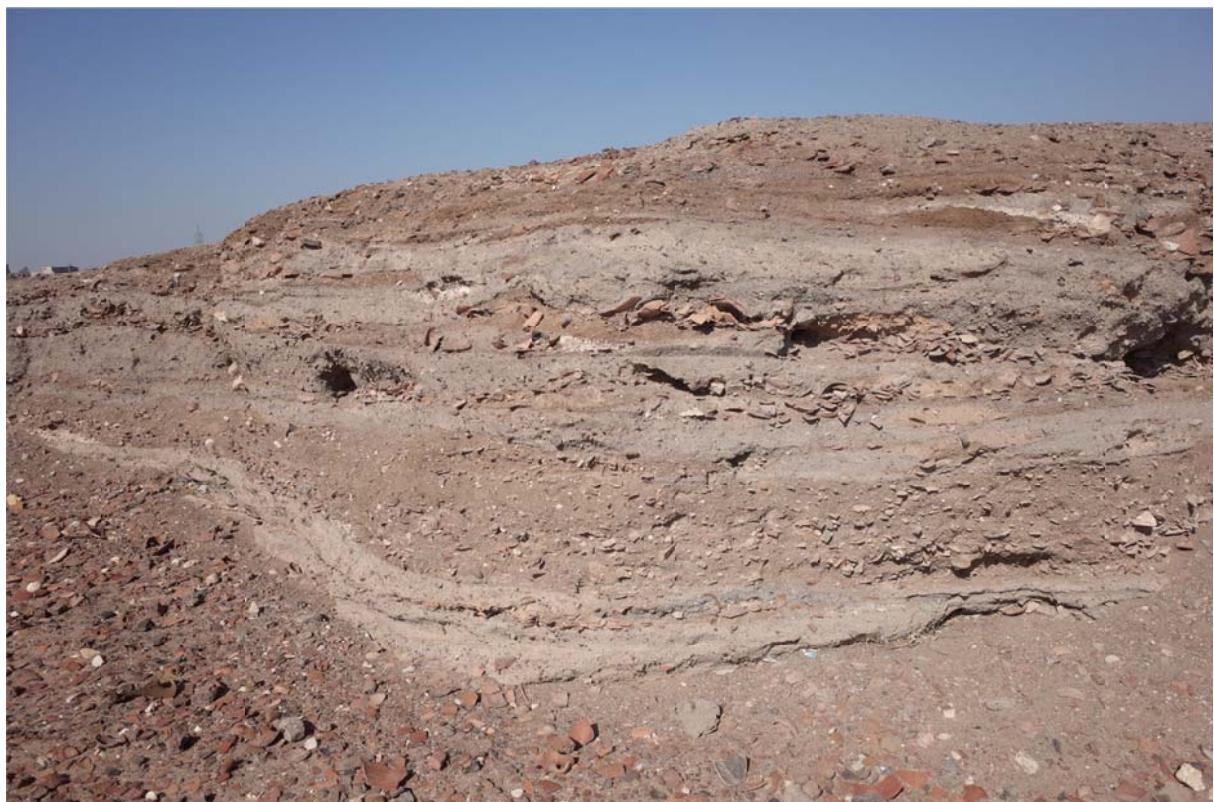
An anthropic accumulation of materials, appearing as a little kom, is visible a few tens of metres further to the West. In the most eroded points, it was possible to observe the internal stratigraphy, which is composed of layers of ceramic fragments intercalated by thick layers of ash. It seems likely that this could have been a dumping area. The ceramics found within these deposits are mixed with imported forms, especially LRA 1 and LRD or Cypriot red slip ware. Among the many forms of Egyptian ceramics, including amphorae, the typologies LRA 7 or AE 7 and AE 3 late version have been observed, along with common pottery for canteens and cooking, and finally ceramics produced in the region of Aswan. Overcooked elements have also been observed among the materials; they may have been bricks exposed to direct fire. The maximum height of this kom is 2.80/3.00m (Figs. 36-38)

Fig. 36 - Profile view of a mound composed of ashes waste of a production structure and fragments of potters and plaster

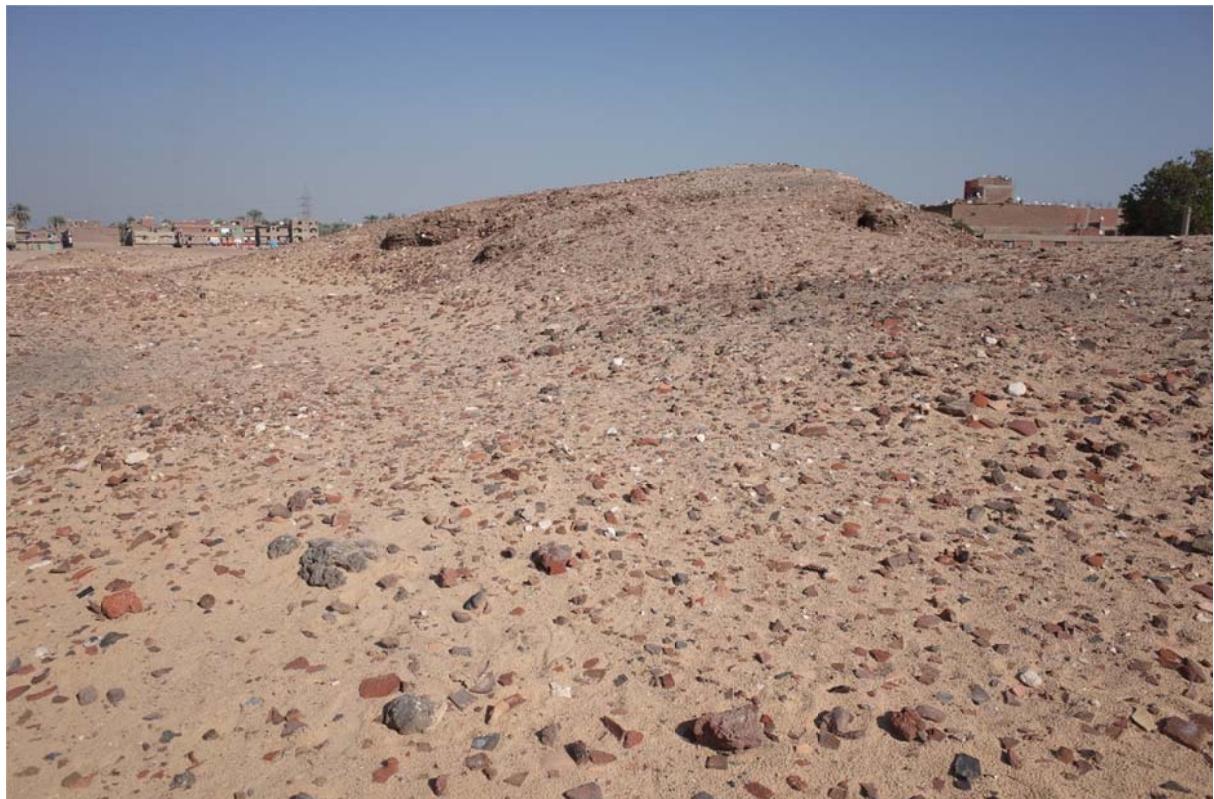
Fig. 39 - Section with various layers of ash intercalated with ceramic deposits and various materials

From the chronological point of view, several fragments belong to a chronological horizon dating from the second half of the 4th-early 5th centuries AD. Both Egyptian productions and imported amphorae support this chronology: in addition to the LRA 1, there are Gaza or LRA 4 amphorae and few materials from Proconsular Africa (Figs. 39, 40);

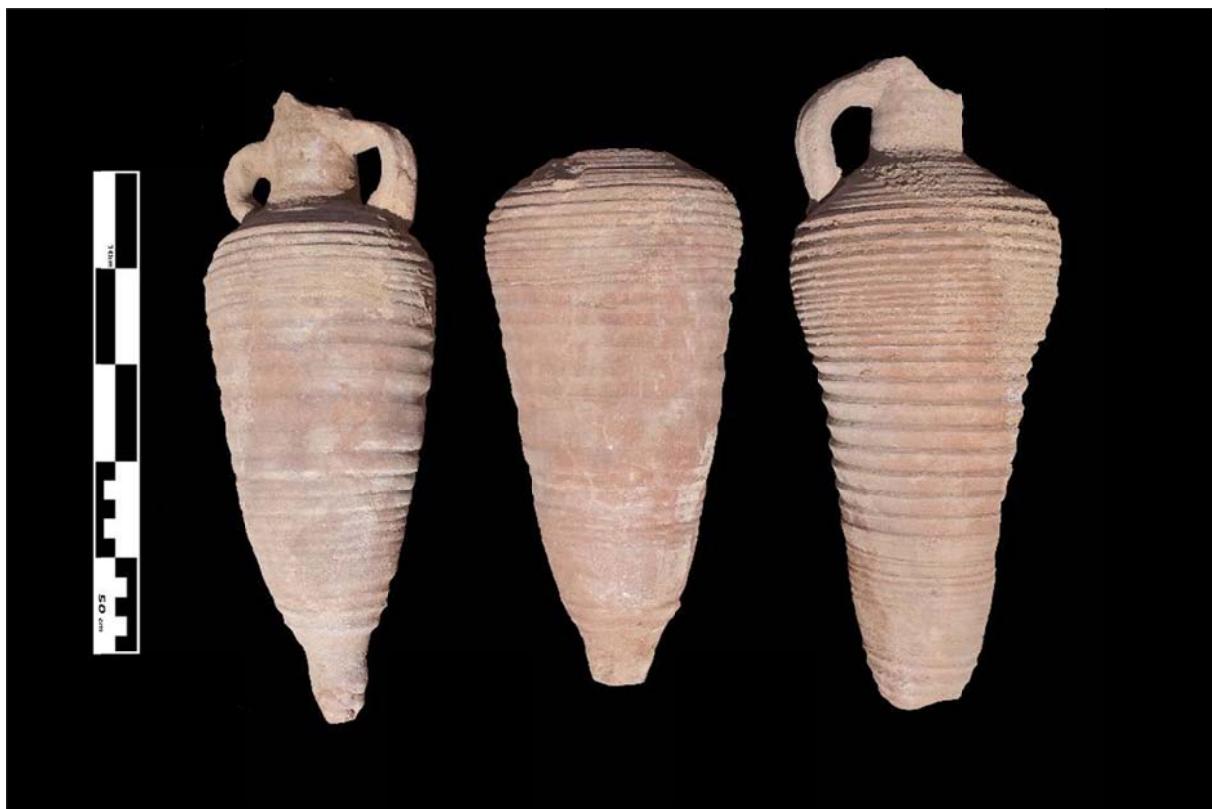
Fig. 40 - Samples of Egyptian Amphorae 7, mainly produced in Middle Egypt

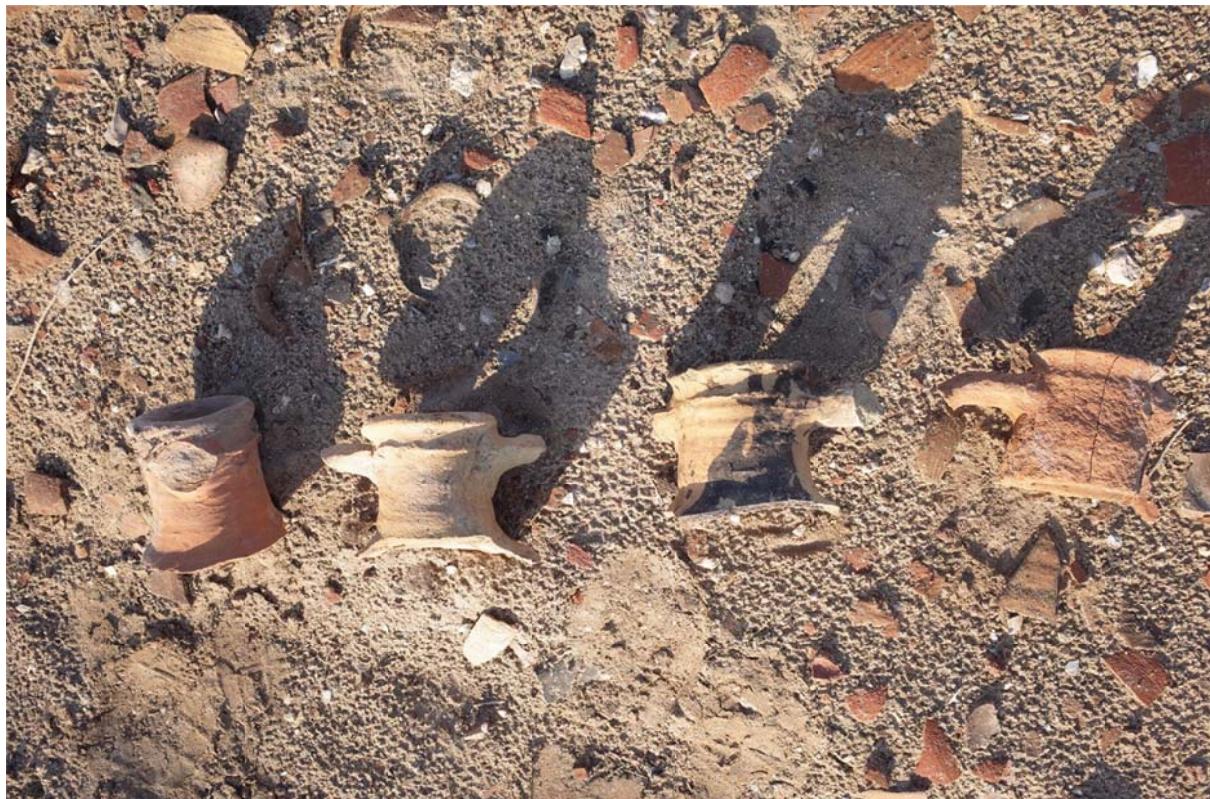
Fig. 41 - Surface observation of hundreds of imported Cilicia amphorae from the 4<sup>th</sup> to 7<sup>th</sup> centuries AD

The abundant and constant presence of fragments of LR1 on the surface of the site is clear evidence of its strong commercial activity with the Cilician and eastern Mediterranean ports. The chronology of the surface material spreads mainly from the 5th century AD and continues at least until the 7th century AD (Fig. 41).

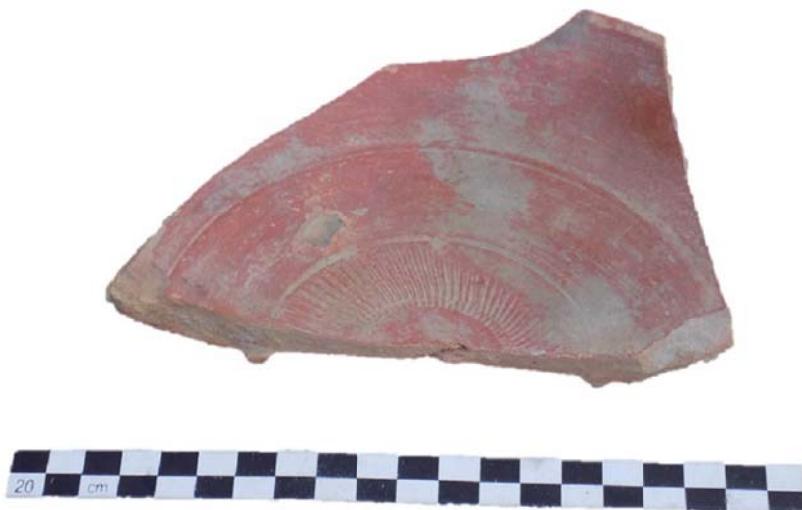
Fig. 42 - Red Slip Ware fragment

Among the typologies identified, there are amphorae Late Roman 1 and Egyptian Amphorae 7 (LRA1 and AE7) dated to the 5th-7th cent. AD, some possibly fragments of 'Saqqara jars' dated to the 6th cent. AD, fragments possibly of 'Pseudo-Samien' ware, dated to the 7th cent. AD, and fragments of amphorae with painted decoration dated from the first half of the 5th- to the 7th cent. AD. Some fragments of Red Slip Ware possibly dated to the 5th cent. AD are interesting (Fig. 42).

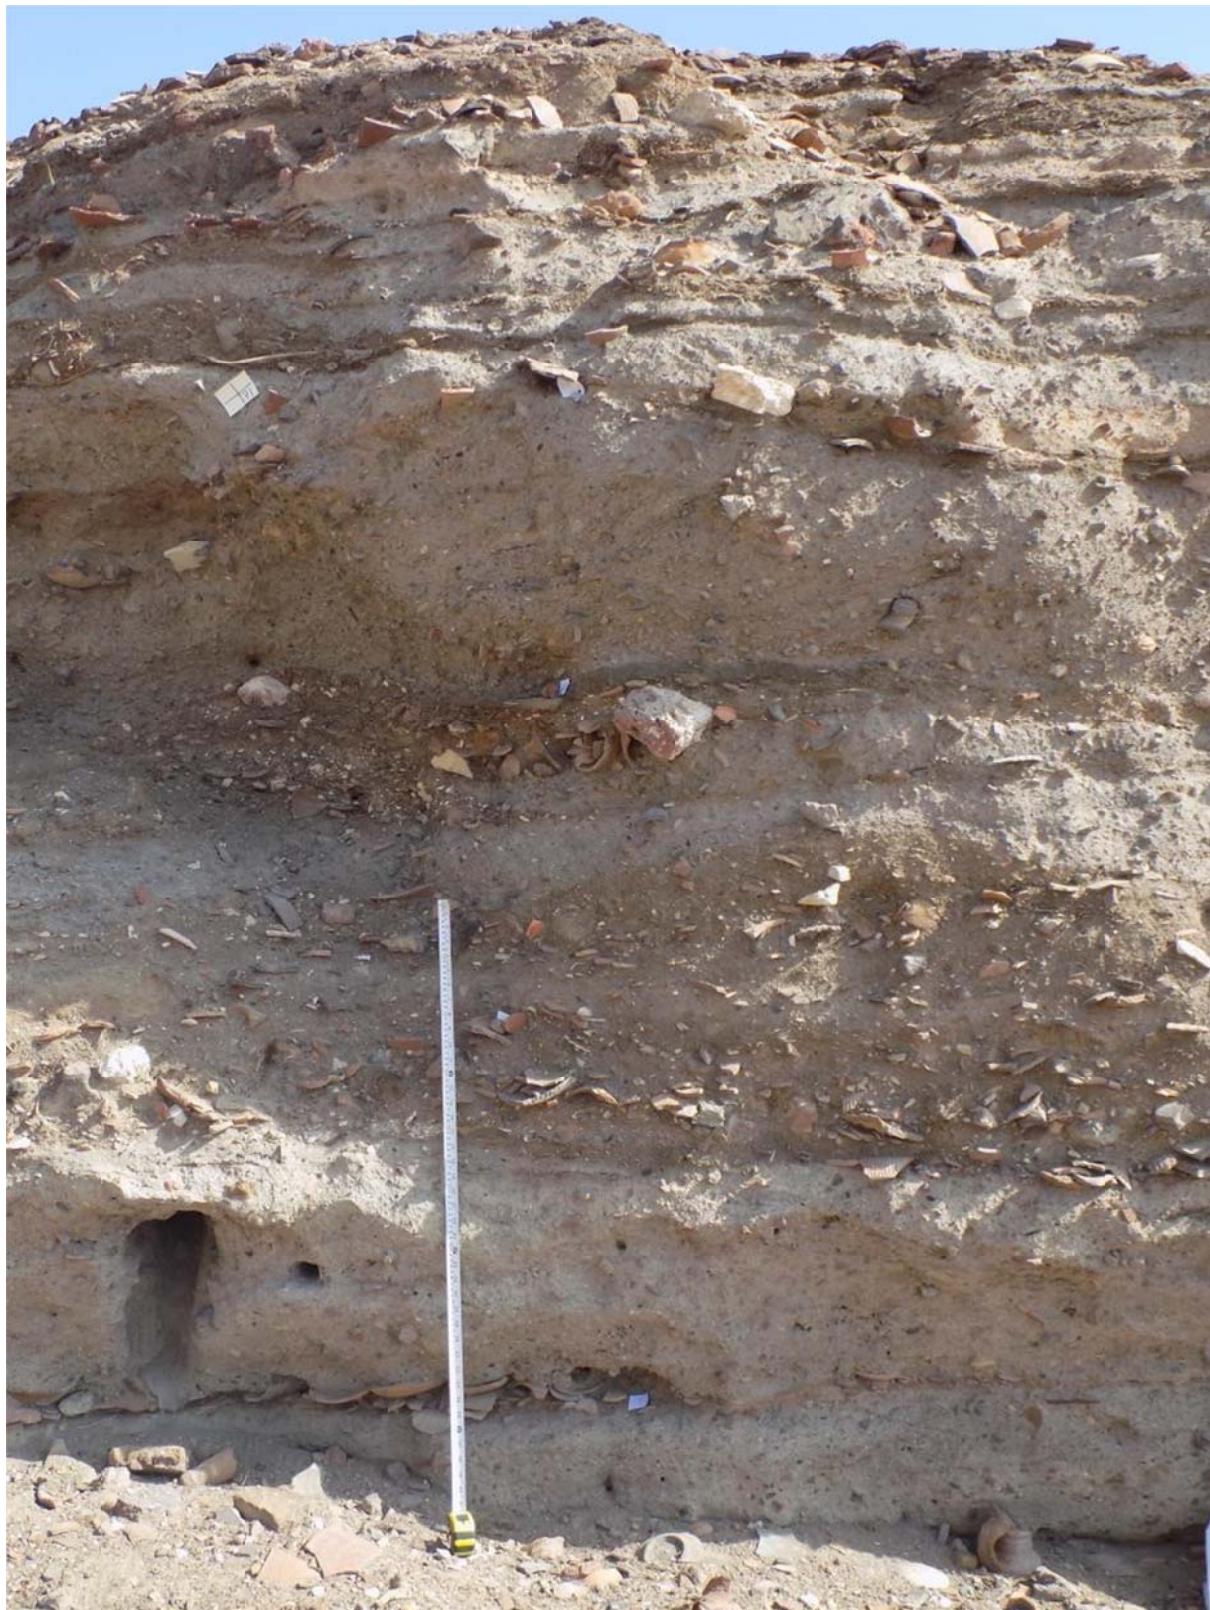
Fig. 43 - Pottery dump at the southern end of the site

Particular attention was focused on the southern end of the site, where a significant amount of discarded pottery piled up in two or three 'kom' had already been noticed in 2014. In the area where a natural vertical section of the pottery 'kom' is exposed (close to the topographical point 71, Fig. 43), four different layers of deposits were identified, located in a 2.5m. high wall. A total of 20 diagnostic pottery fragments have been collected, documented and included in the digital database. Among them, four fragments could possibly be evidence of pottery production on the site (Fig. 44). Three of them seem burnt and the fourth is the pointed base of an amphora with rough clay all around it. The area should be object of a more systematic survey in the coming seasons in order to get more evidence to support (or reject) the hypothesis of a production site.

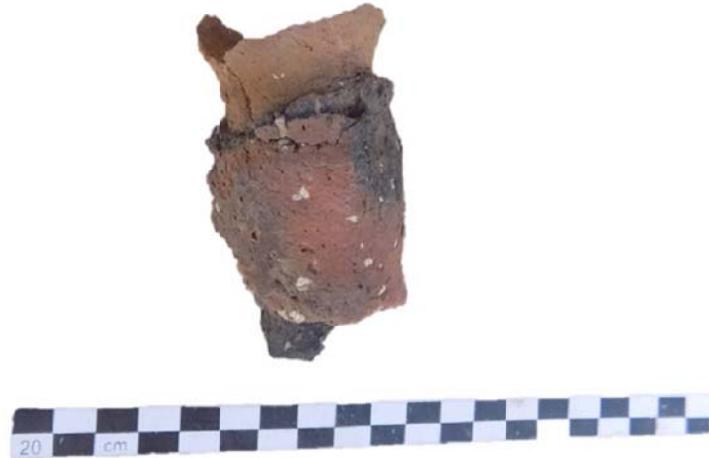
Fig. 44 - Possible evidence of production

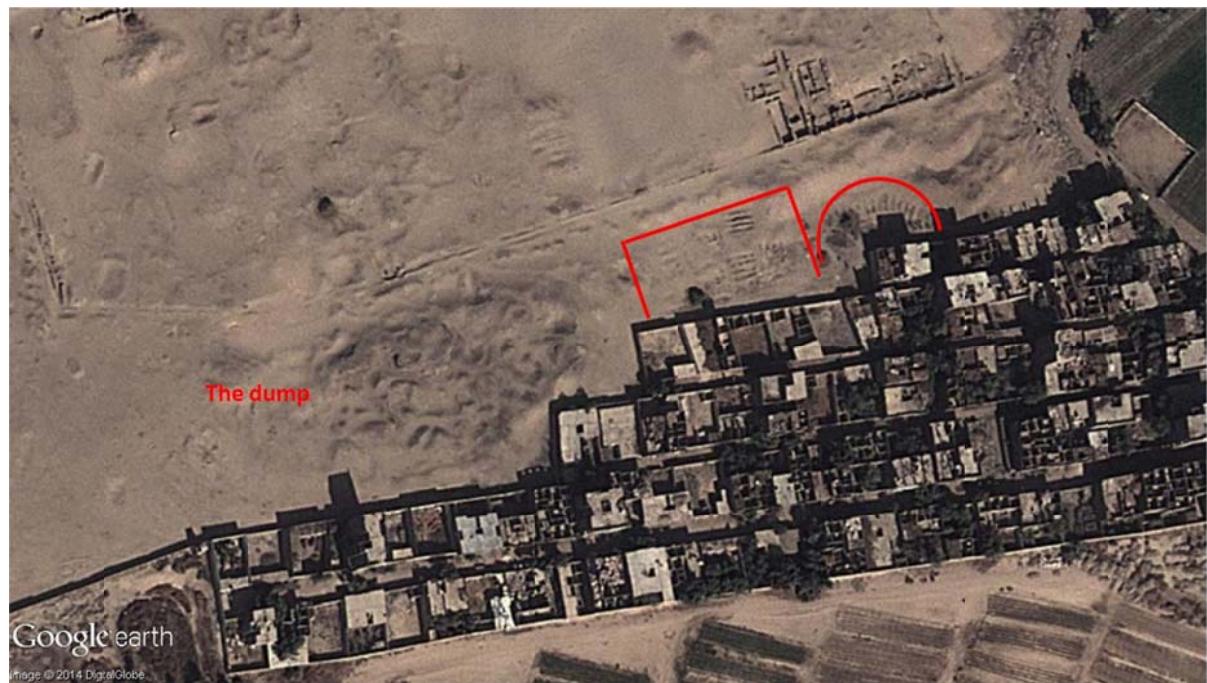
Fig. 45 - Remains of structures, South of the city wall, partially below the modern village
