THE ITALIAN EGYPTIAN PROJECT OF STUDY AND CONSERVATION OF THE MONASTERY OF ABBA NEFER AT MANQABAD 2020 - PRELIMINARY REPORT OF THE 6TH CAMPAIGN

Rosanna Pirelli, Università degli Studi di Napoli “L’Orientale”

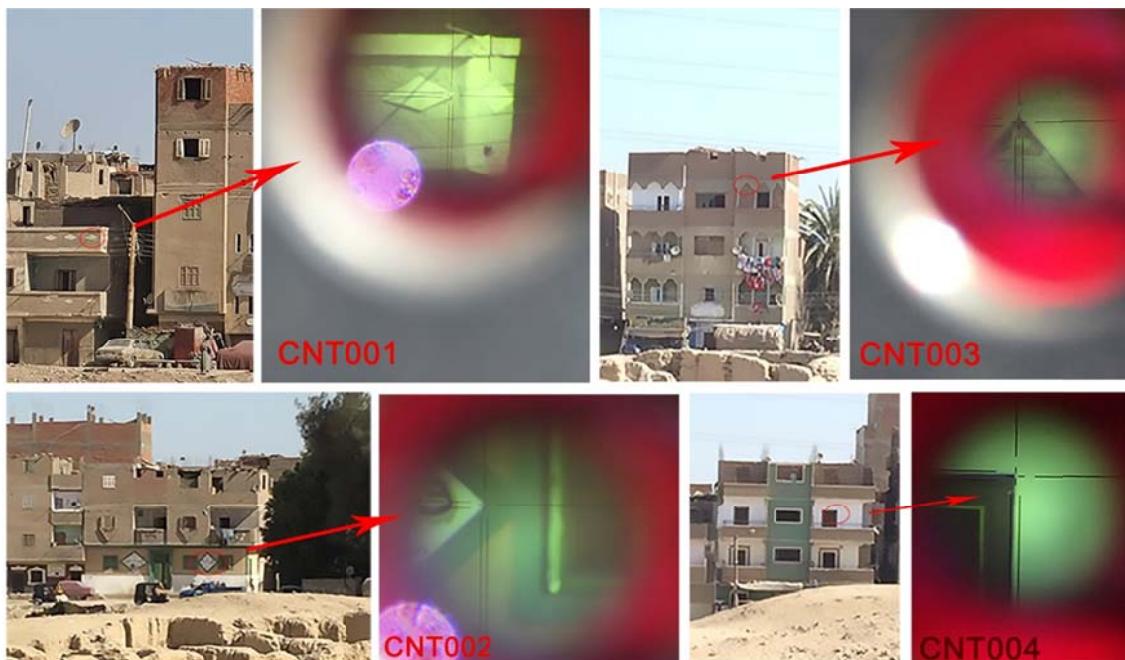
Fig. 1 - Images of the control points on the façades of the modern houses of Manqabad

Some control points were acquired on the façades of modern houses, East of the site (points from CNT001 to CNT004) (Tab. 1; Fig. 1) and on the structure used by the police at the entrance, always to the East (points from CNT005 to CNT011), so as to verify the correct territorial inclusion of the topographic survey.

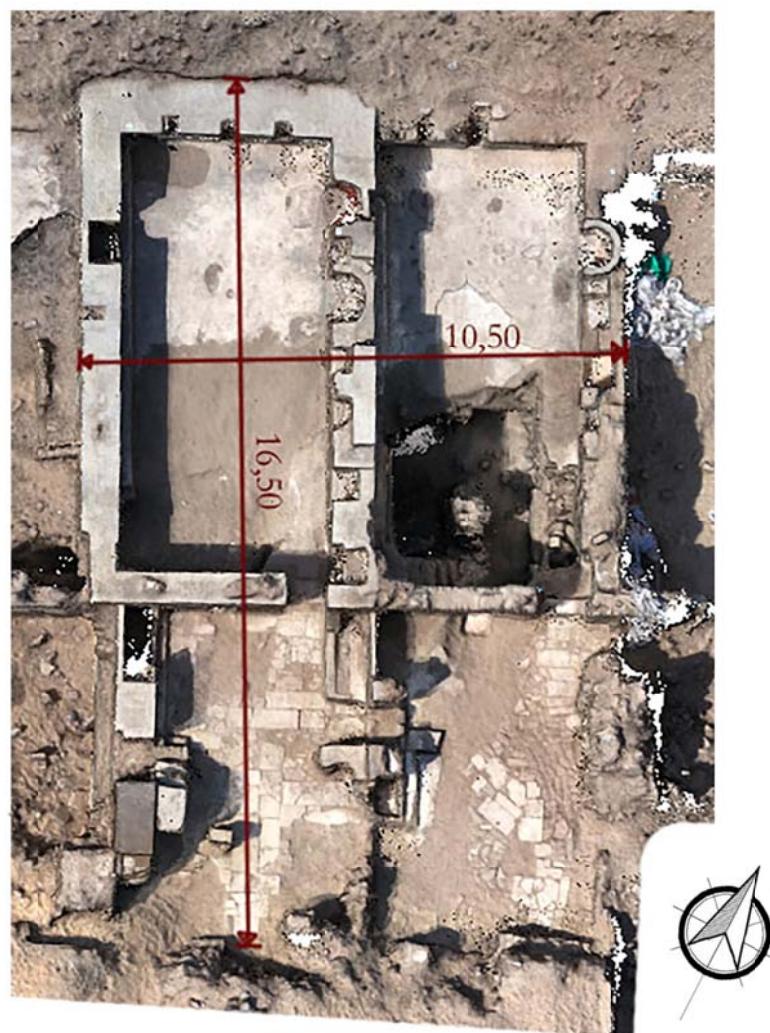
Fig. 2 - Plan of AU2-AU3. GoPro model

The acquired areas were: AU2 + AU3 (1243 photos) (Fig. 2); dump (981 photos before cleaning the eastern side - 1305 photos after cleaning) (Fig. 3); AU12 + AU13 (1420 photos) (Fig. 4); and, finally, the West wall including the West gate (1107 photos).

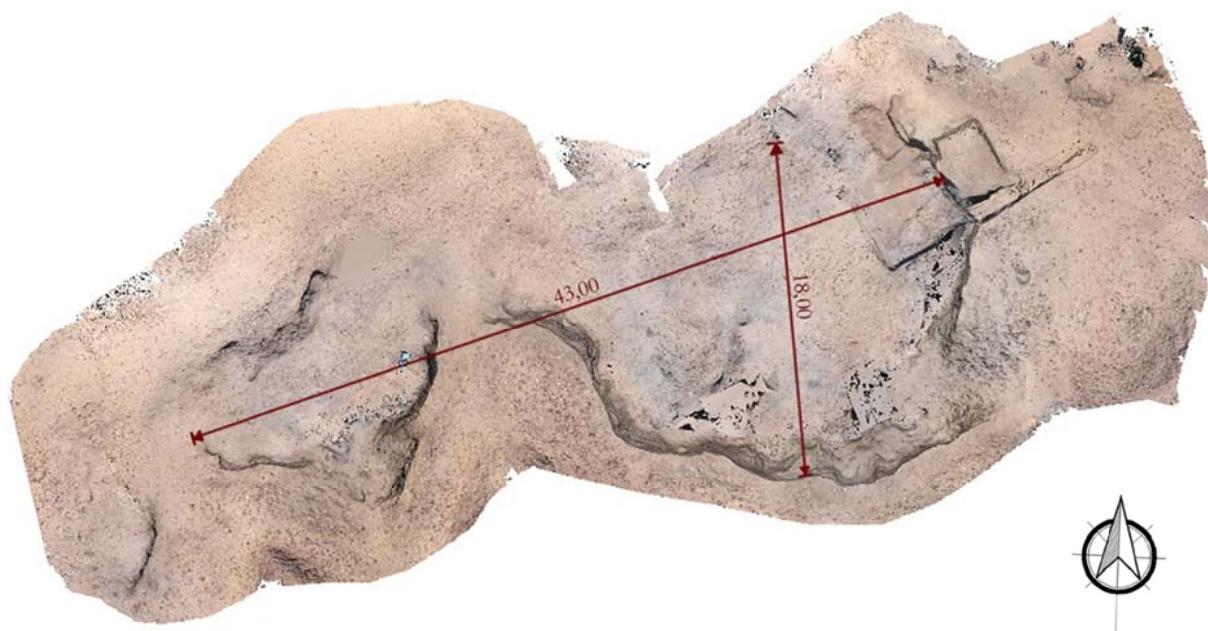
Fig. 3 - Plan of the so-called dump. GoPro model

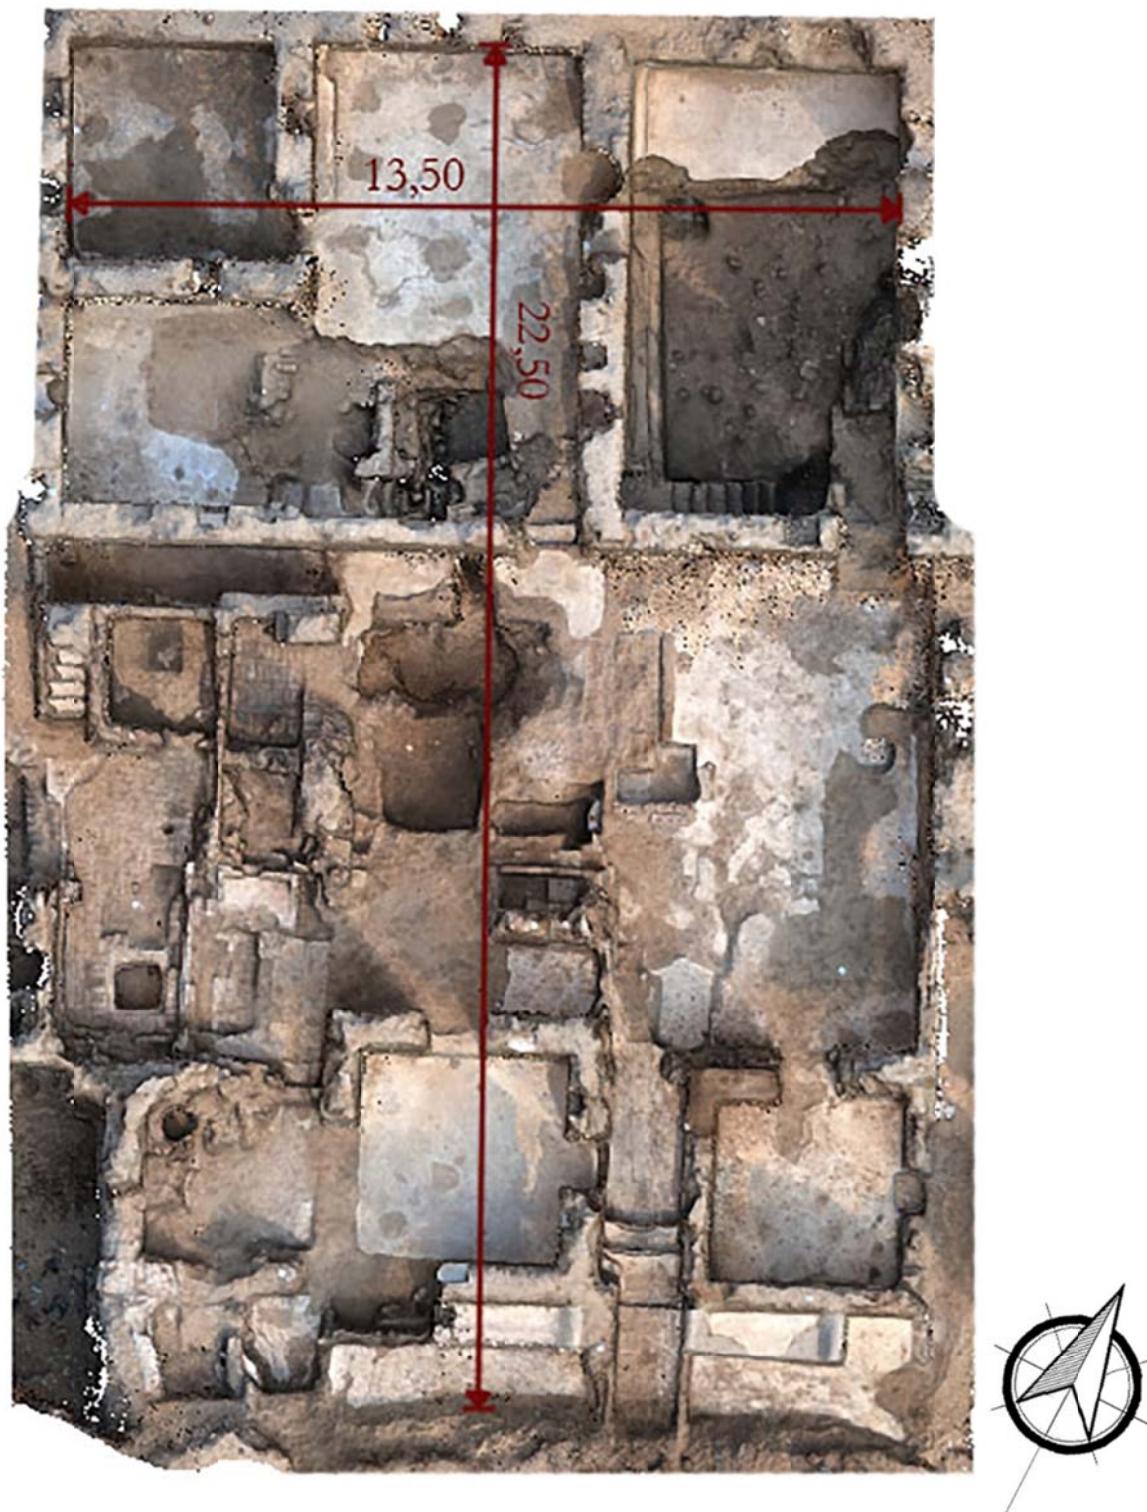
Fig. 4 - Plan of the AU12-AU13. GoPro model

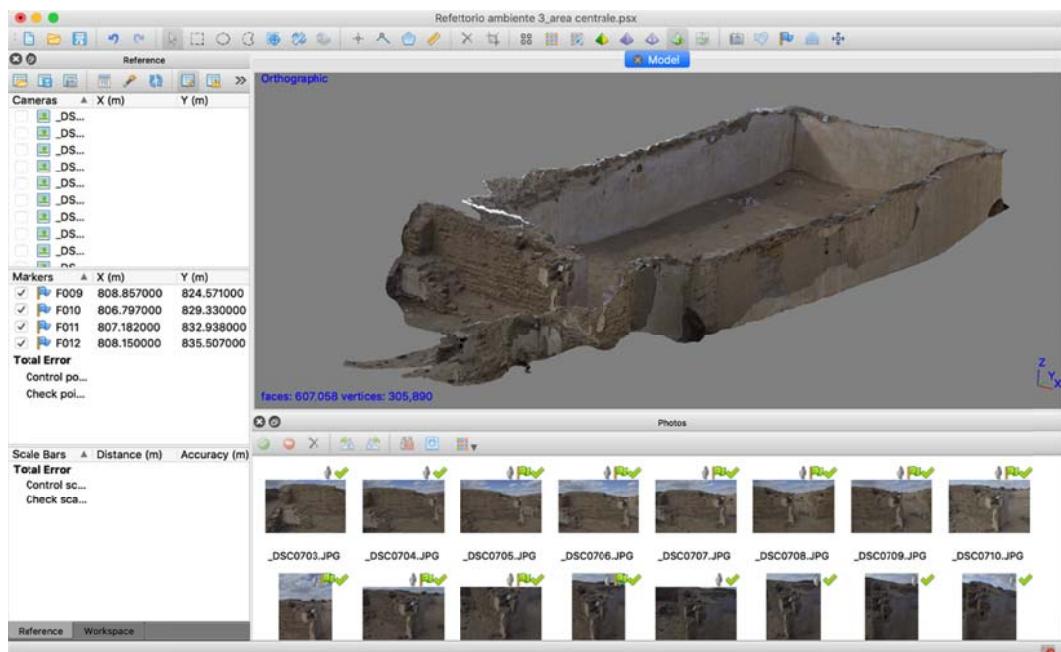
Fig. 5 - A view of the model of the room 3 in software Agisoft Photoscan

The acquisitions by Nikon D750 involved, first of all, the documentation of the wall decorations in the Central Sector of the site, in Room 3, in order to generate ortho-photos useful for studying the patterns. Two single walls were acquired (North wall of room 1, with 32 photos, and North wall of room 2, with 42 photos) and the whole of Room 3 (206 photos) (Fig. 5). Later, at the end of the cleaning operations, the acquisition of AU12 and AU13 was carried out. Different shooting modes were used, in order to obtain overall (248 photos) and detailed models (383 photos for AU12 and 265 photos for AU13).

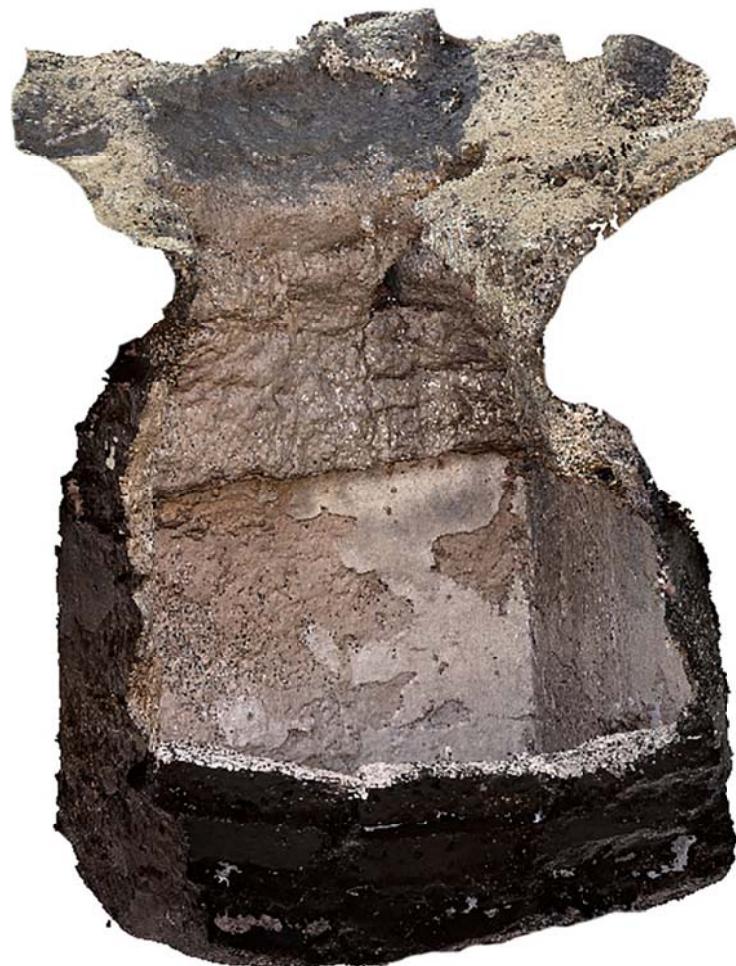
Fig. 6 - Elevation of the niche in AU2. Reflex model

Using the Canon EOS1300D 89 photos were acquired of the covering system of a niche in AU2S/W3 with the aim of determining the type of its original covering to guide the restoration (Fig. 6); 250 detailed photos of the plaster situated on AU12-AU13 walls to supplement the data missing in the GoPro model.

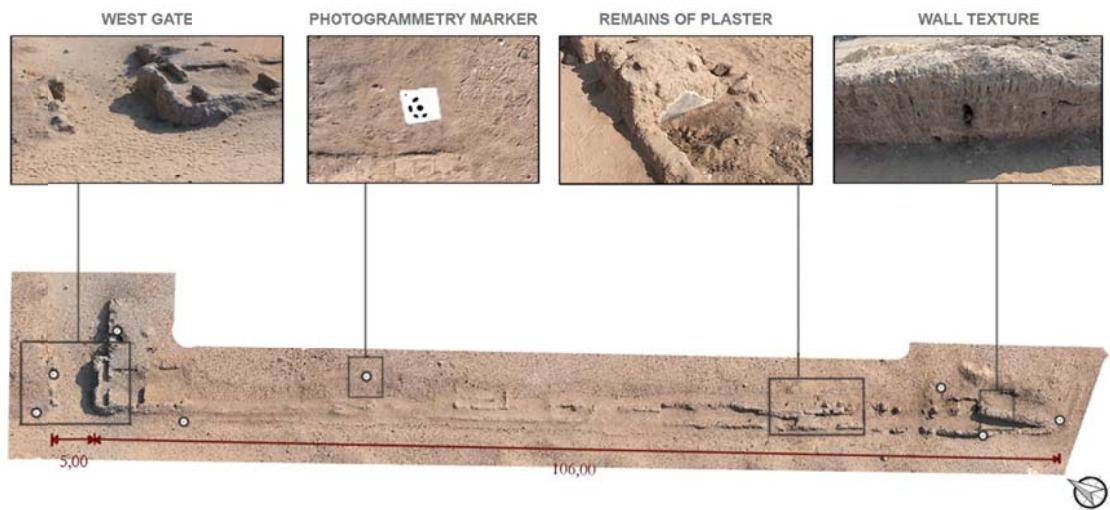
Fig. 7 - Plan of the West wall. GoPro model

The images were automatically oriented in a state-of-the-art SfM software application and the photogrammetric models (dense cloud and mesh) were scaled using a known distance thanks to the topographical grid (Fig. 7).

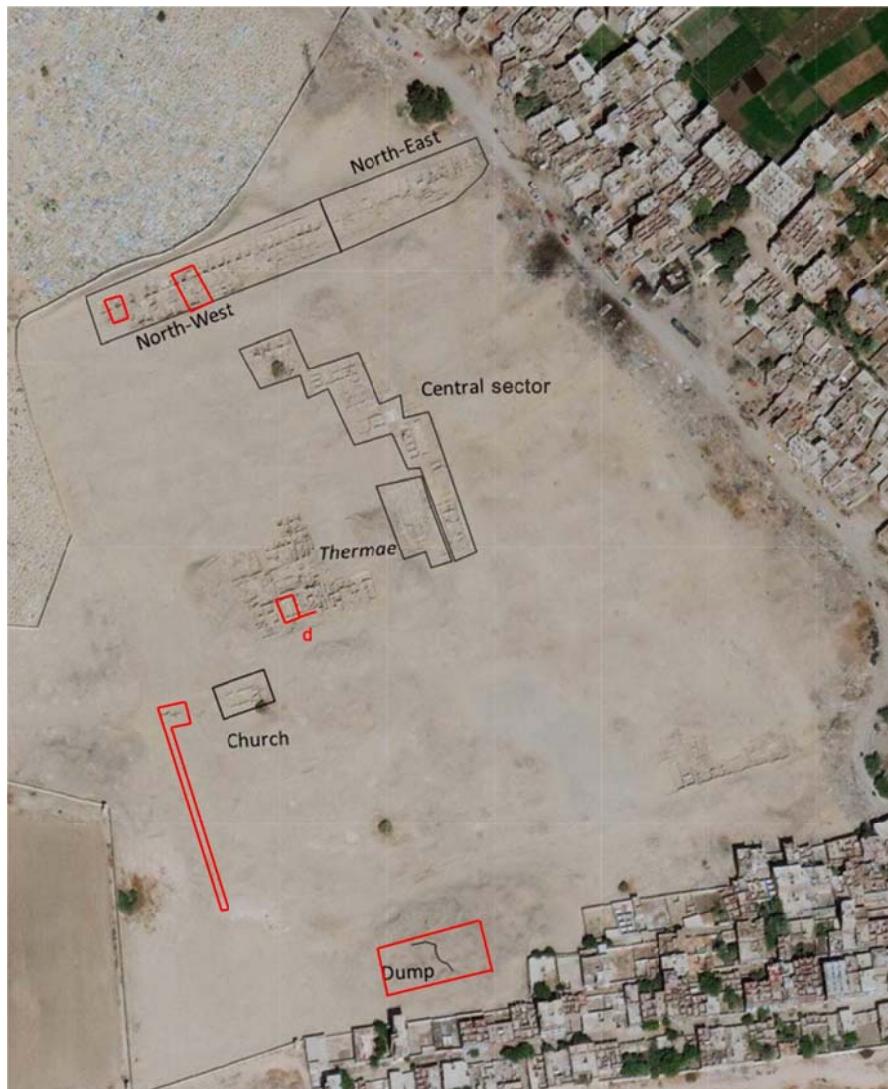
Fig. 8 - General plan of the site with the areas investigated acquired by photogrammetry: 2018 fieldwork (in black); 2020 fieldwork (in red)

The archaeological activities concerned four areas of the site: the Northern Sector (investigation of the Areal Units and their materials), the Central Sector (survey of the paintings), the Southern Sector, outside the town wall (trial trenches and pottery survey), and a preliminary analysis of the South-West corner of the city wall (Fig. 8).

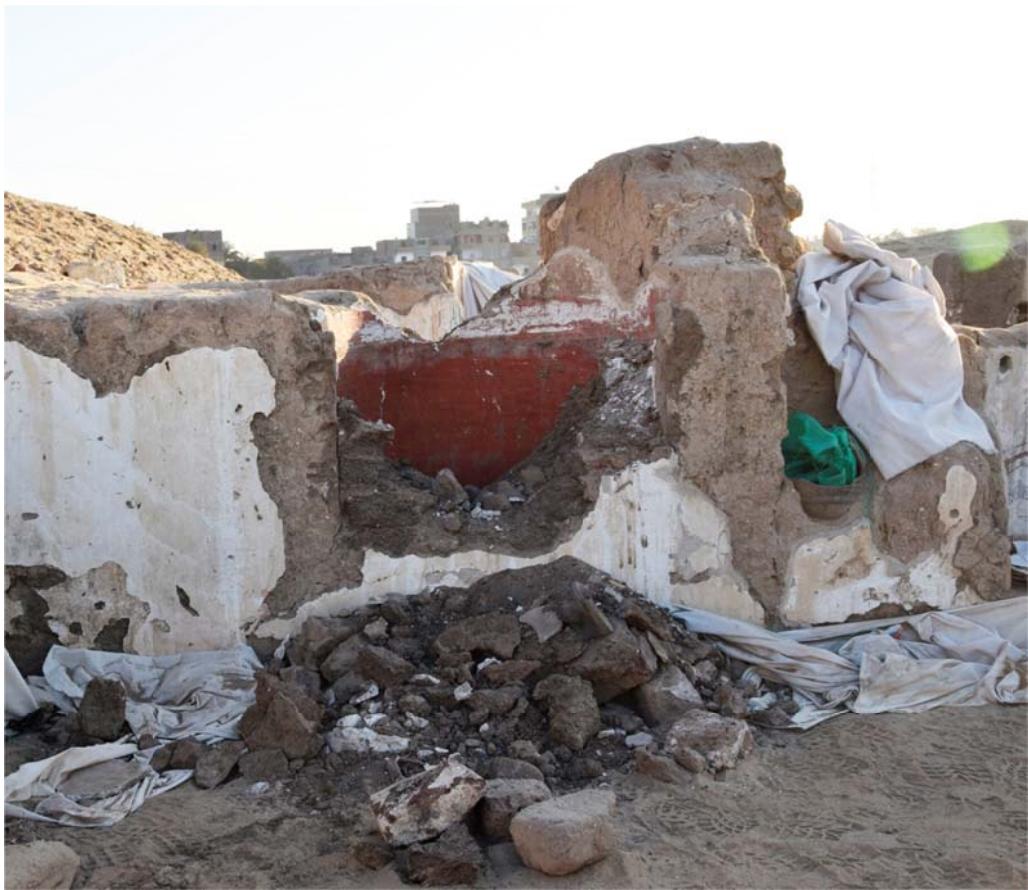
Fig. 10 - Niche AU2N/E7 after the vandalism

Although AU2 had been already cleaned and studied during the 5th campaign (Pirelli *et alii* 2018), the mission had planned to go on with investigation of its underground floor and its southernmost area (AU2S1), because the Egyptian colleagues could not dig them in past years. However, upon arrival on the site, we noticed that a destructive intervention by unknown persons had damaged the ground floor of the monastic cell (AU2N) and in particular one of its refined niches (E7) in the eastern wall. In this niche, a vase had been embedded in a secondary phase of use. Perhaps in search of precious objects, the vandals broke through the ledge where the vase (fortunately abandoned near the niche) (Fig. 9) was embedded, leaving the filling material partly in front, partly within the same niche (Fig. 10).

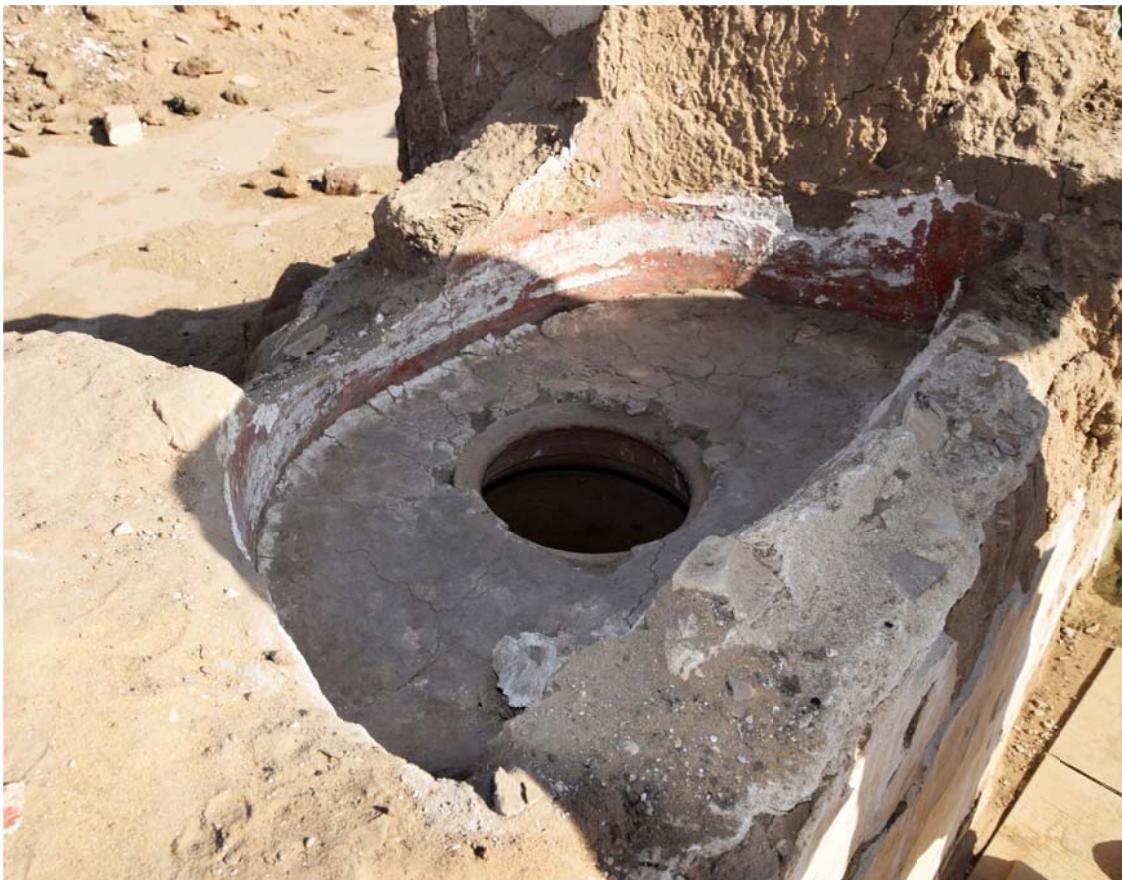
Fig. 11- Niche AU2N/E7 in 2018

The cleaning of the debris and the excavation of what remained confirmed our previous assumption: in a first phase an apsidal niche, with walls painted red, opened at ground level; at a later time, the niche was partially walled up (to a height of 73.7cm) - filled with debris and reused materials - and closed with a ledge; a large decorated jar was embedded in it, leaving only its rim outside (Fig. 11).

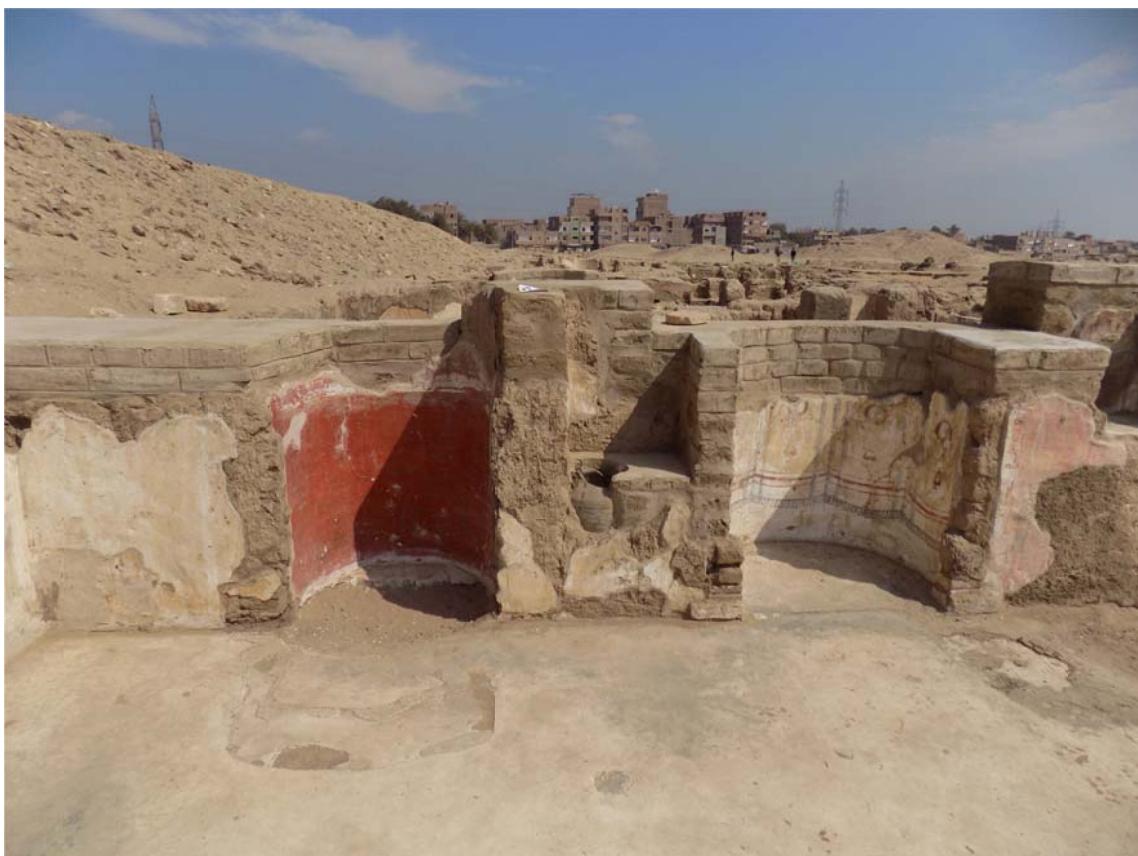
Fig. 14 - Niche AU2N/E7 after digging and restoration

an exceptional state of conservation which still shows the original vividness of colours: they will certainly allow us to better place the work of the artists of Manqabad within the tradition of Christian Egypt, and will constitute a fundamental reference point for constructing at least part of the relative chronology of the site (see below: Bragantini, § B.2.1). After the excavation and cleaning of the niche, the whole East wall was restored (Fig. 14: see also below § E.1)

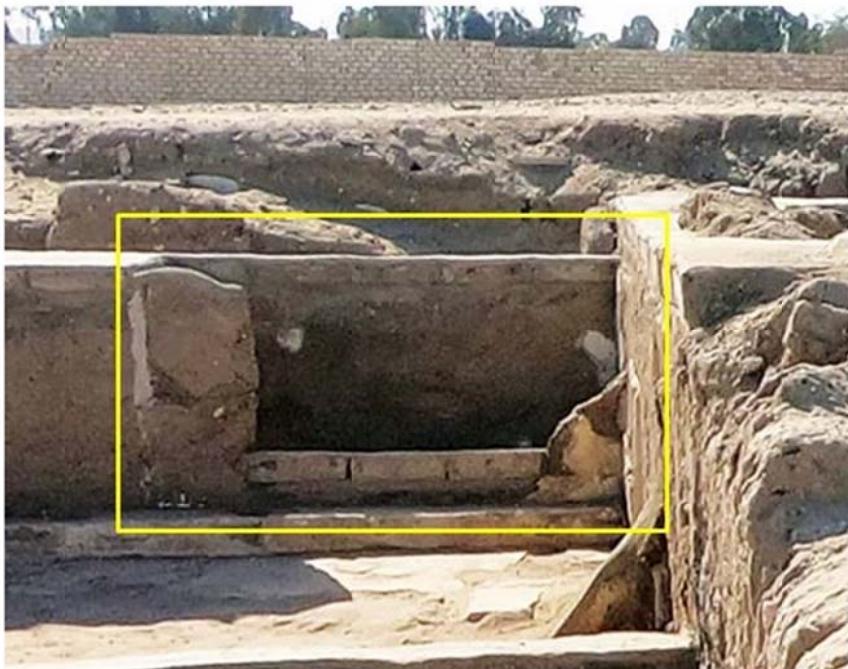
Fig. 15 - Niche/storeroom AU2S/W1 after digging and restoration

The niche/storeroom (Fig. 15) (dimensions 135×48.5×98 cm) was built when the West wall of the court was reinforced in phase 2 (Pirelli 2018, 310) and was inserted between the southern wall of AU2N and the thickening (60cm) of the western wall of AU2S; its floor is about 15cm below the walking surface of AU2S, and access to the internal space is partially reduced by a low curb (about 7cm high) that runs along the base of the niche, and by a thin wall (32cm wide) that limits its width to the South.

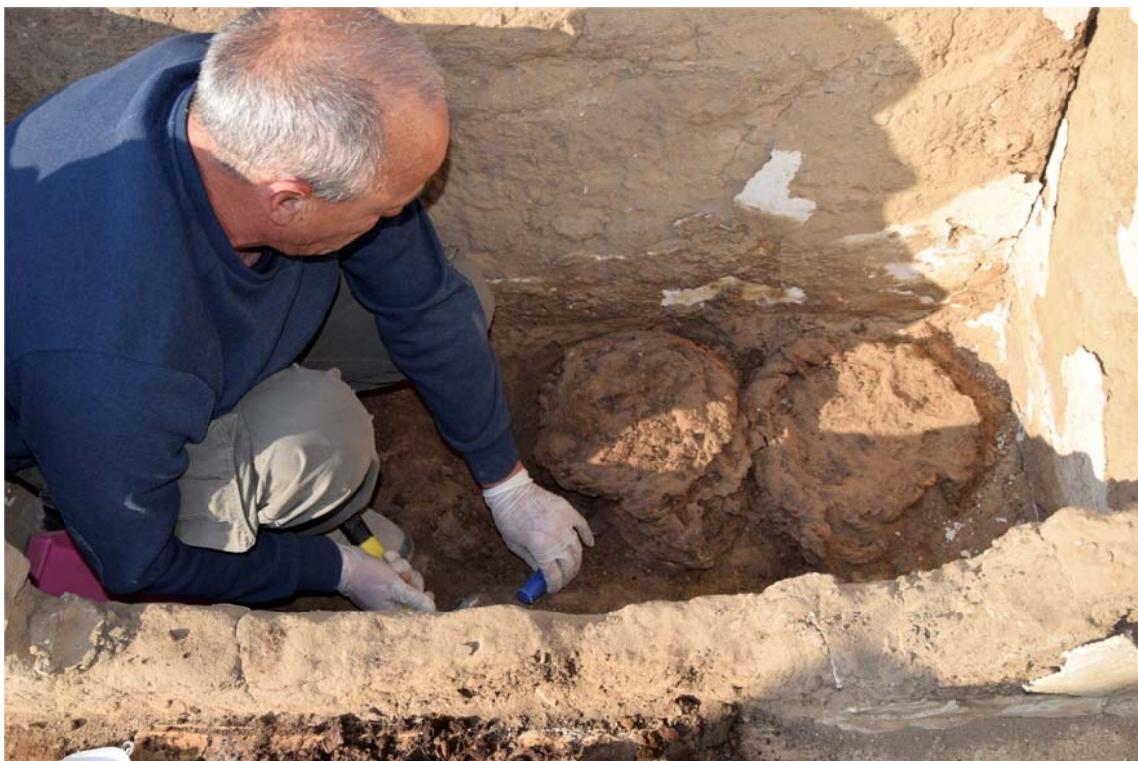
Fig. 16 - The thick ropes from niche/storeroom AU2S/W1, during extraction

The small storeroom was partly covered by a modern anthropic deposit (dating back to the time of the Egyptian excavations), partly by the collapse, in ancient times, of a portion of the West wall (W1, II phase). The modern deposit (1) contained a few potsherds in loose sand, while the ancient one (2) was composed by compact soil and sand with some potsherds, fish bones, animal bones and seeds. By removing both of them, a thick and hard layer of organic and inorganic materials in concretion emerged (3). It was carefully removed and several items were sampled for future analyses: fish bones, animal bones, minerals (especially quartzite and calcite), shells, fragments of leather, fragments of textile; fragments of vegetal fibres (possibly palm tree stalks); pieces of wood; flowers and leaves; snails; a huge amount of different seeds (date and olive seeds were clearly identified); fragments of glass; potsherds. Some metal instruments were also found: a square-section nail and a pair of tweezers with a round hook and a spike, probably used to pull out date seeds. Within this thick layer, two circular skeins of large ropes (\varnothing 37 and 26cm) (Fig. 16) and

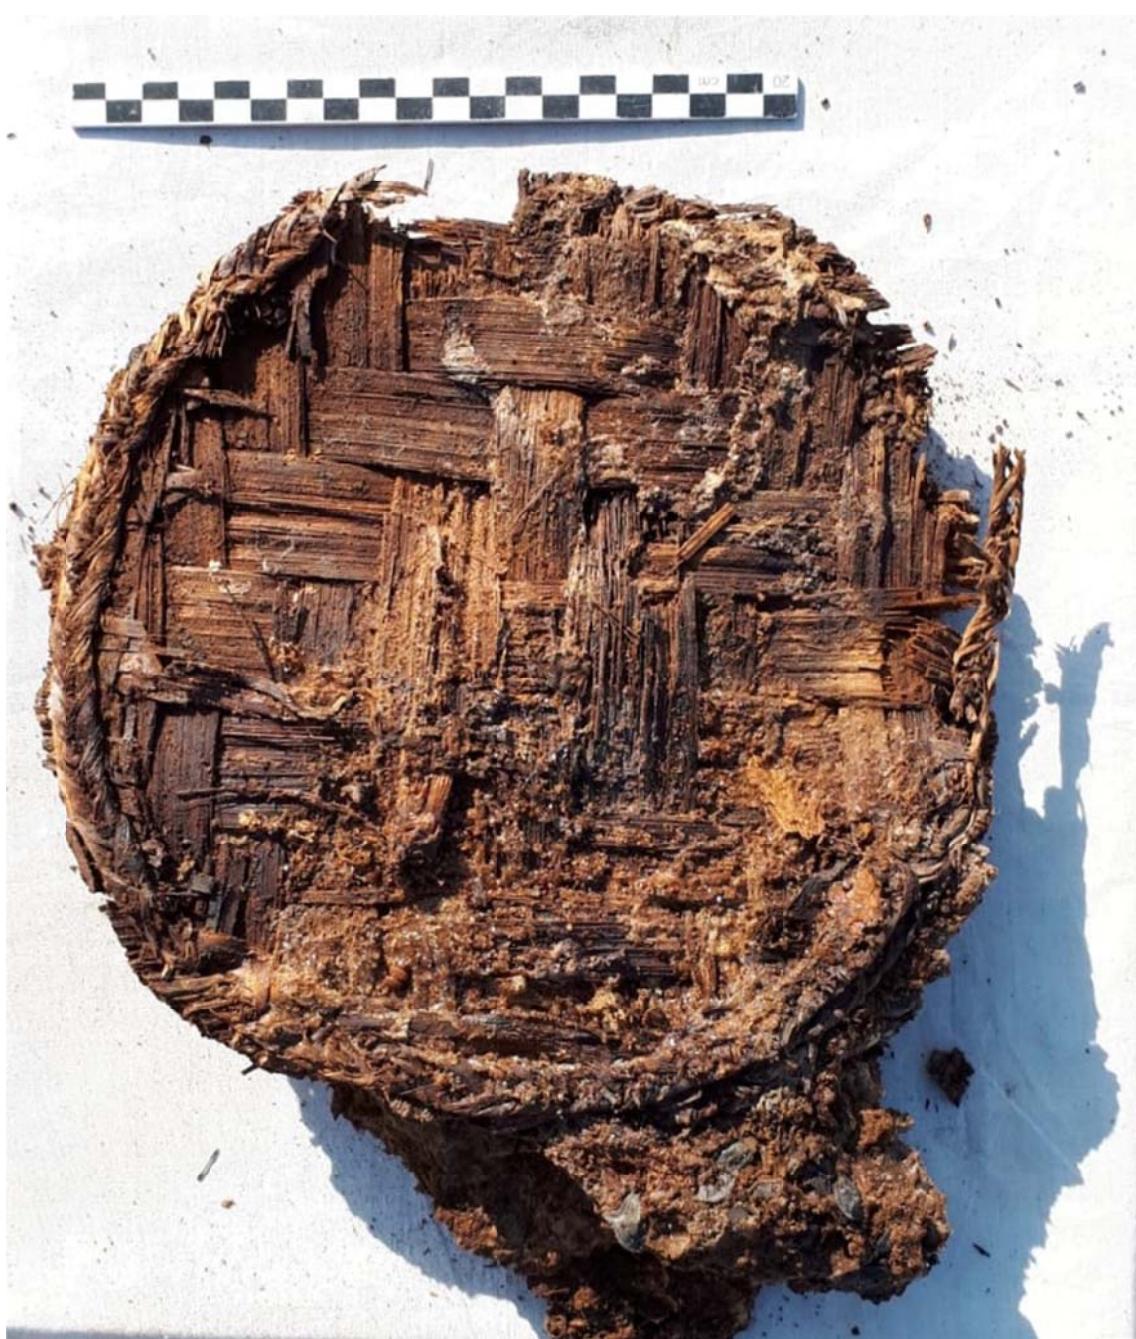
Fig. 17 - The bottom of a basket from the niche/storeroom AU2S/W1

the bottom of a basket (\varnothing 24.5cm) (Fig. 17) were also concreted.

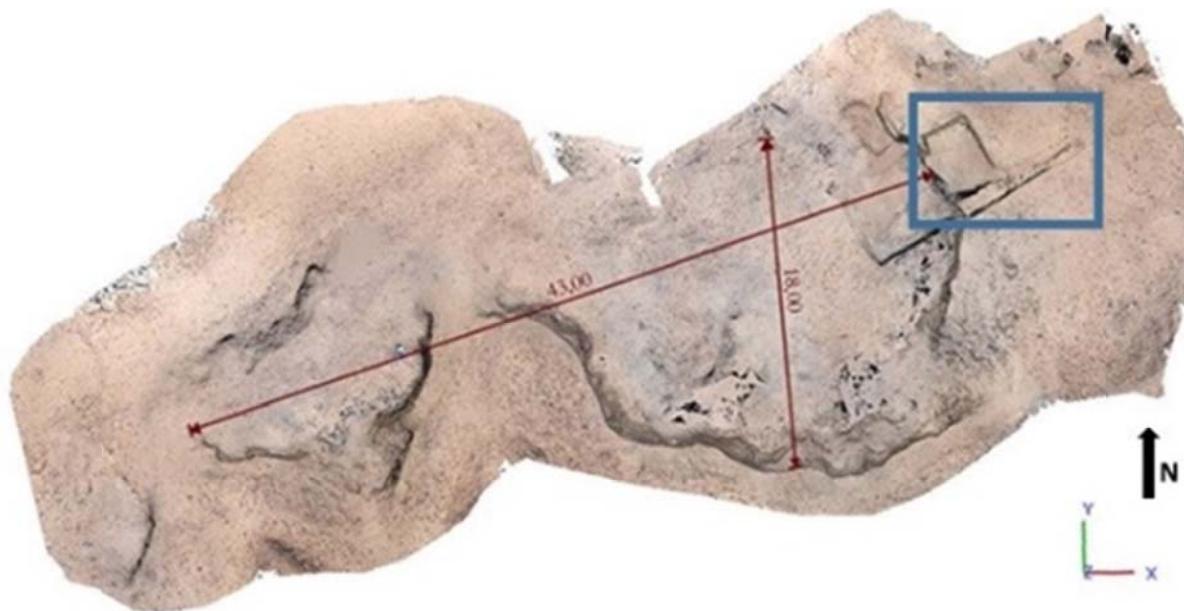
Fig. 29 - 3D model of the dump area (the blue area indicates the Trench Pits sector)

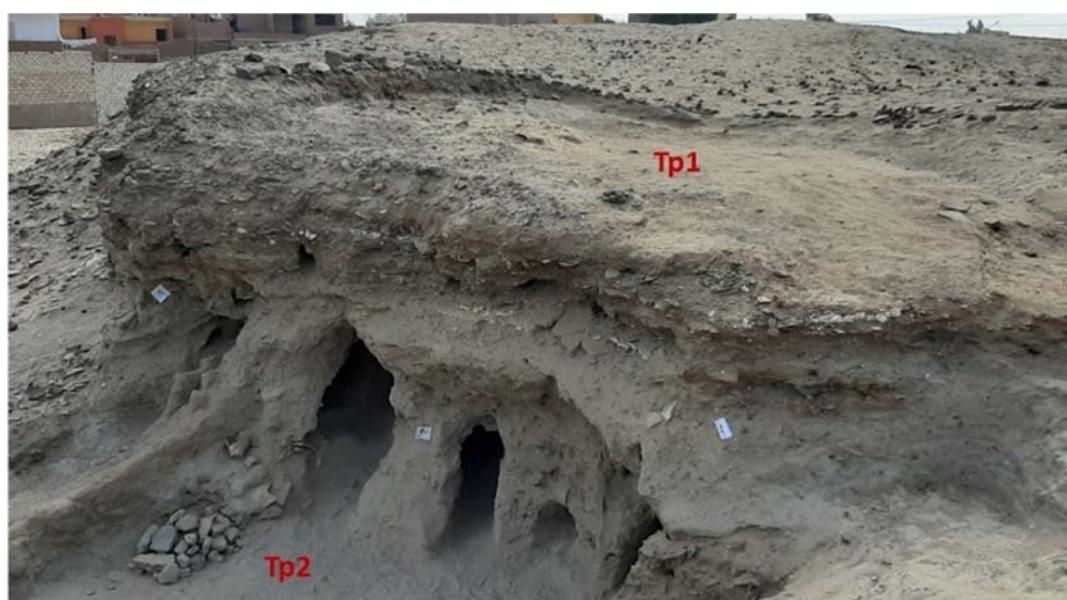
Fig. 31 - Trench Pit 1

The first square trench pit (Tp1) of 4×4 m was opened in the top of this structure, revealing a complex stratigraphy made up of five different layers of deposits, often mixed by natural atmospheric agents. In order to identify the extension and nature of each layer, the trench pit was enlarged (5×10 m). Clearly visible also in the vertical section on the eastern side of the structure, these layers can be summed up as follows: the first was made up of soil mixed with a huge number of pottery sherds, some whole pots, charcoal, and a great quantity of burnt bricks; the second, thinner than the first, was made up of pottery sherds mixed with light ash-coloured sand; the third looked like the second one, except for the presence of yellow sand mixed with vegetable fibres, limestone and flints; the fourth was made up of yellow sand mixed with potsherds and vegetable fibres. The fifth layer showed more or less the same composition as the previous one but was darker in colour.

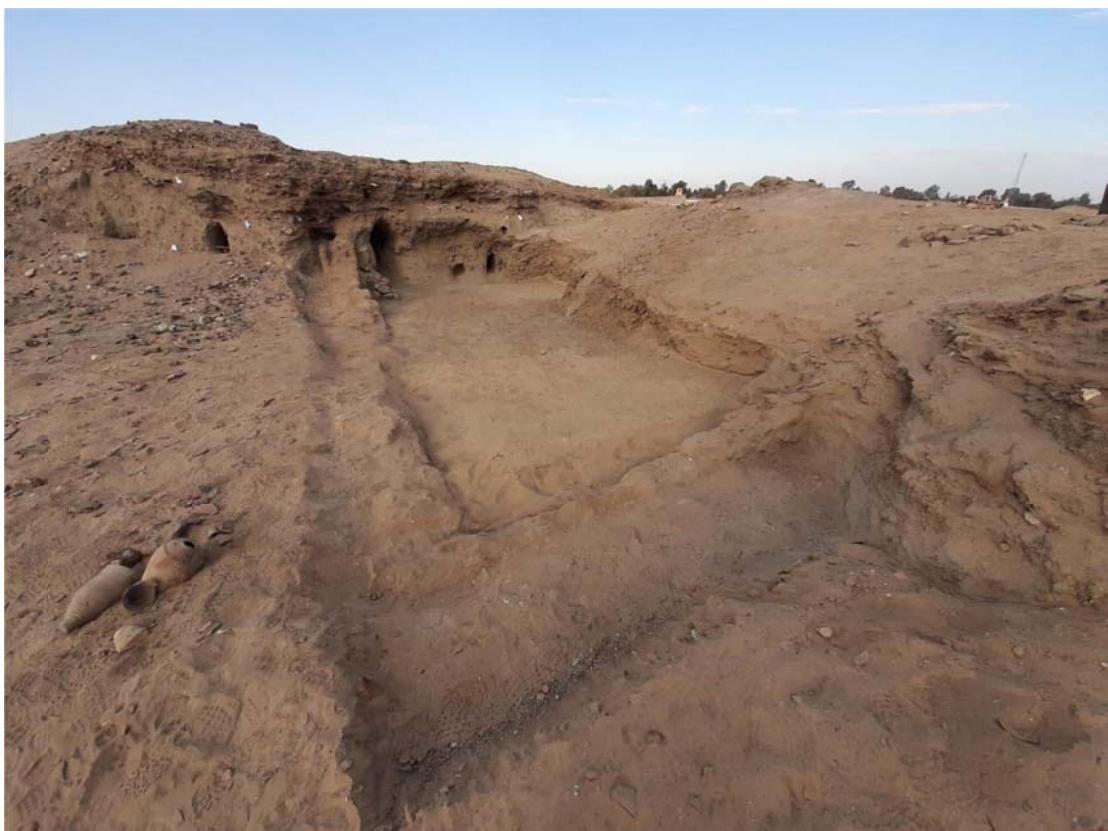
Fig. 33 - The brick wall connecting the main structure with a secondary one (Tp3)

On its eastern edge, the wall meets at right angles another mud-brick wall 2.54m long. This second wall runs from the façade of another structure similar to the former one and located just in front of it. A third trench pit (Tp3) was opened here. No openings have been found so far, but the stratigraphy - made up of unbroken and fragmentary mud bricks and baked bricks, complete amphorae, potsherds, mats, ashes and charcoal - revealed the same layers seen in the Tp2 structure. This suggests that the two buildings worked together as a single system (Fig. 33). This brief archaeological and topographical survey of the area suggests that the main structure should have a maximum size of 43.9×21.3m., with the possible addition of at least 4 or 5 smaller similar structures, maybe connected to one another by mud-brick walls.

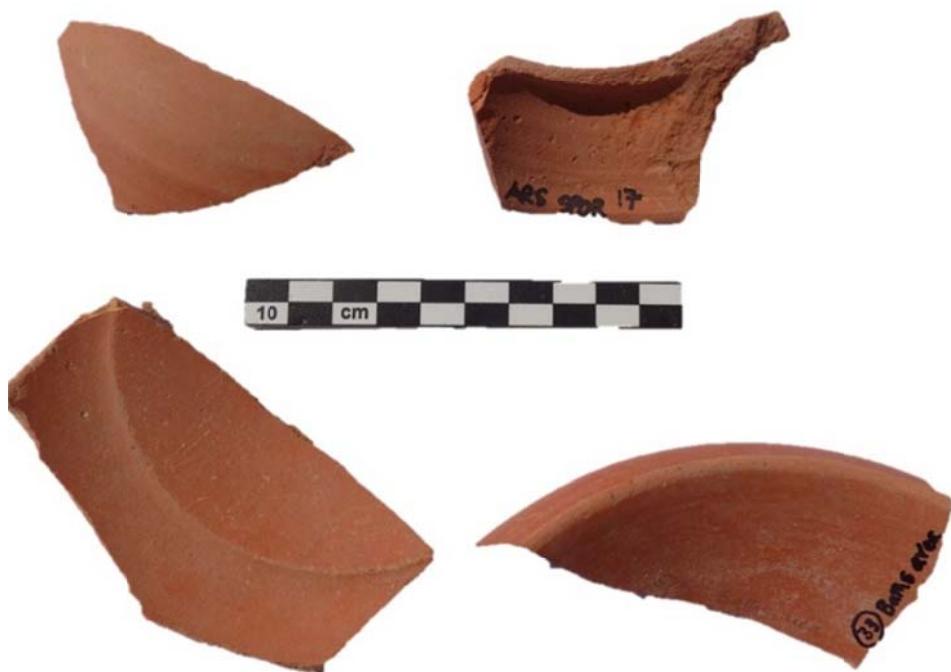
Fig. 35 - Fragments of African Red Slip Ware (ARS) from North Africa (early 5th-6th cent. AD)

Also documented were 7 African Red Slip Ware fragments from long-distance trade with North Africa. They can be dated to the early 5th to 6th century AD (Fig. 35). Other pottery in this category includes the Late Roman 1 amphorae from Cilicia or Cyprus (South-East of Turkey); Late Roman 5 Palestinian amphorae, which were also made in Egypt in a different workshop from the late 5th century onwards, and Gaza amphorae from that region. One rim of an African amphora was also noted. Altogether 101 drawings were completed to start a type series, and 82 diagnostic sherds were selected to be kept at the warehouse of the site. In addition, about 46 fragment of glass containers have been documented and stored (together with fragments of glass crucibles, evidence of glass production at Manqabad), in order to be analysed in the near future.

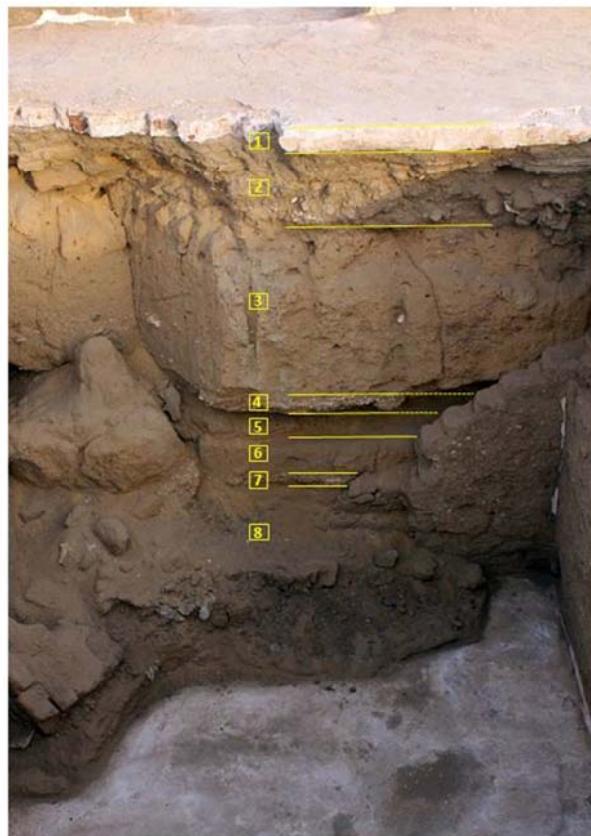
Fig. 36 - Geological stratigraphy in AU8/9S1/β

Considering that the two sections observed during the survey (AU8/9S1 and "qasr") are located respectively in the Northern and in the Central Sector of the site (about 150m apart), and that these are perfectly comparable, the entire archaeological area of Manqabad appears as resting on a homogeneous stratigraphic sequence consisting mainly of sands that makes up layers from small - (above) to well -compacted (deep) soils. This condition certainly had an immediate impact on the construction techniques, and in particular on the preparation of the screed immediately underlying the floors, as can be observed in the cases reported above.

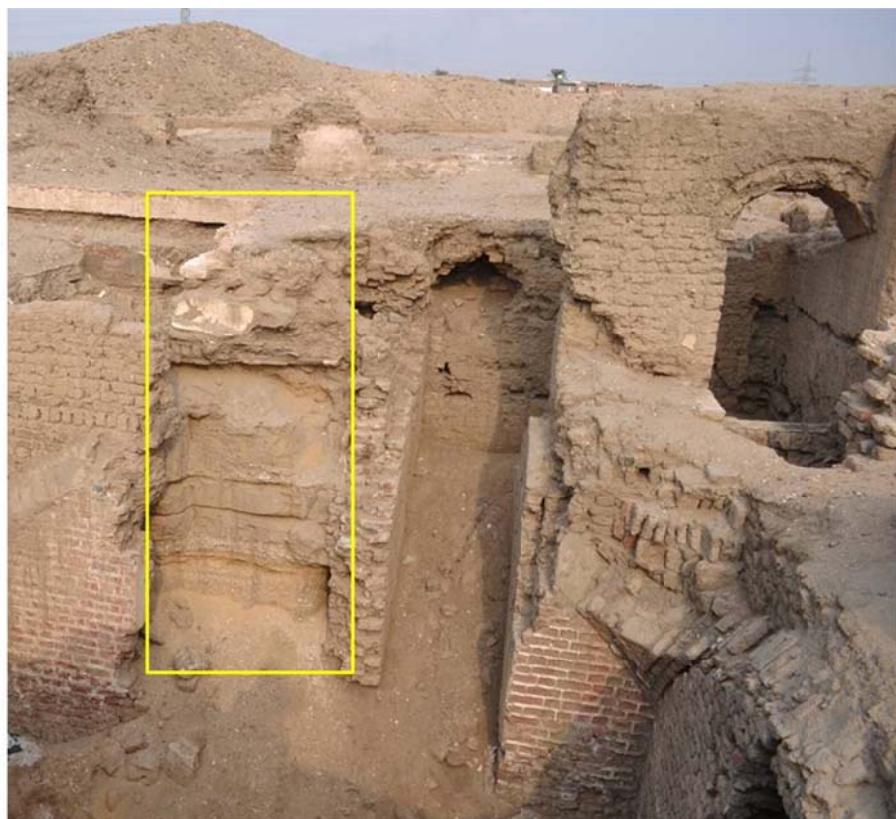
Fig. 37 - Geological stratigraphy in the “Qasr”

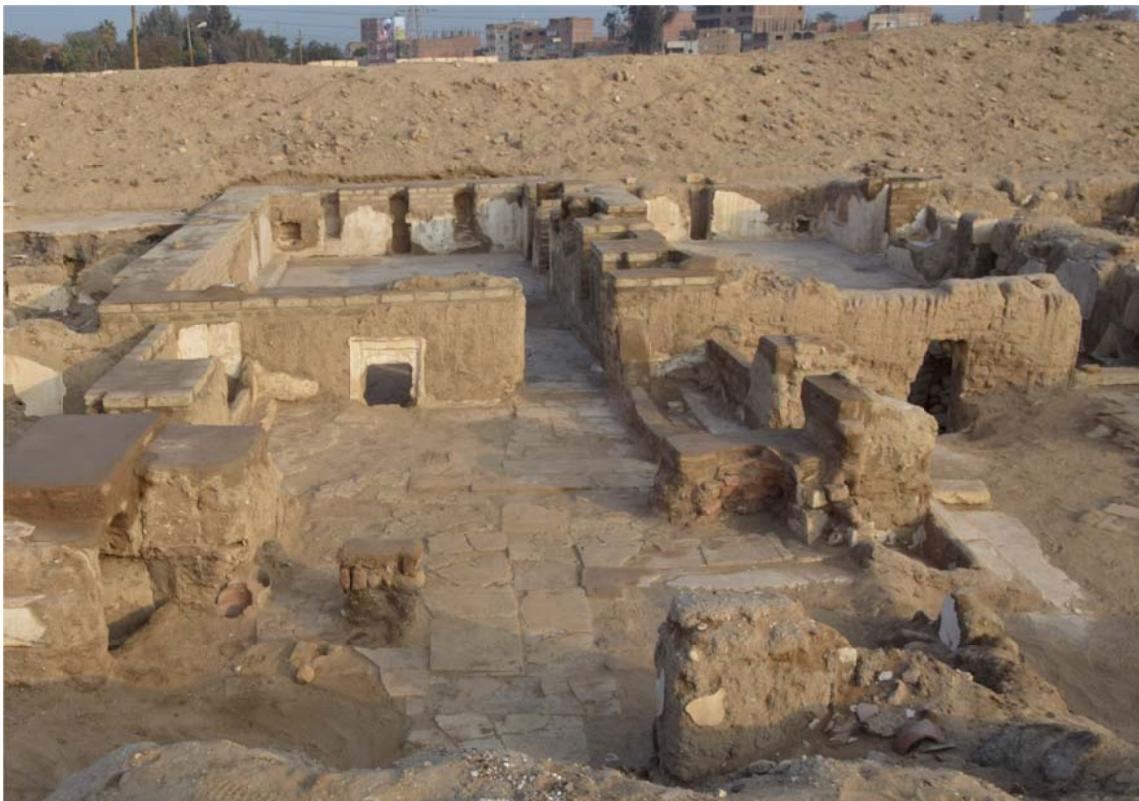
Fig. 38 - AU2 after complete restoration compared with the contiguous AU3

After the documentation of the niche/store-room and the collection of samples, interventions of anastylosis and restoration of the entire AU2 were carried out: it will constitute the restoration model for the other AUs during the subsequent campaigns (see below § E.1., Fig. 32).

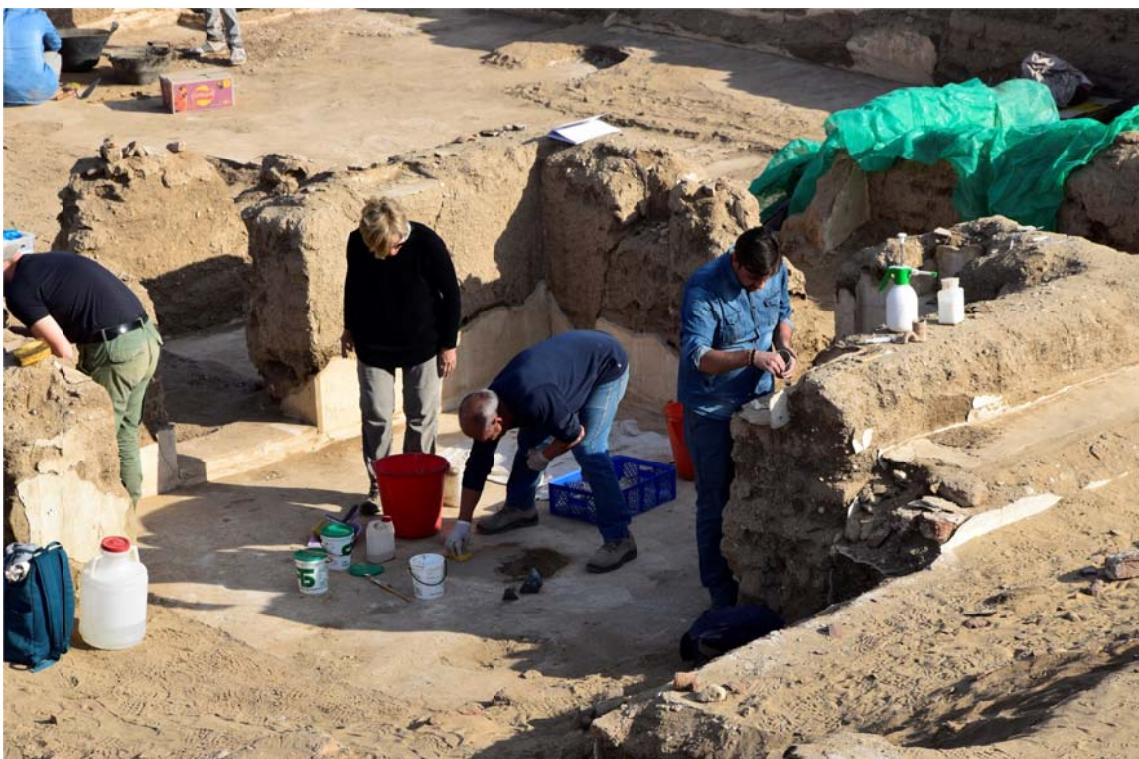
Fig. 39 - Restorations of the walls of AU12S1/a

was consolidated. In the southern area of this HU (AU12S1) other restoration activities were carried out. This important room, where the painting of the Virgin was found, was completely restored and consolidated, both in its vertical and horizontal architectural cladding. In particular some fragments of decorated plaster of the right pilaster of E1 (the niche of the Virgin), that were found near the niche itself, were placed in situ and consolidated using Acril 33.

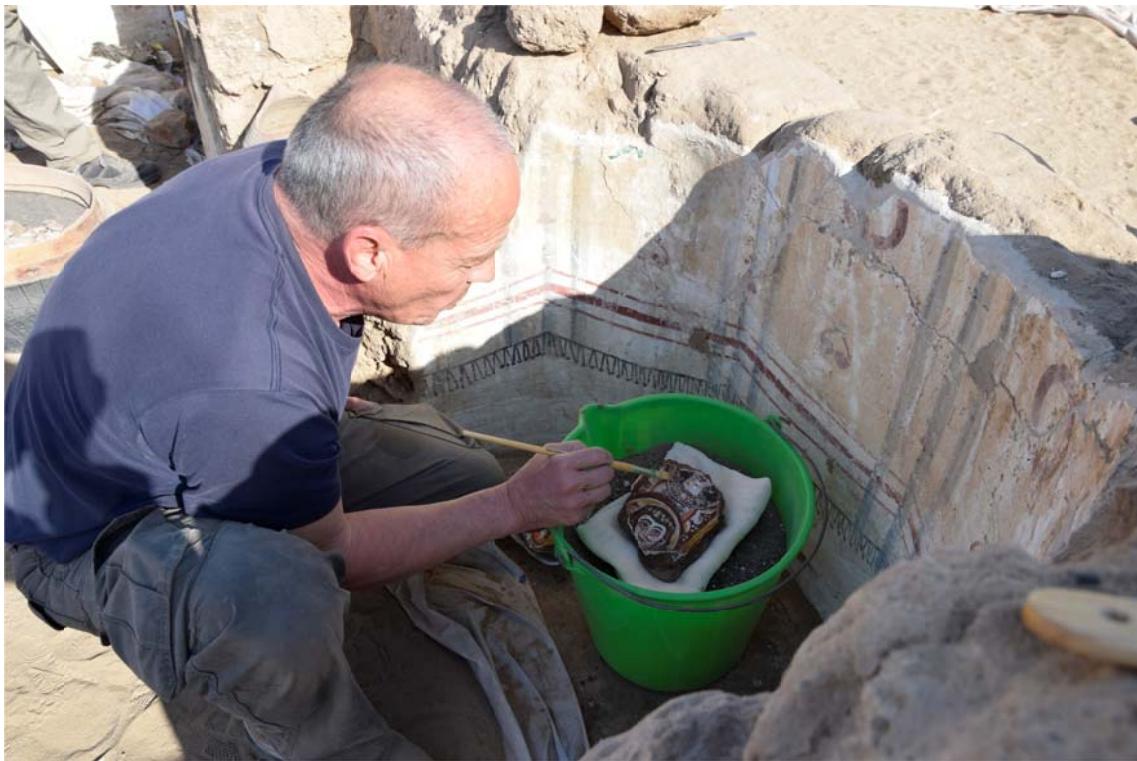
Fig. 40 - Consolidations of the paintings from niche E7 in AU2N
