A METHODOLOGICAL APPROACH TO COMPARE PROS AND CONS OF DELOCALIZING VILLAGES: SOCIO-ECONOMIC AND TECHNICAL ISSUES

THE 7TH MARCH 2005 LANDSLIDE

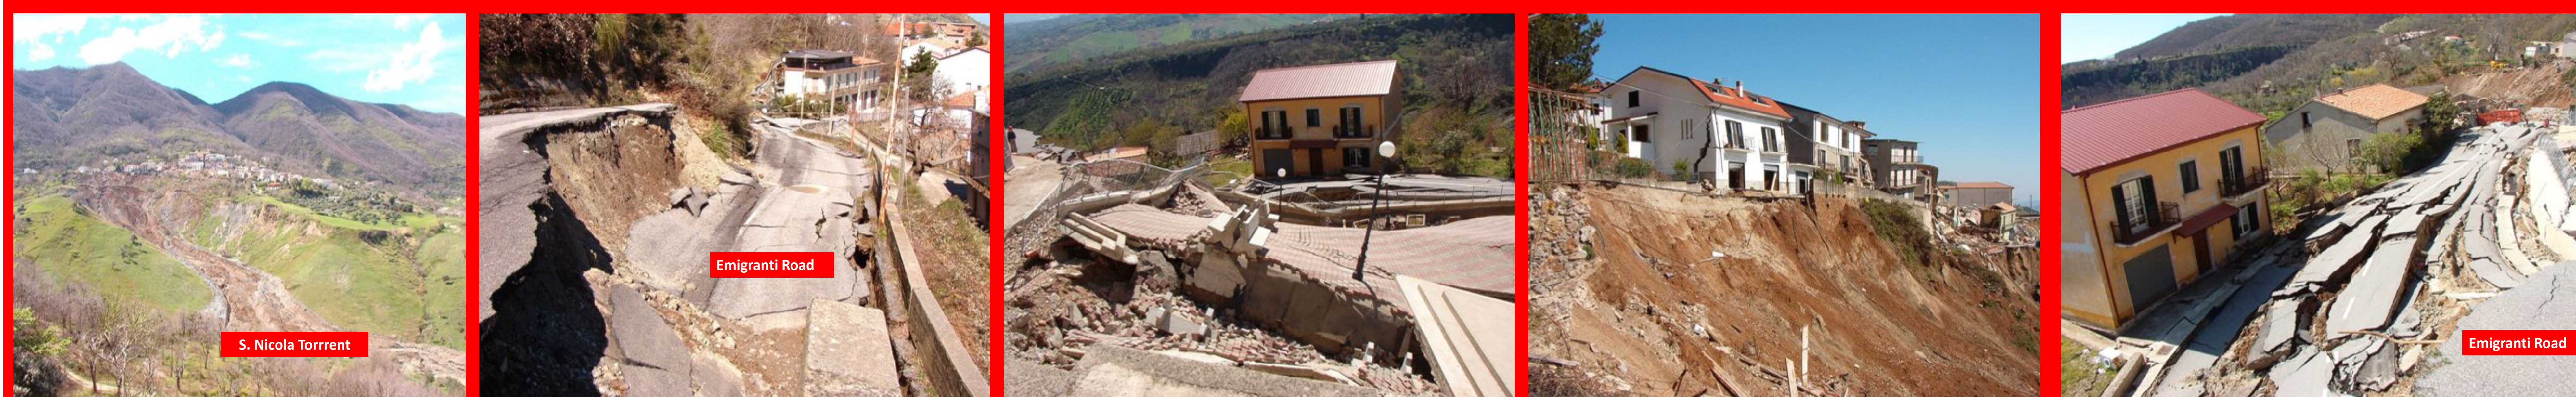
The Cavallerizzo landslide: panoramic view and damage caused to roads and buildings

- March 7th, 3 a.m.** One inhabitant who was still in the area for monitoring purposes, having noticed a rapid increase of displacements (ca. 6 cm/day), gave the alarm by ringing the church bells, thus allowing any people still remaining in the area to escape. Almost instantly through a series collapses, the southernmost part of the village was destroyed. Activity slackened during the following weeks.

- Direct damage.** The buildings along the main scarp were heavily damaged (L4), as was the road connecting the hamlet to nearby villages (L4), and the municipal and country roads located in the landslide area (L4). A school and a church suffered high (L3) and medium (L2) damage. Damage suffered by commercial, handicraft, farming activities, aqueduct and drainage system was L4, while electric and telephone lines suffered damage of level L2.

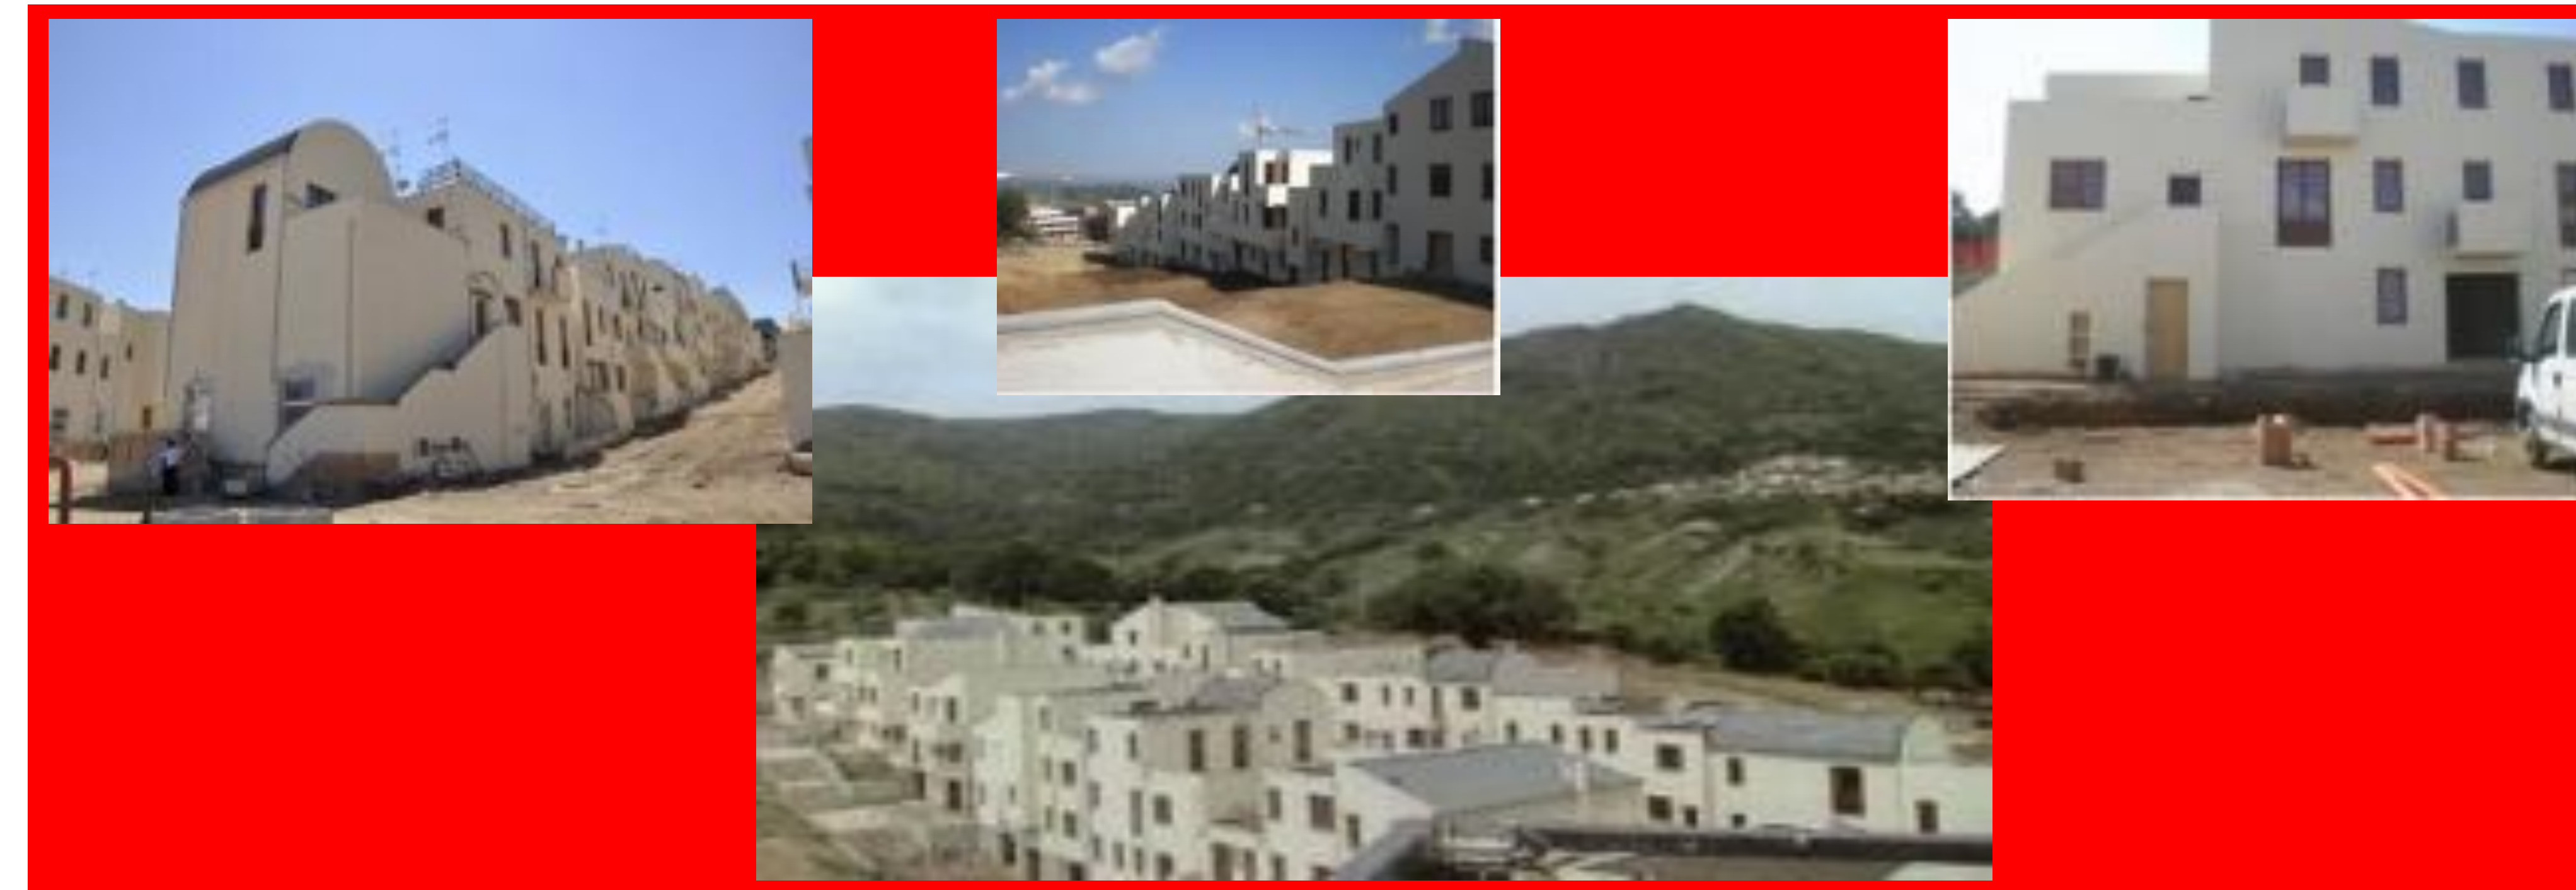
- The new Cavallerizzo was born in the village of Pianette downstream of the originating country.
- According to Civil Protection, the new town was planned taking into account the suggestions of Cavallerizzo inhabitants.

- The project followed the traces of the old village, trying to create an urbanized structure organized in five surroundings arranged according to the shape of the petals of a flower.

- The national government funded the construction of 260 dwellings in order to house 560 people. The houses were projected according to people requests.
